Operational responses to geotechnical asset failures impacting on transportation infrastructure.

BEAR Scotland North West Trunk Road Maintenance – efficient management of geotechnical emergencies.

27 October 2017

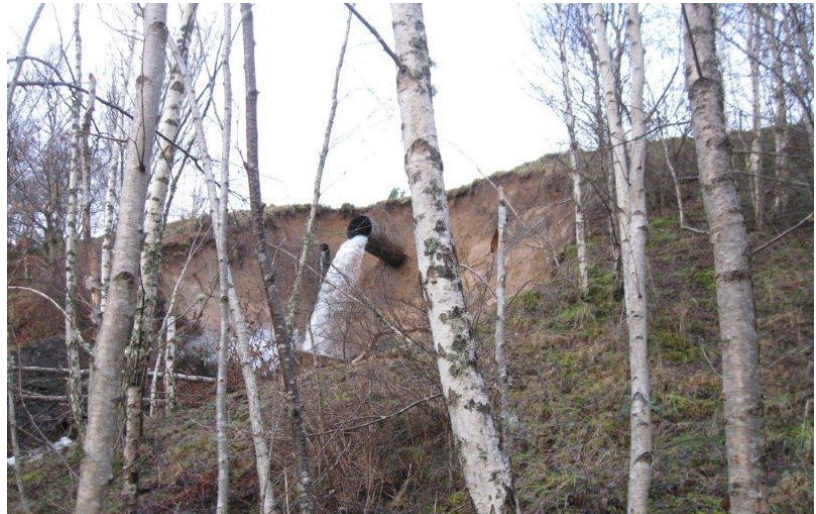
Post Failure

- Cause: embankment washout failure
- Date: 22 December 2014
- Scale: failure ~10m high and 10m to 20m wide
- Failed section of embankment 30+ years old
- Quantity of imported material ~5,000t
- Cost of remedial repair ~£80k

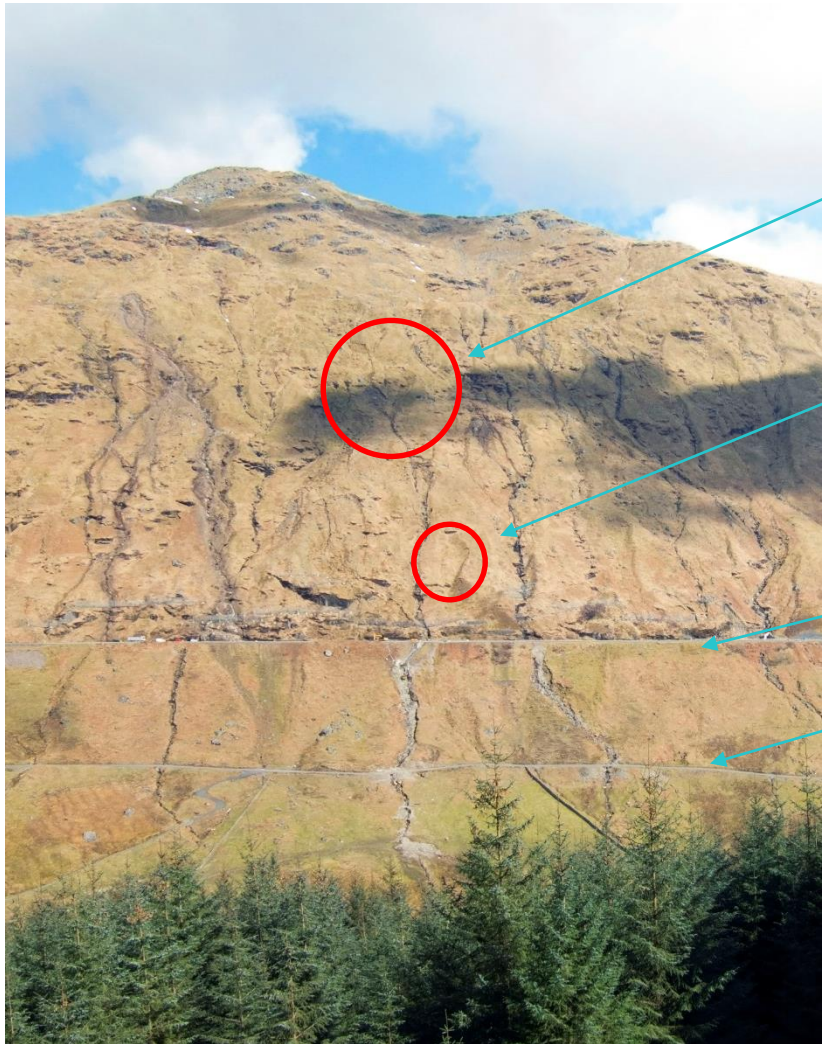
A83 RaBT – hillside prior to events of Dec 2015

Source of second failure
30 December 2015

Source of first failure
5 December 2015

Note: photo predates
failures and shows earlier
failures on hillside

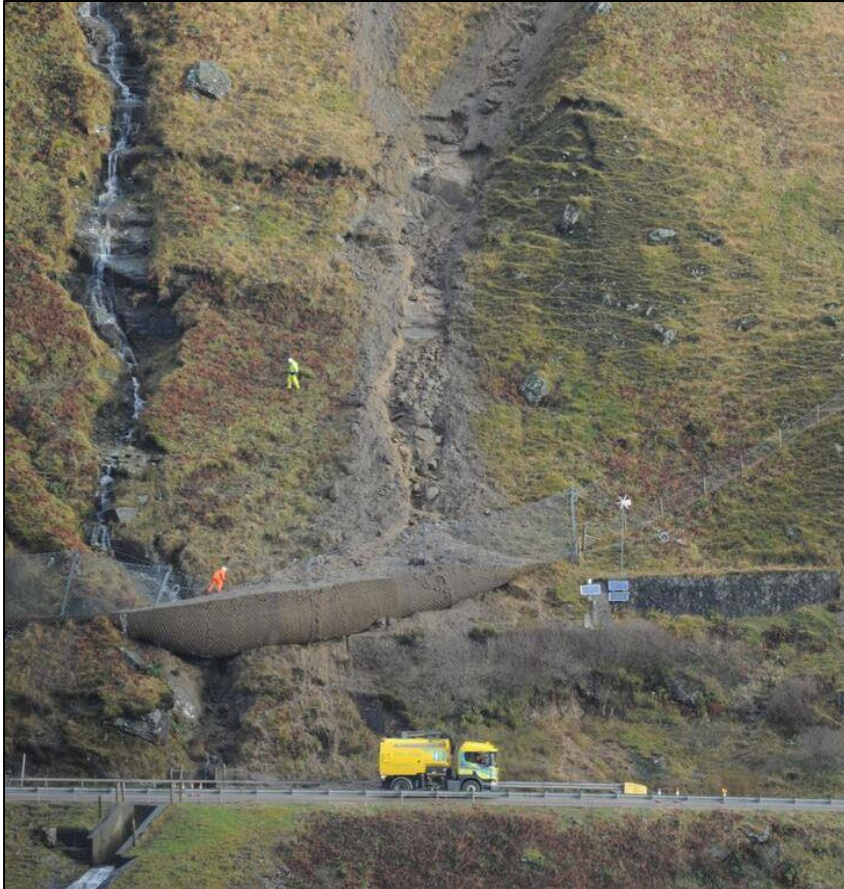
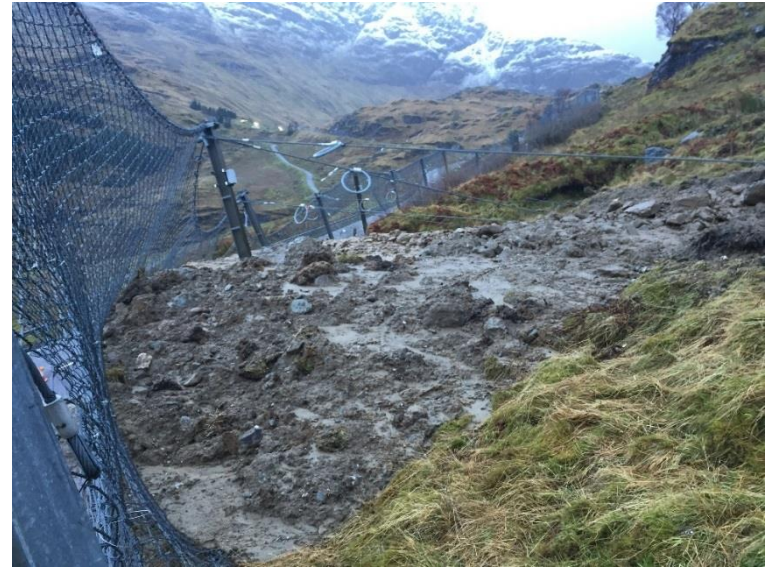
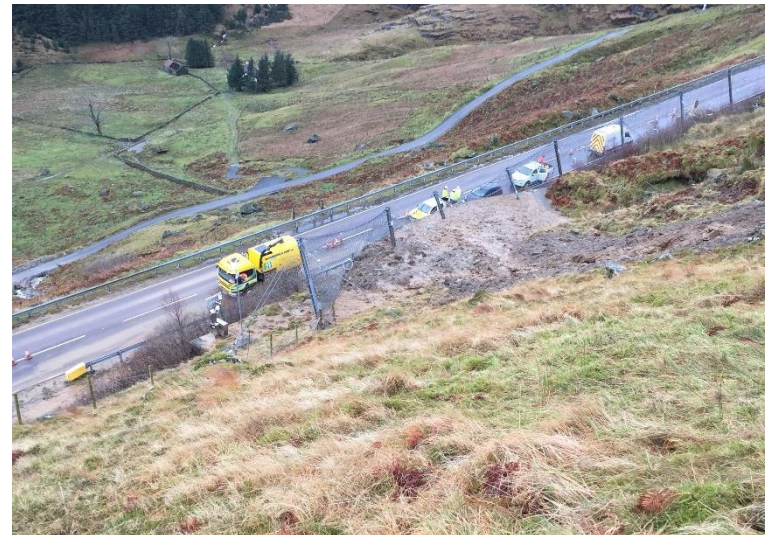
A83 RaBT – 5 December failure

- Cause: two significant debris flows
- Date: 5 and 30 December 2015 (storm Frank)
- Scale: initial failure ~60m above A83, second failure ~240m above A83
- Volume of debris flow: 5 Dec ~400m³ (intercepted by barrier), 30 Dec ~100m³ (breached temporary barrier)
- Barrier design capacity: 600m³
- Cost of repair ~£140k
