Track Monitoring Data Systems for Evaluation of Earthworks Instability

*Ian Payne – Senior Asset Engineer (Geotechnics)
Jonathan Garelick – Asset Engineer (Geotechnics)
Jason Lund - On Track Machine Engineer*

26th October 2017

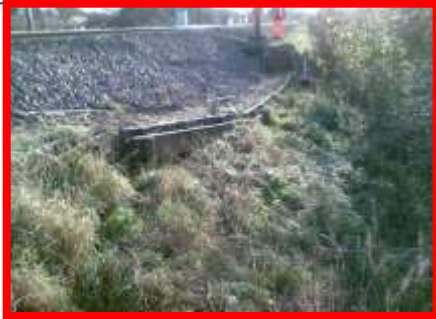
Deep seated London Clay embankment instability
Chelmsford 2009

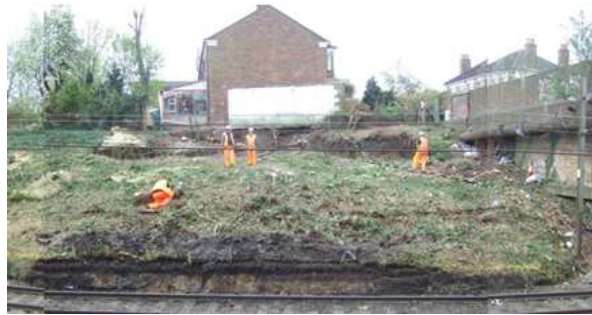
London Clay cutting slope failures
Walthamstow Central 2009

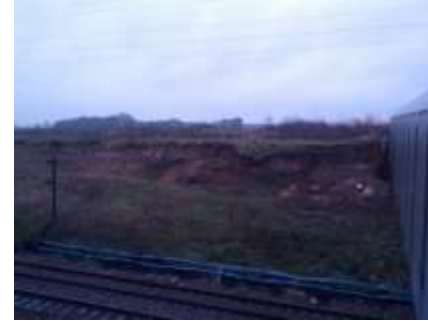
Perched Water table instability
(Tills over Clays) Brantham Hall 2014

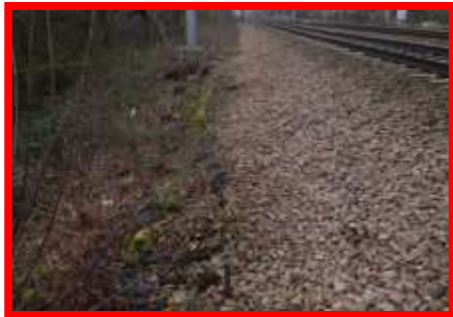
Ash degradation /instability
Nags Head Lane 2016

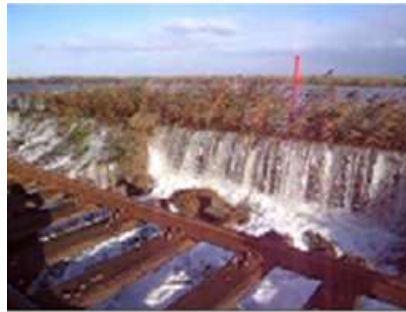
Storm Surge track and embankment washouts
Haddiscoe 2014

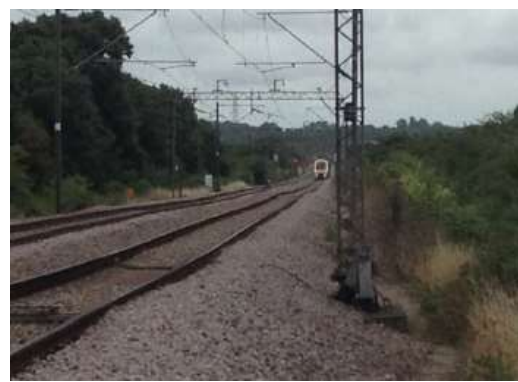
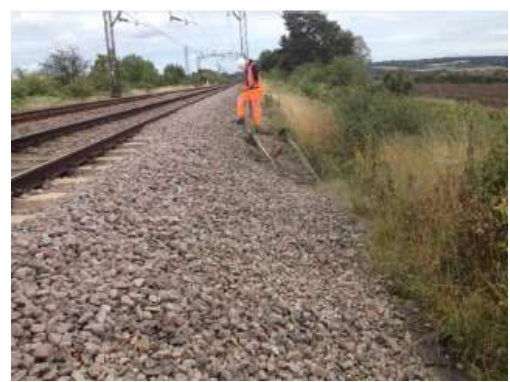
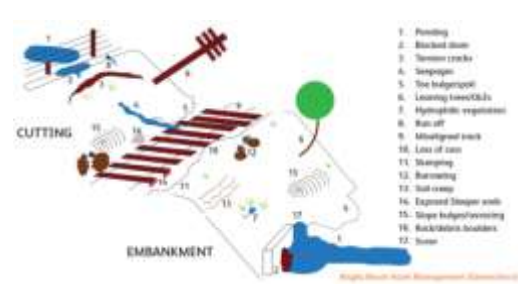
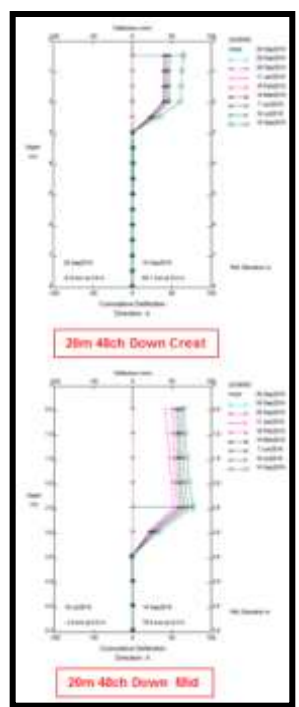
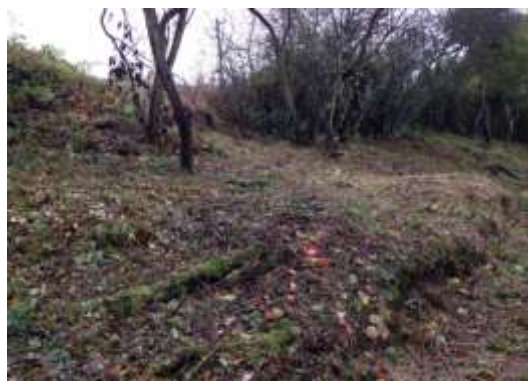
West Horndon to Dunton - FSS2 19m 35ch to 20m 55ch

Typical of issues on many embankments in Anglia

- Slope Slip Surface Instability
- Soil Creep
- Vermin Burrowing
- Tree Root Desiccation
- Ash Degradation

- Thick Ballast
- Structures Run-on/Run-off
- Poor Toe Drainage
- Locally Prolific Hydrophilic Horsetail
- Wet Beds
- Inadequate Cess Walkways
- Historic Patchwork of Treatments

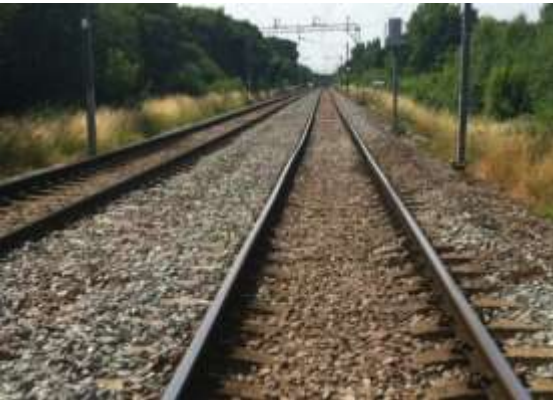
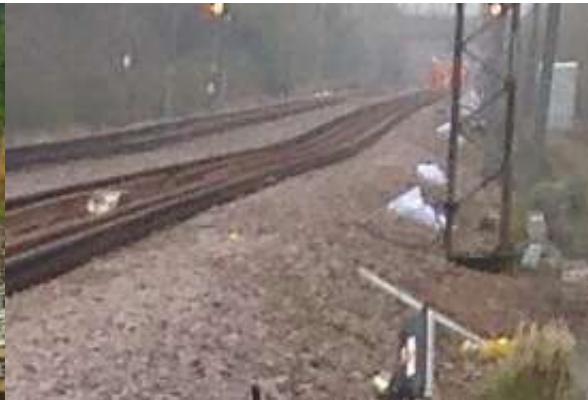
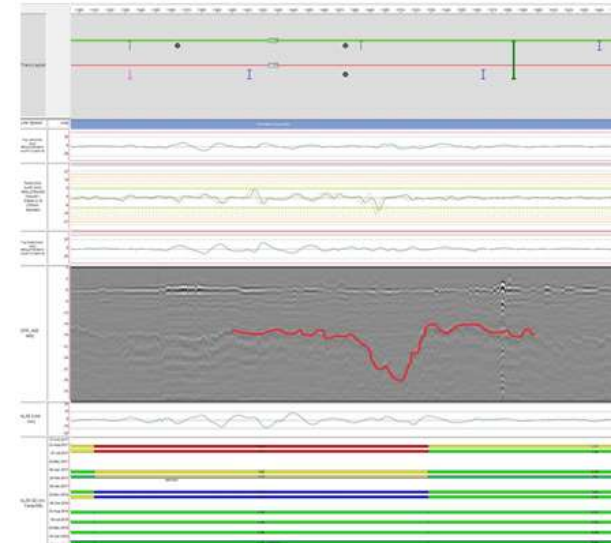
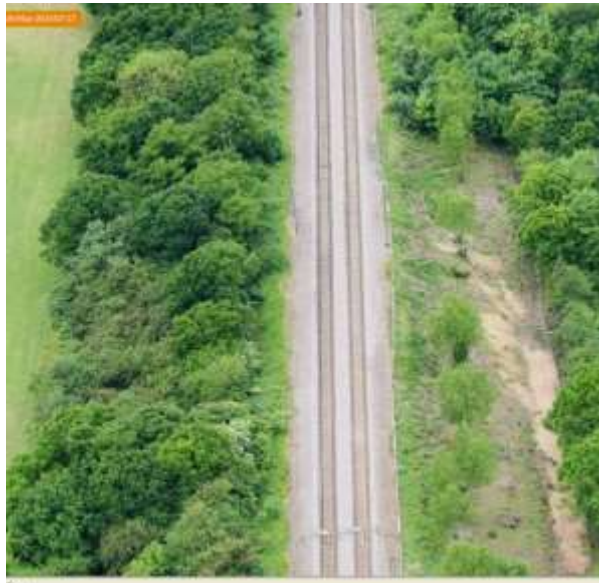
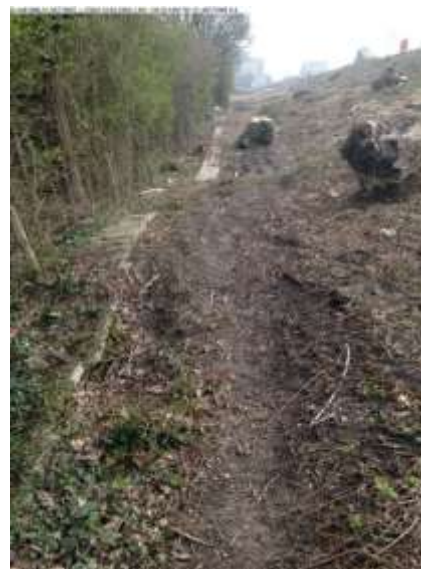
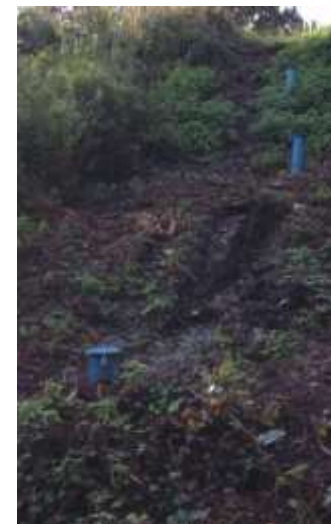
Ashdon Way Basildon – Deep Seated Progressive Embankment Failure (FSS2 23m 60ch to 24m 10ch)

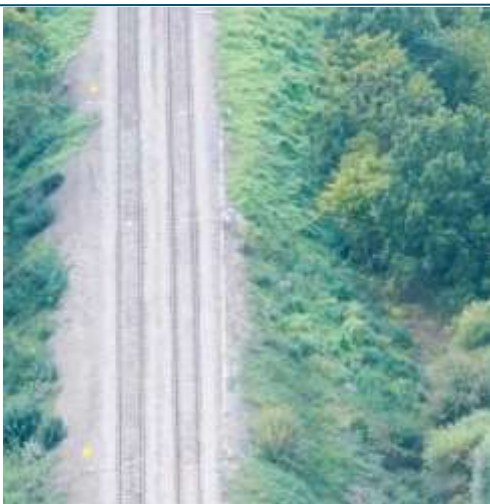
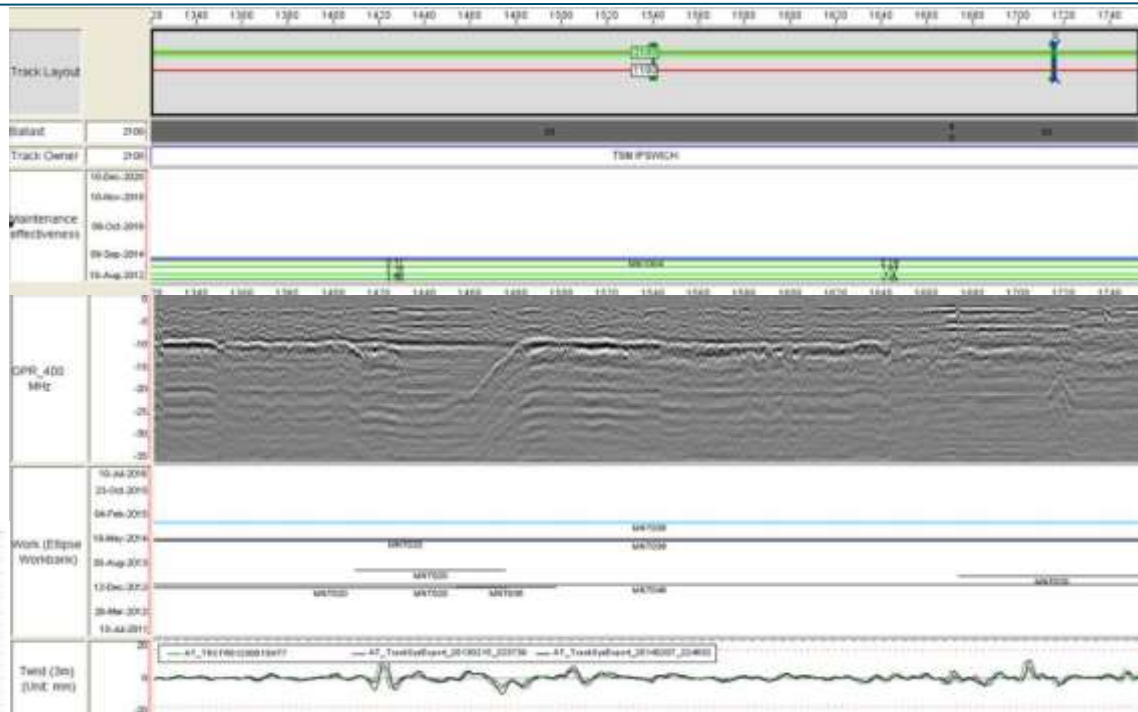
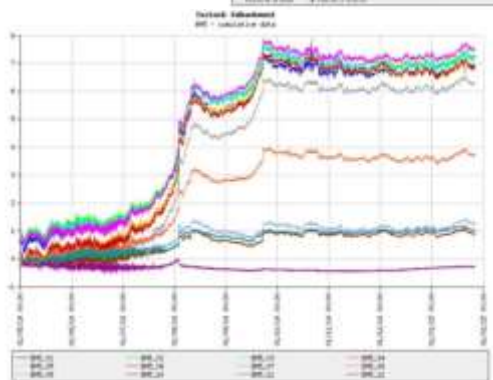
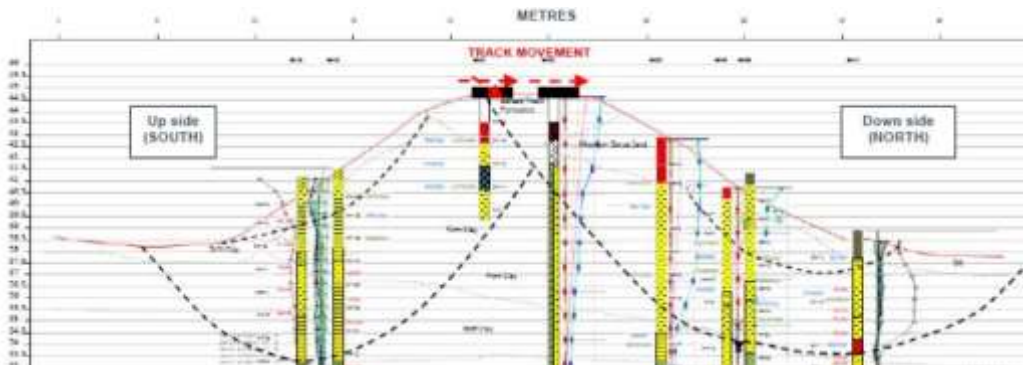
(CCH 34m 65ch)

Tostock Embankment – Deep Seated Progressive Failure

- Early identification of problem area extents
- Both GPR and twist faults show similar extents
- Identified progressive deterioration
- Targeting site investigation and embankment monitoring locations

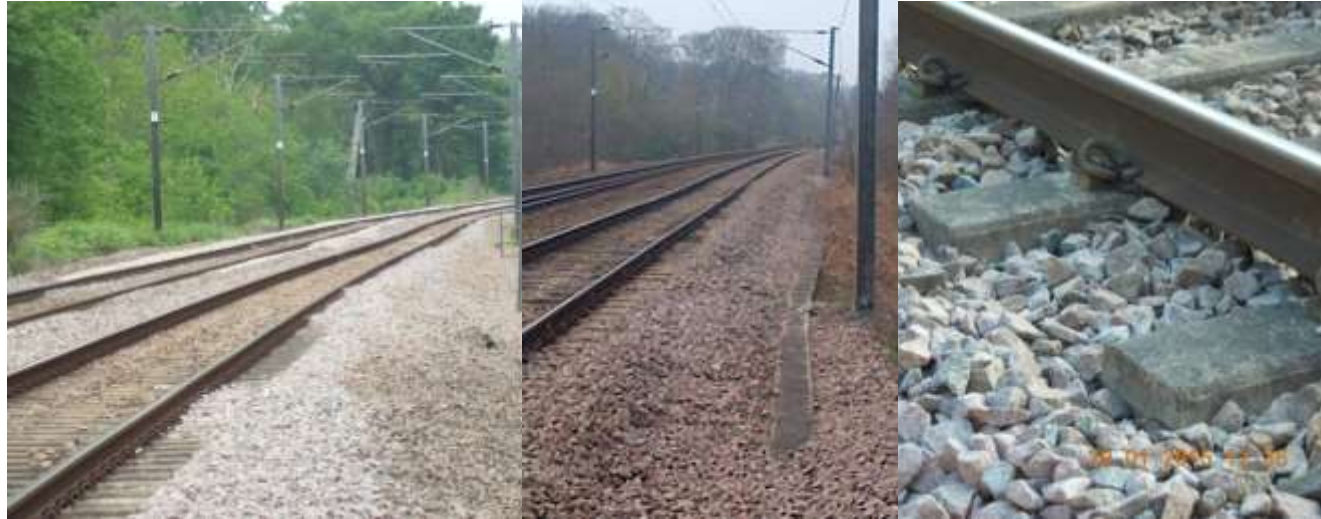
Wrabness Embankment – Deep Seated Progressive Failure (MAH 65m 60ch to 70ch)

Sleeper Ends Exposed - Twist Fault

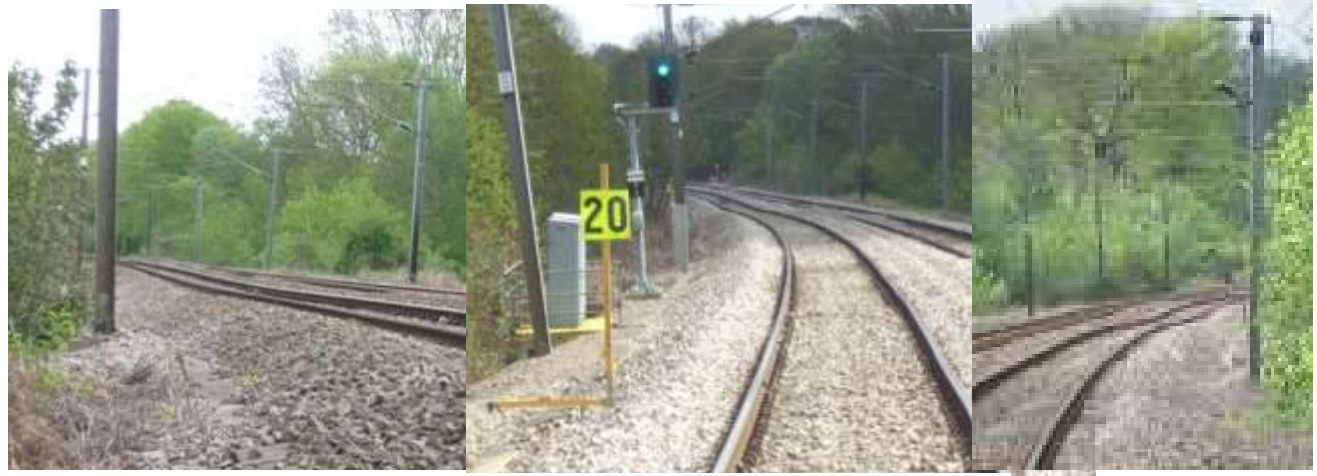
Long Dip in track – Alignment Fault

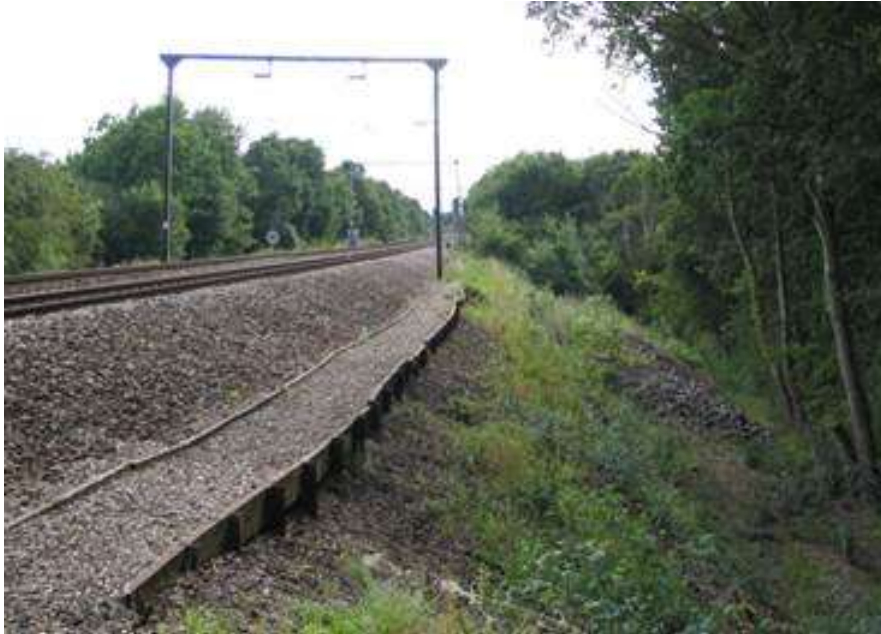
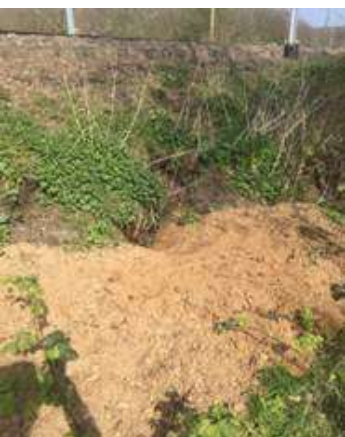
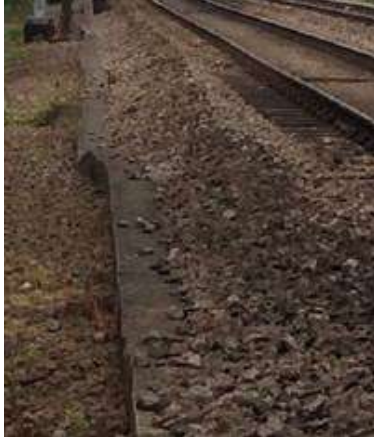
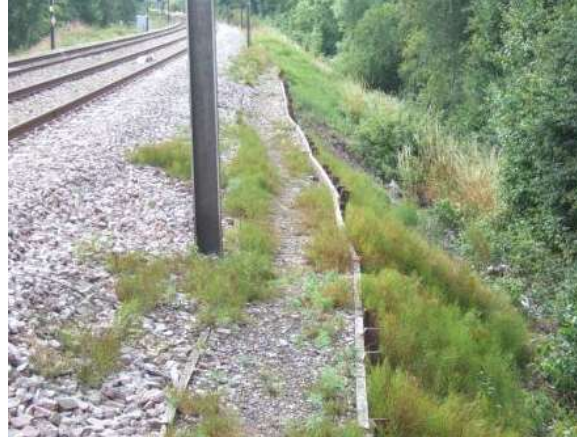
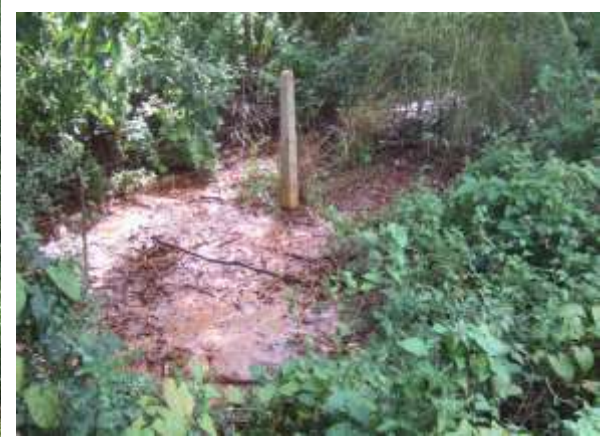
Blountswood Road SSV 34m 05ch to 65ch

Slope Slip Surface Instability

Soil Creep

Vermin Burrowing

Ash Degradation

Poor Toe Drainage

Leaning OLE Mast

Thick Ballast

Locally Prolific Hydrophilic Horsetail

Leaning trees

Inadequate Cess Walkways

Historic Patchwork of Treatments

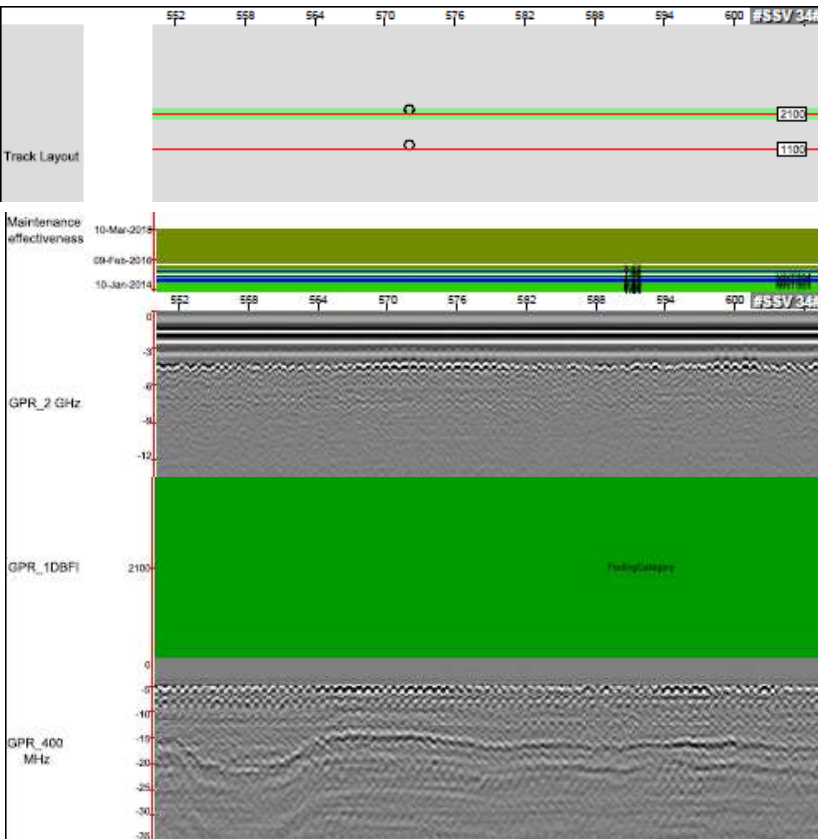
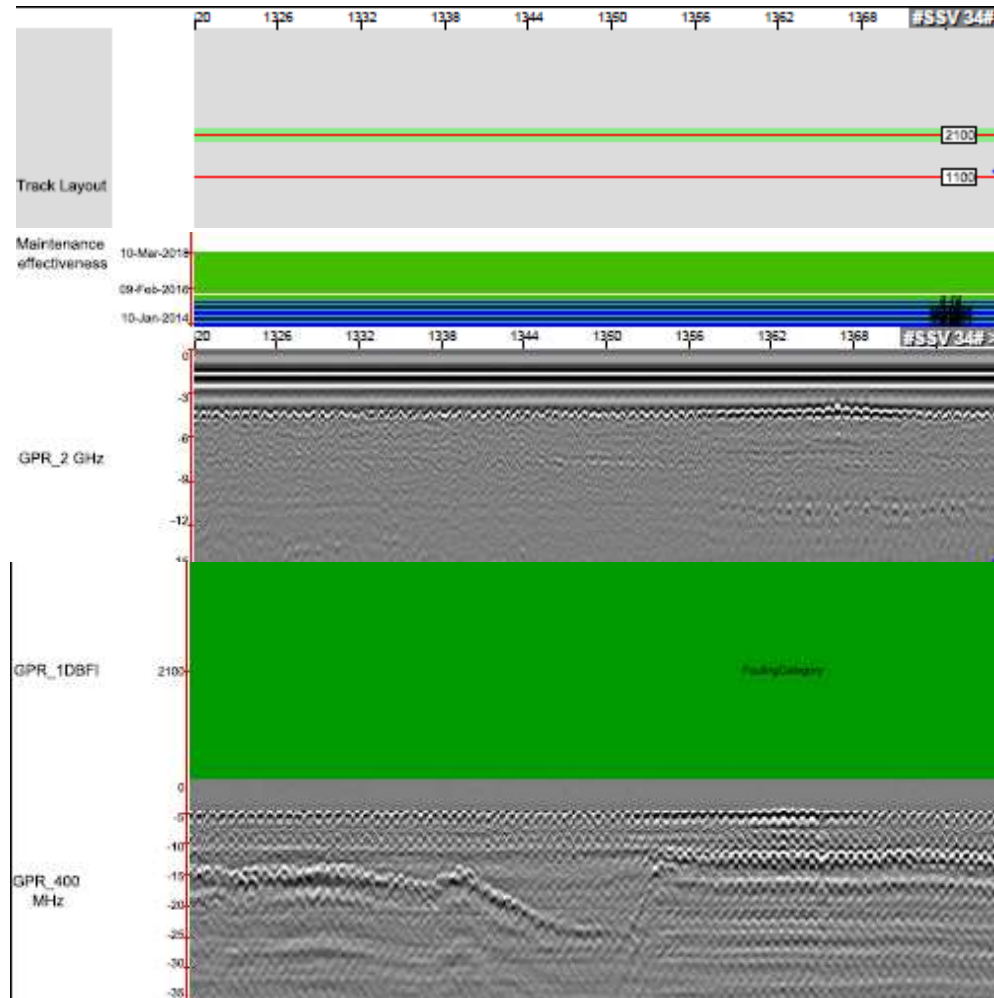
GPR features at 25ch and 61ch

SSV 34ml 25.25ch to 34ml 25.75ch Down embankment shoulder drops and walkway restrained, but 3.5m cress, track good although recently tamped. Cress walkway in poor condition between 34ml 59.5ch and 34ml 65.75ch Down, track good but recently tamped. From 34ml 60.25ch to 34ml 63.5ch cress and walkway drops with increased ballast thickness, there is also Horsetail in walkway. There is a gabion toe berm between 34ml 60.75ch and 34ml 61.75ch

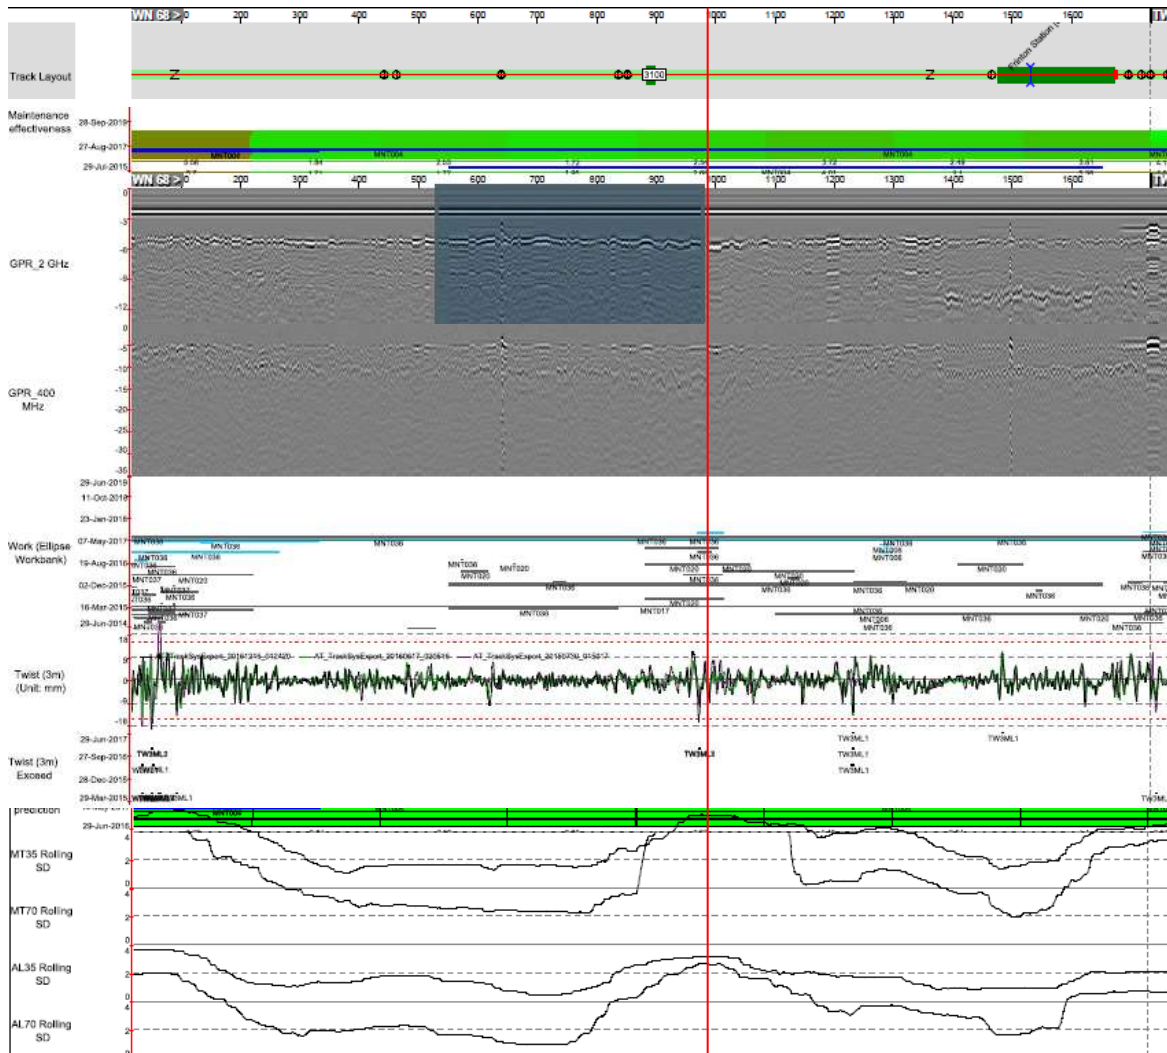
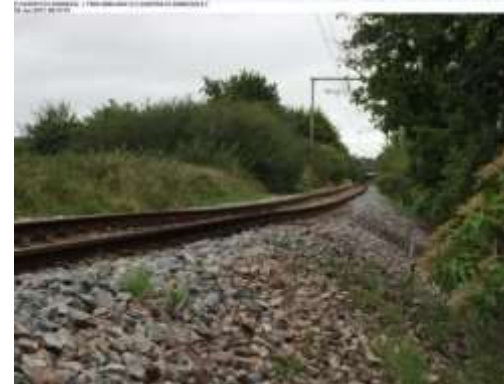
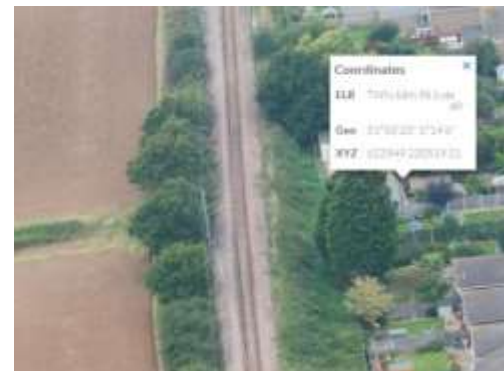
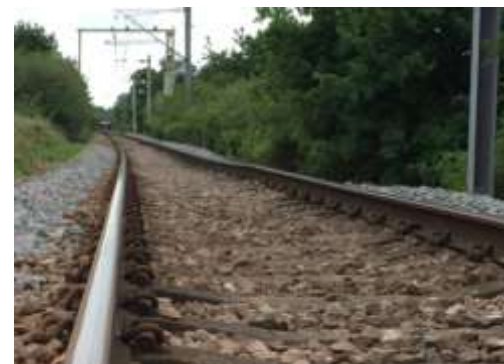
TWN 68m to 69m - LADS Up and Down (Single track) Problem 68m 45ch

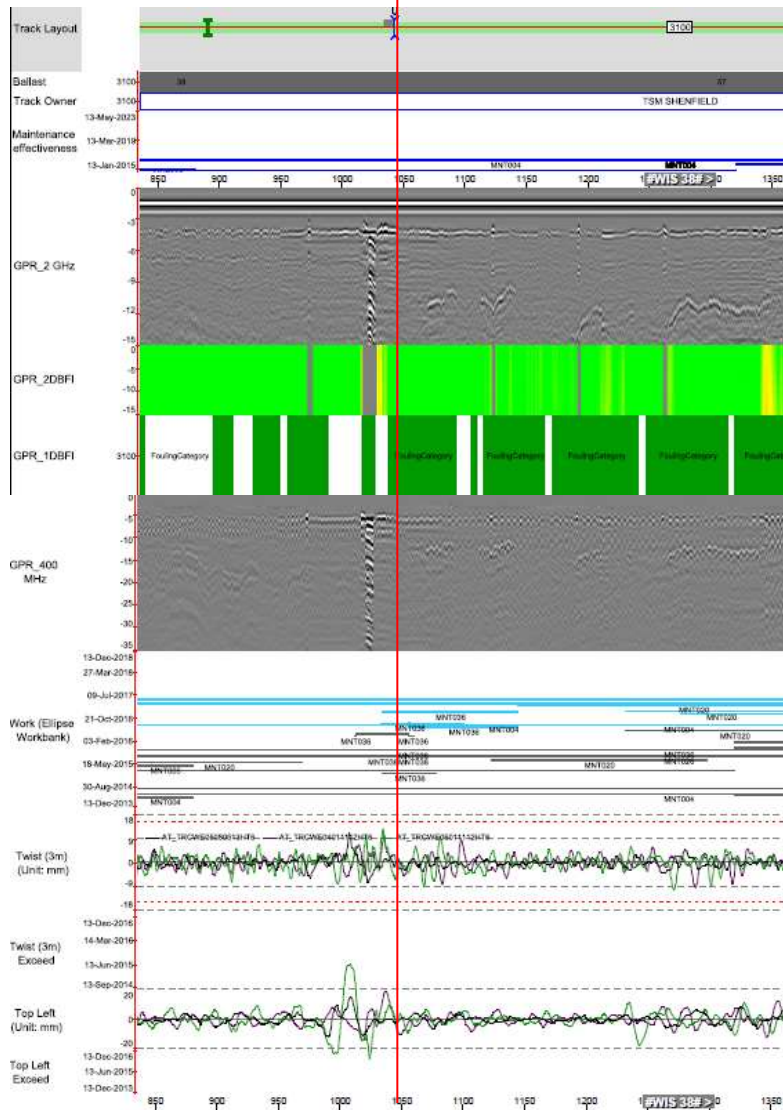
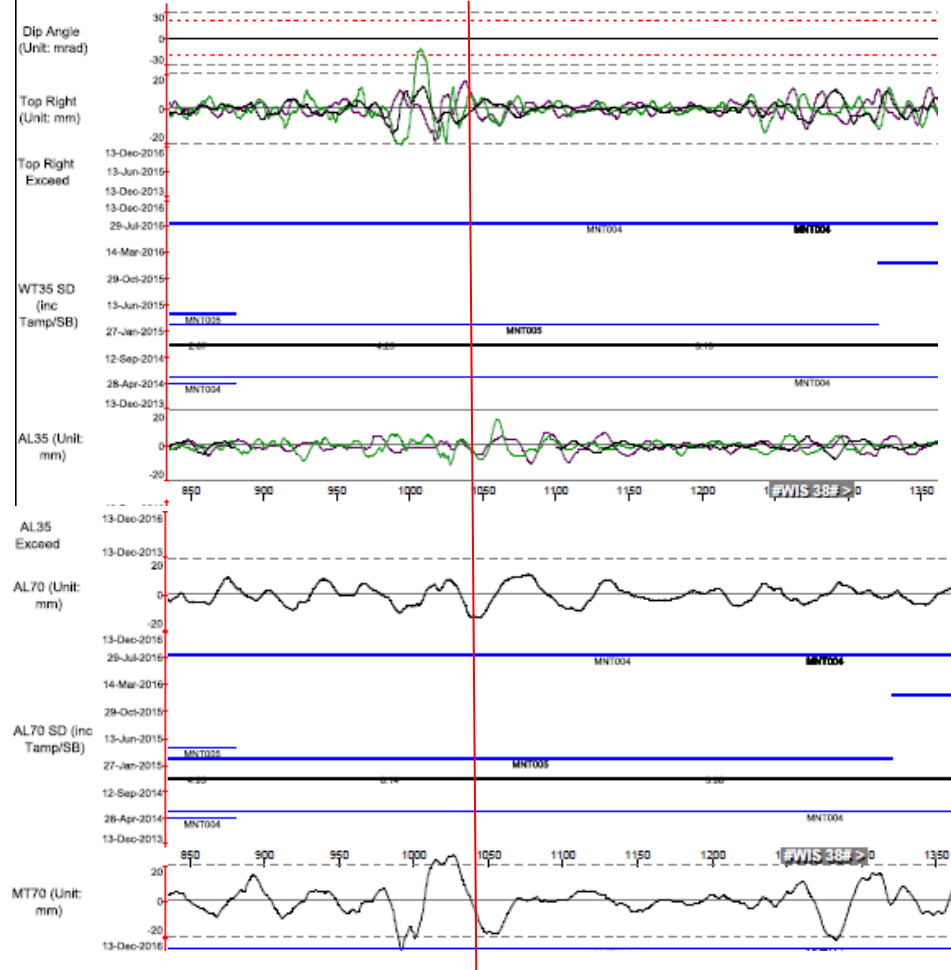
Ulemans Farm WIS 38 miles 1015yds to 1120yds - Embankment instability

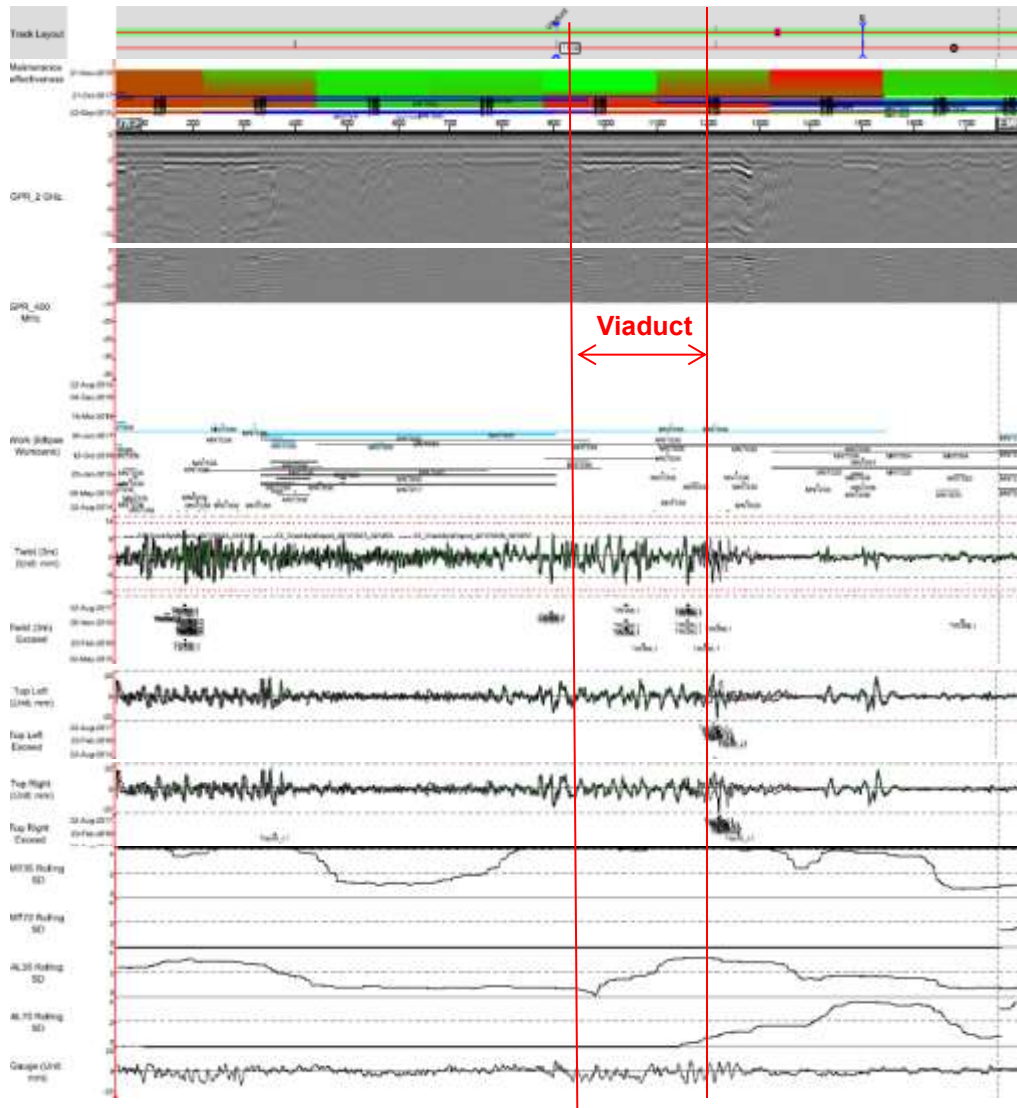
Manea Viaduct Approach Embankments EMP 78m (east) to 79m (west) - LADS Down

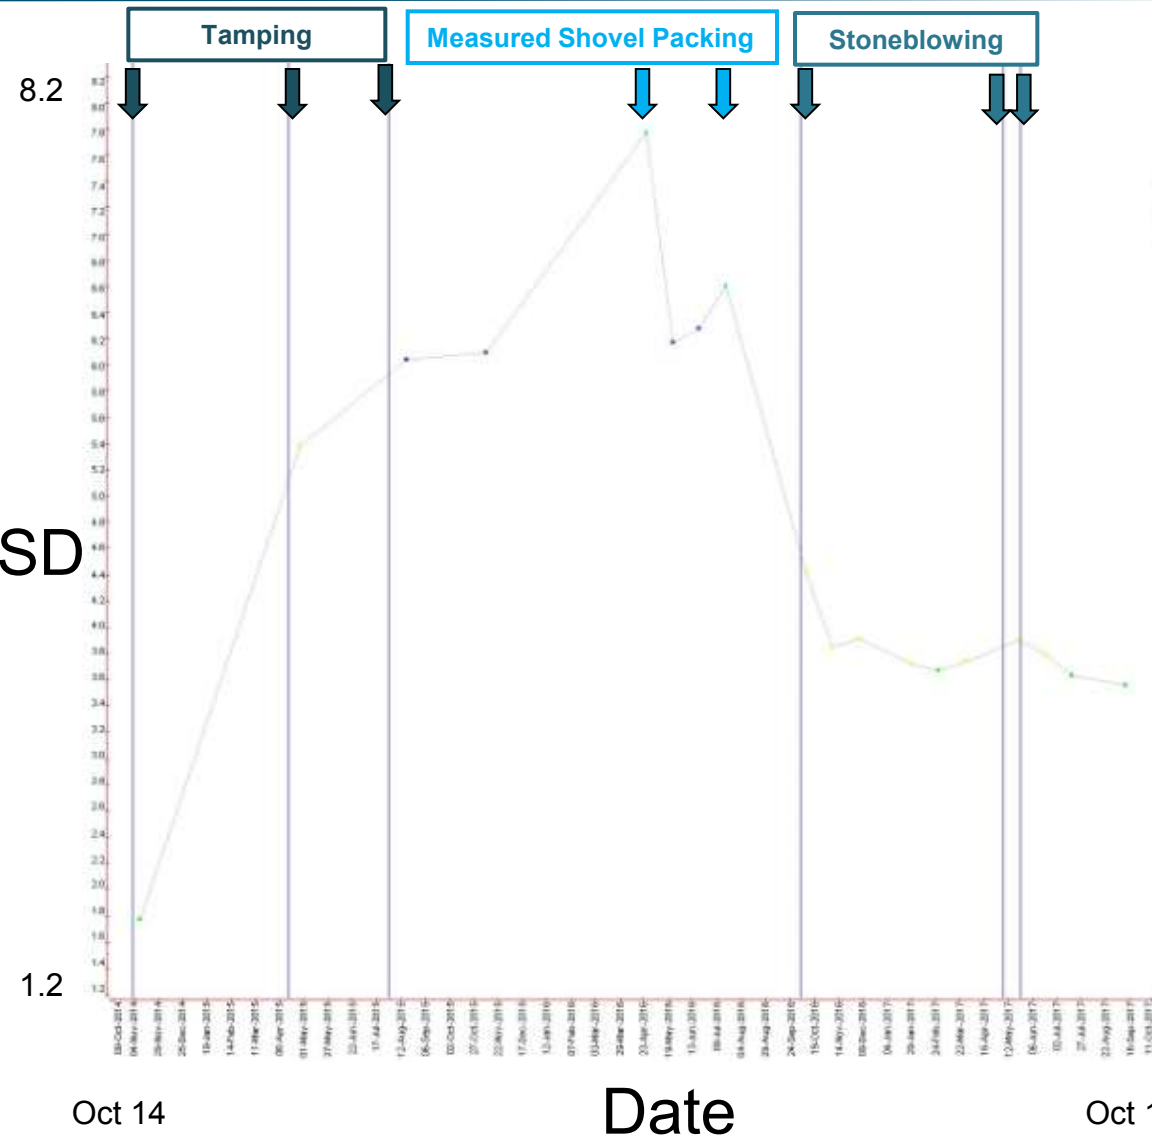
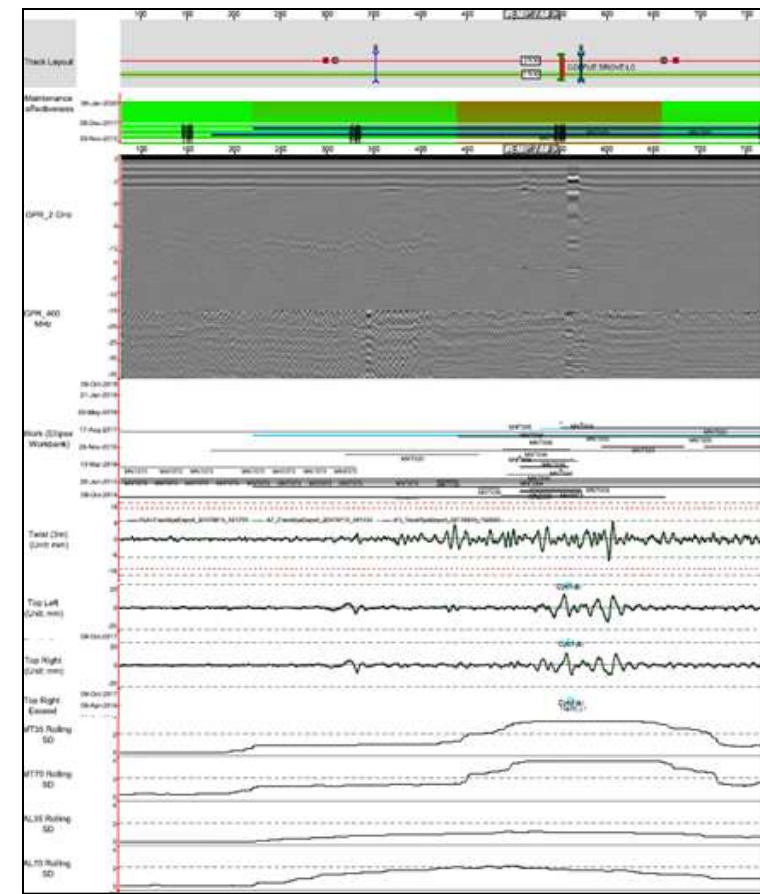
Maintenance effectiveness on Fens (EMP 74m 0550yds Up)

Stoneblowing more effective than Tamping

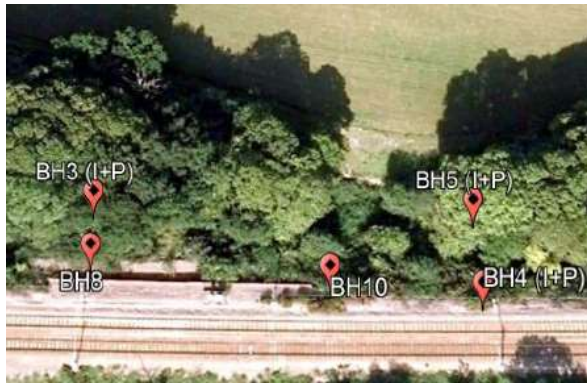
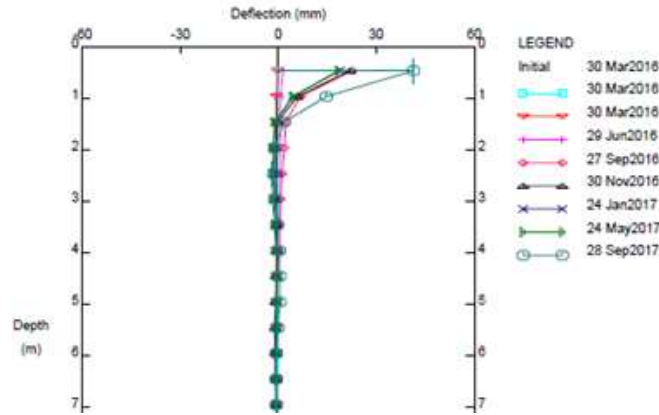
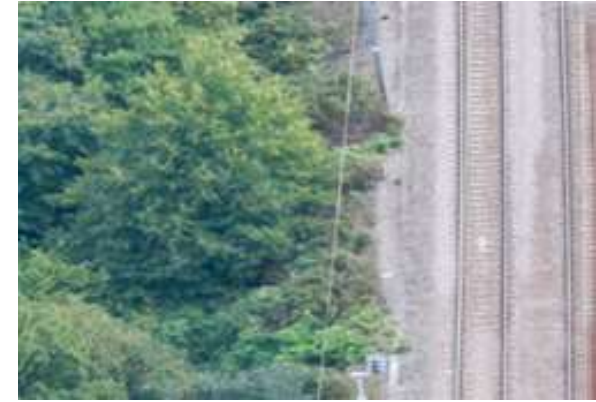
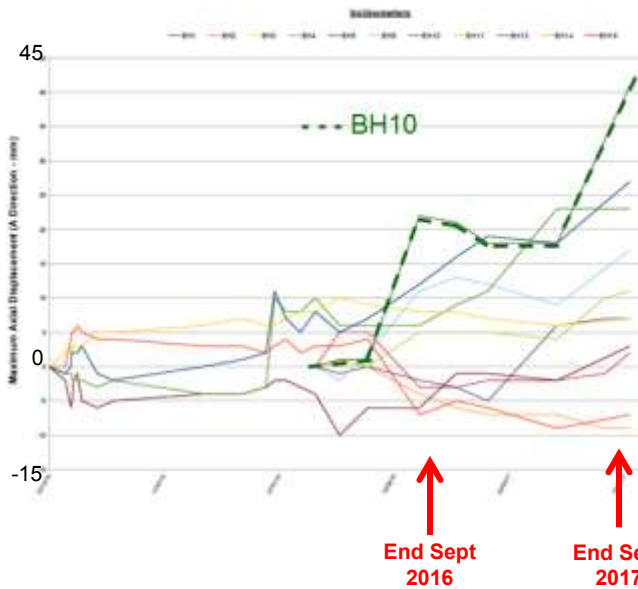
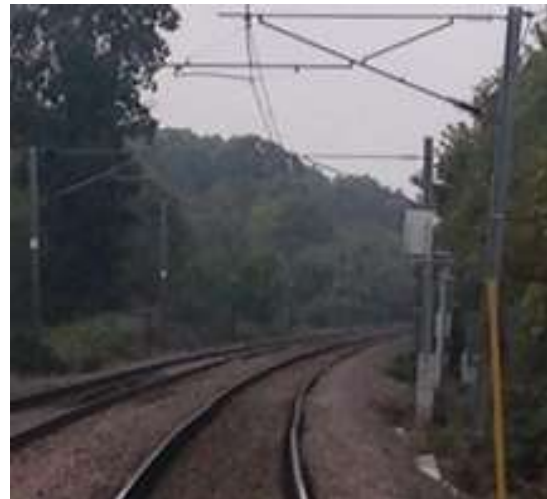
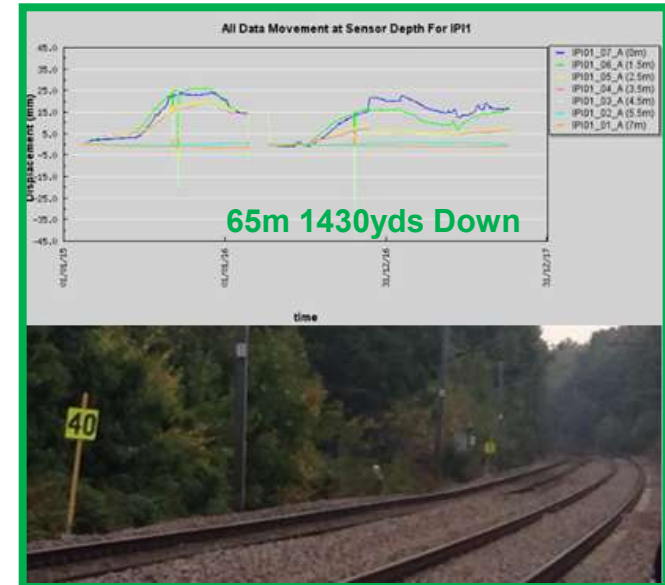
Wrabness Desiccation Rough Ride 65milesM 1317yds Down 28.09.17

Desiccation related track deterioration

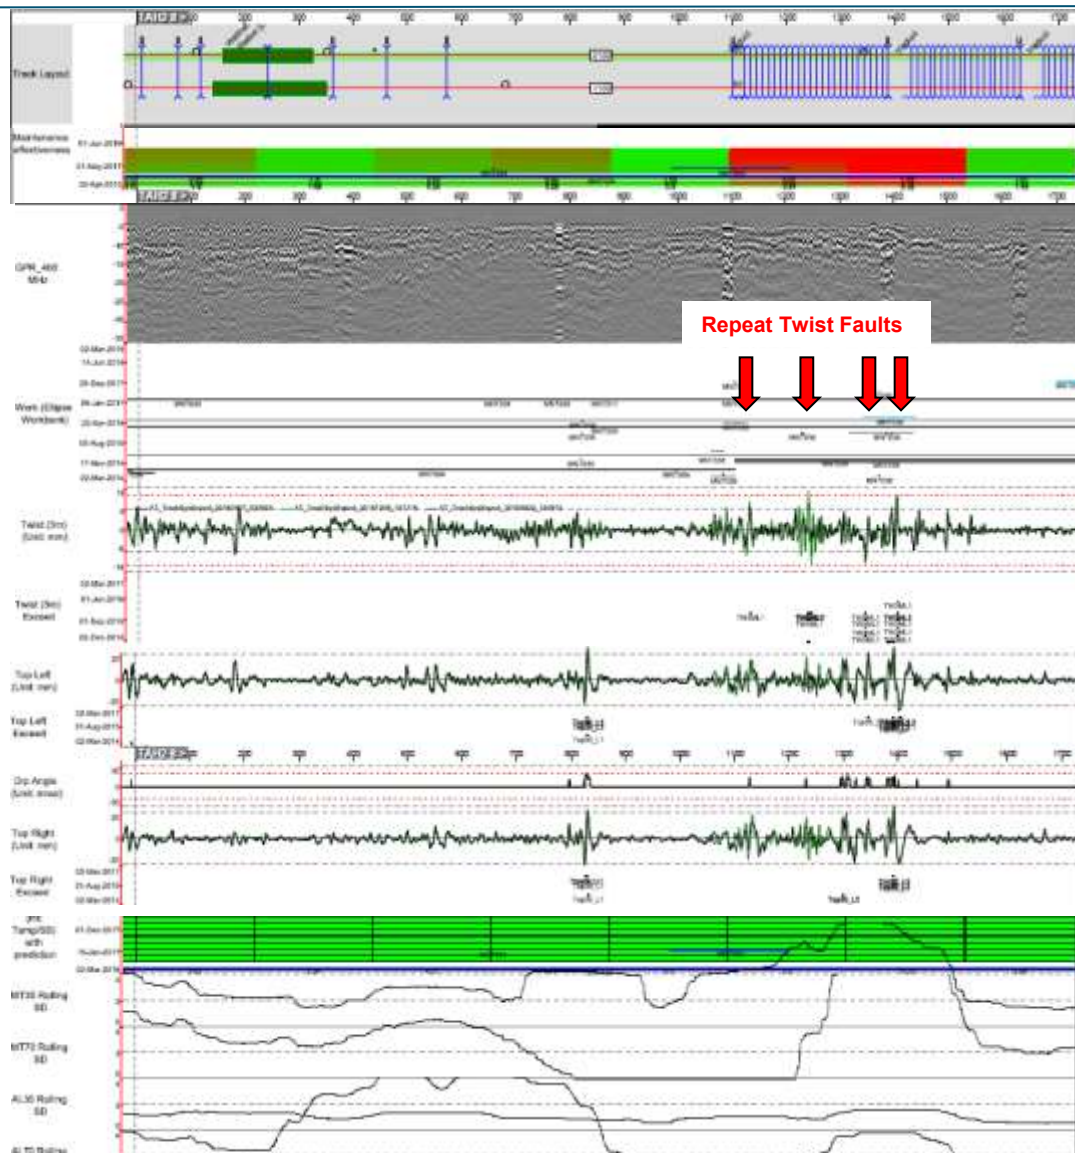
TAH2 8m 1270yds to 1340yds Down Wet Beds
