The Periglacial Legacy: Landslide Stabilisation on the M25

Fleur Loveridge & John Perry
Engineering Group Forum 23rd November 2011

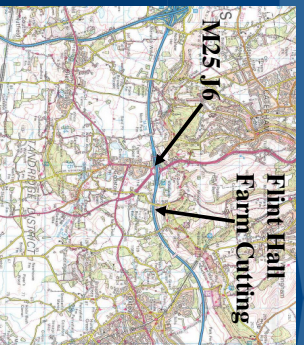
- 19-20th Dec 2000: Major landslide on N side of M25
- Gault Clay cutting only 11 degrees
- Effected hard shoulder and adjacent over-bridge
- Potential to cause closure of anticlockwise carriageway
- Need for fast track approach

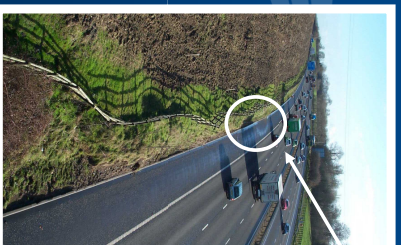
Hard
Shoulder
heave

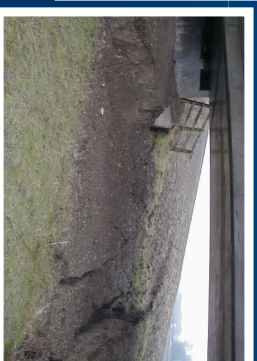
Tensional zone beneath the
bridge – graben structure

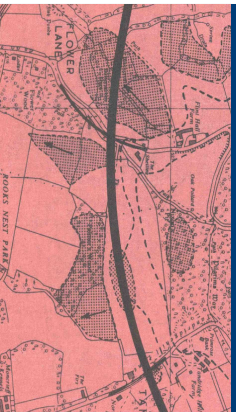
- Below: Soils and Materials Report, 1976 (pre construction)
- Right: Failure surfaces found during construction

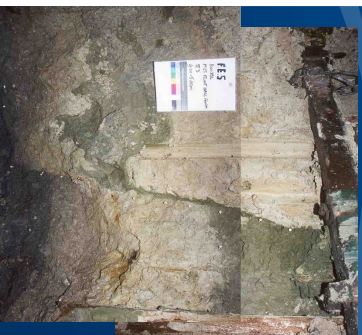
Detailed Soil Logging

- Only possible in shored pits
- Allowed Identification of:
 - Slip surface
 - Gault / Head Interface
 - Ice wedges
 - Desiccation cracks

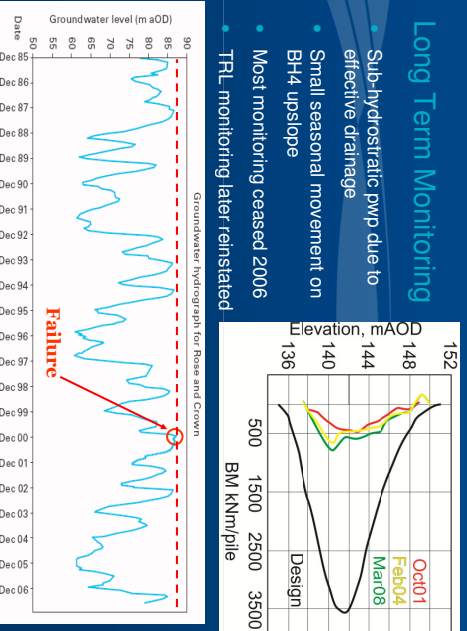
Long Term Monitoring

- Sub-hydraulic pwp due to effective drainage
- Small seasonal movement on BH4 upslope
- Most monitoring ceased 2006
- TRL monitoring later reinstated
