# Non-textbook Flowslides in Fine-grained Colluvium

Oldrich Hungr

University of British Columbia, Canada

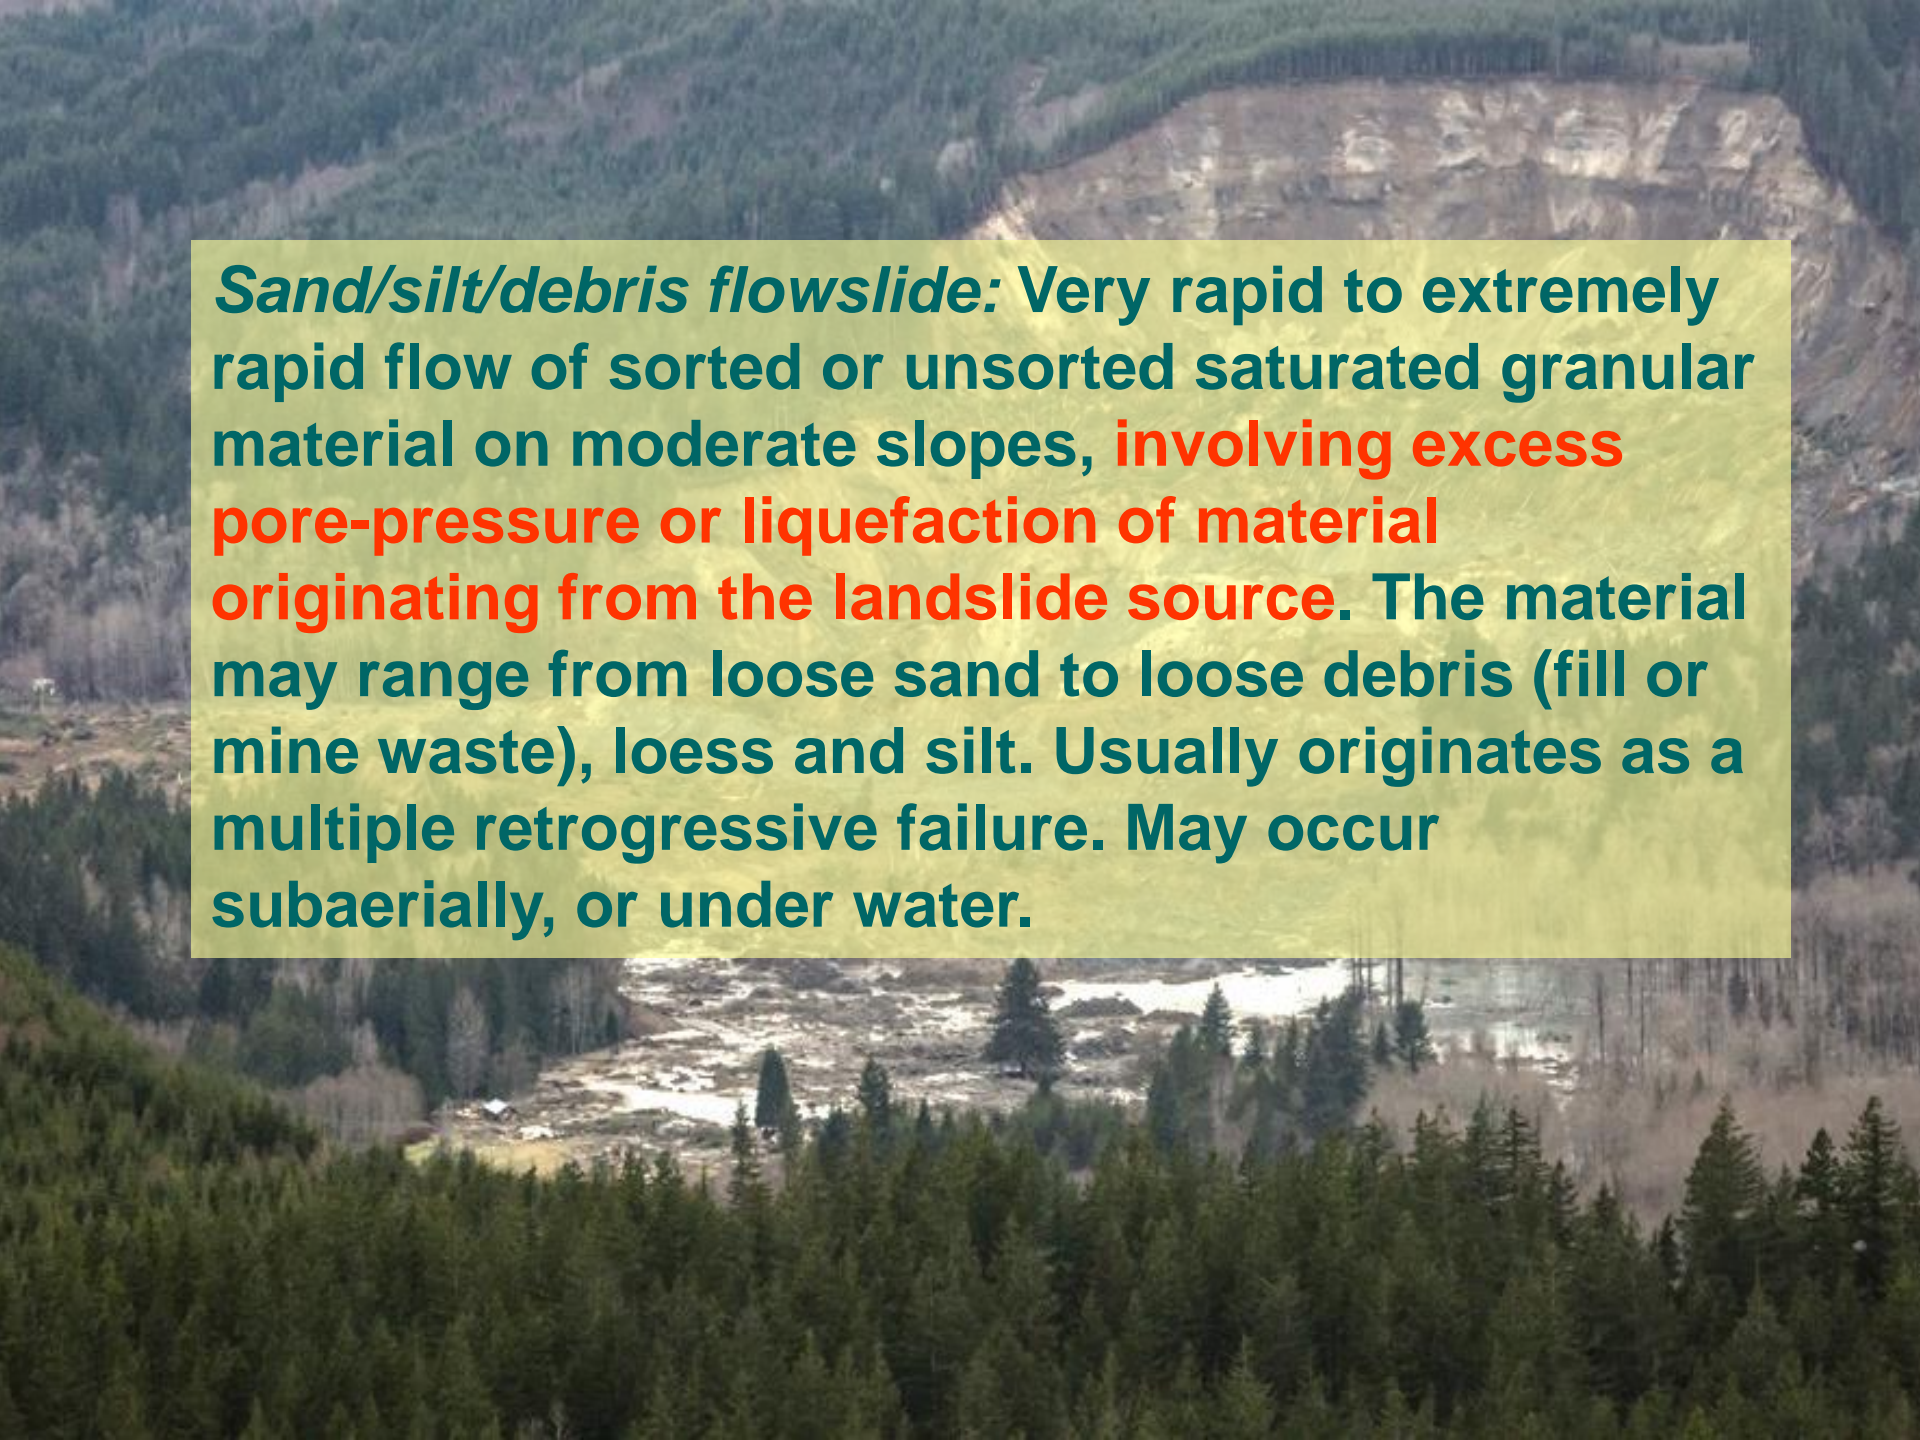
An aerial photograph showing a large, light-colored debris flow field on a hillside, with a river channel visible in the foreground. The surrounding area is covered in dense evergreen forest.

***Sand/silt/debris flowslide:* Very rapid to extremely rapid flow of sorted or unsorted saturated granular material on moderate slopes, involving excess pore-pressure or liquefaction of material originating from the landslide source. The material may range from loose sand to loose debris (fill or mine waste), loess and silt. Usually originates as a multiple retrogressive failure. May occur subaerially, or under water.**

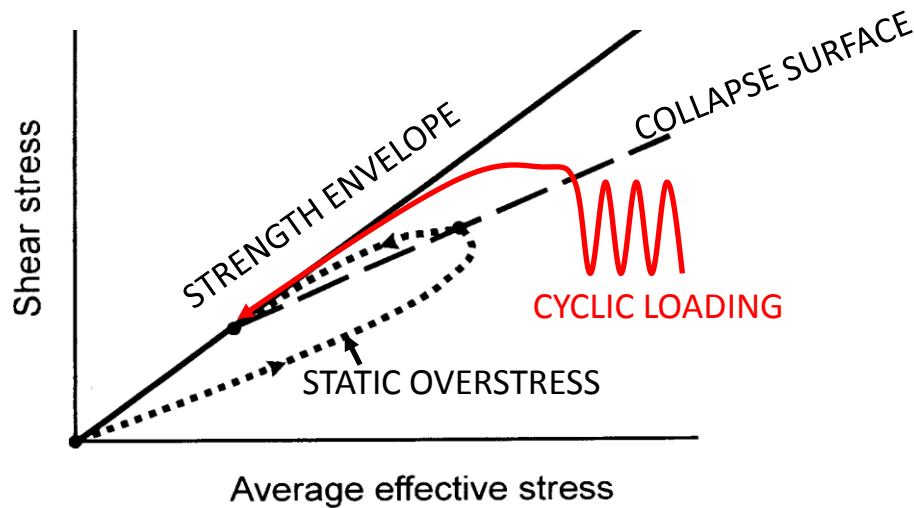
(Mc Roberts and Sladen, 1990)

# 1) Granular materials: Soil structure collapse

*Soil collapse: sudden change from loose to dense packing, volume change. If soil is saturated, volume change cannot occur and pore-pressure increases, reducing effective stress ("liquefaction")*

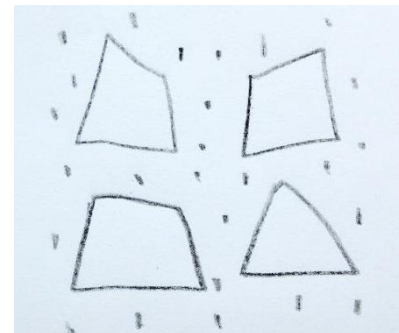
**Attachie Slide, 1973**

# “Macroscopic brittleness”?

**Water  
ingress,  
softening**

**Blocks in  
loose matrix**

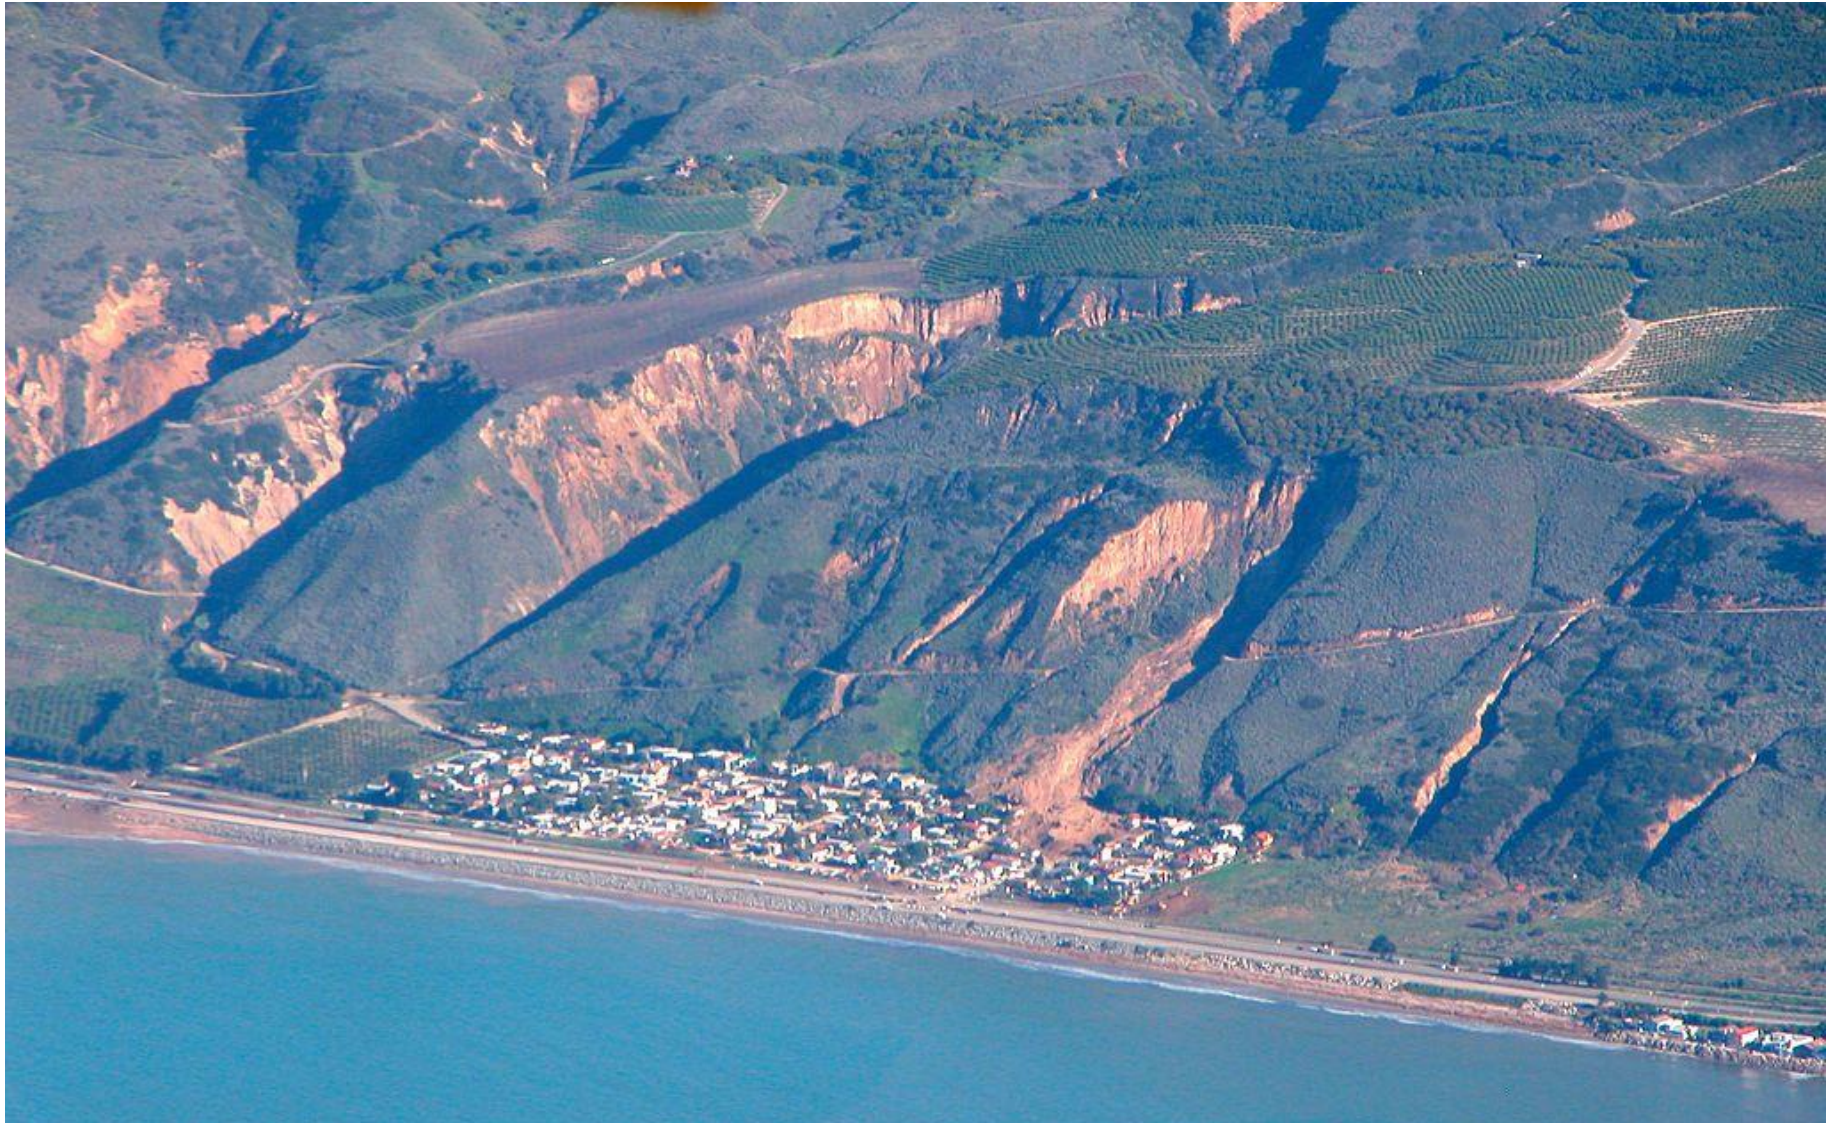
# La Conchita, California, 1996 and 2005 (Jibson, 2005)

Terrace of poorly indurated Tertiary marine sediment. Interlayered siliceous shale, siltstone, and sandstone.

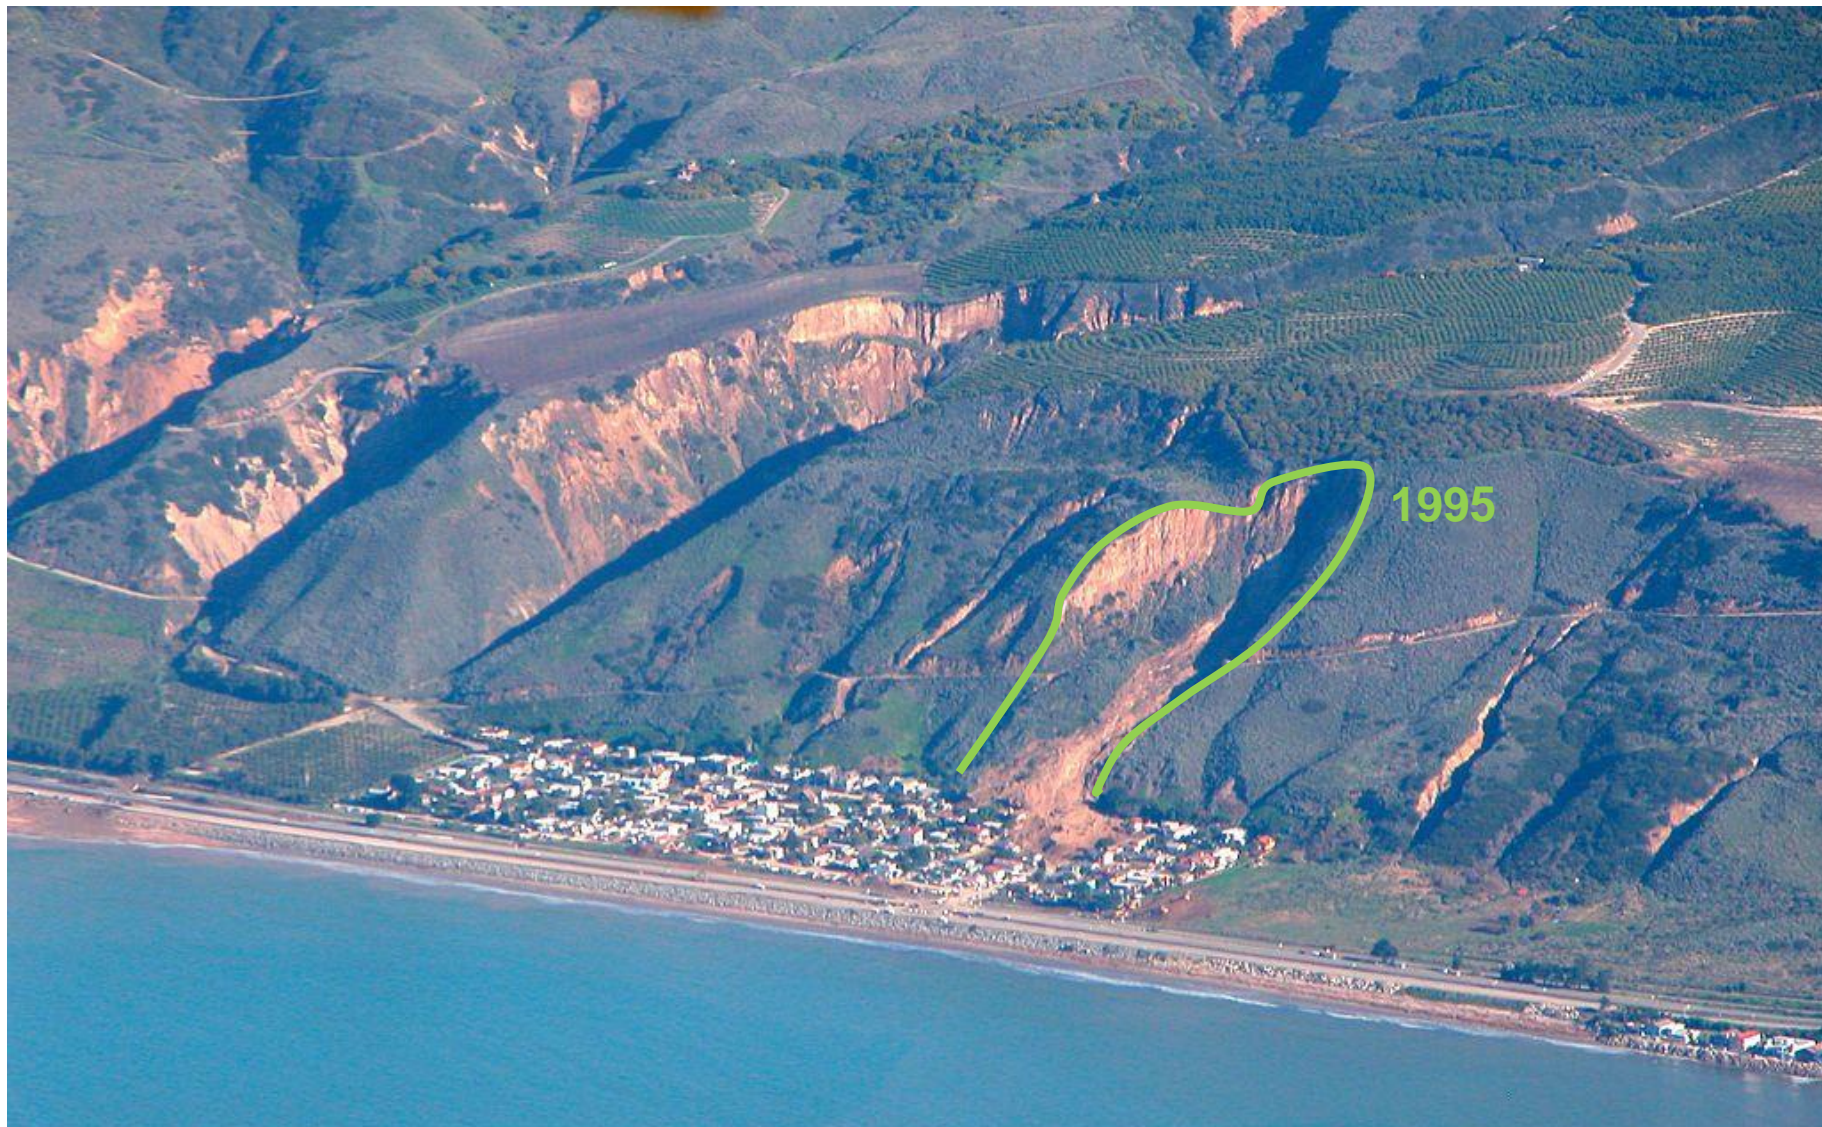
# La Conchita, California, 1996 and 2005 (Jibson, 2005)

Terrace of poorly indurated Tertiary marine sediment. Interlayered siliceous shale, siltstone, and sandstone.

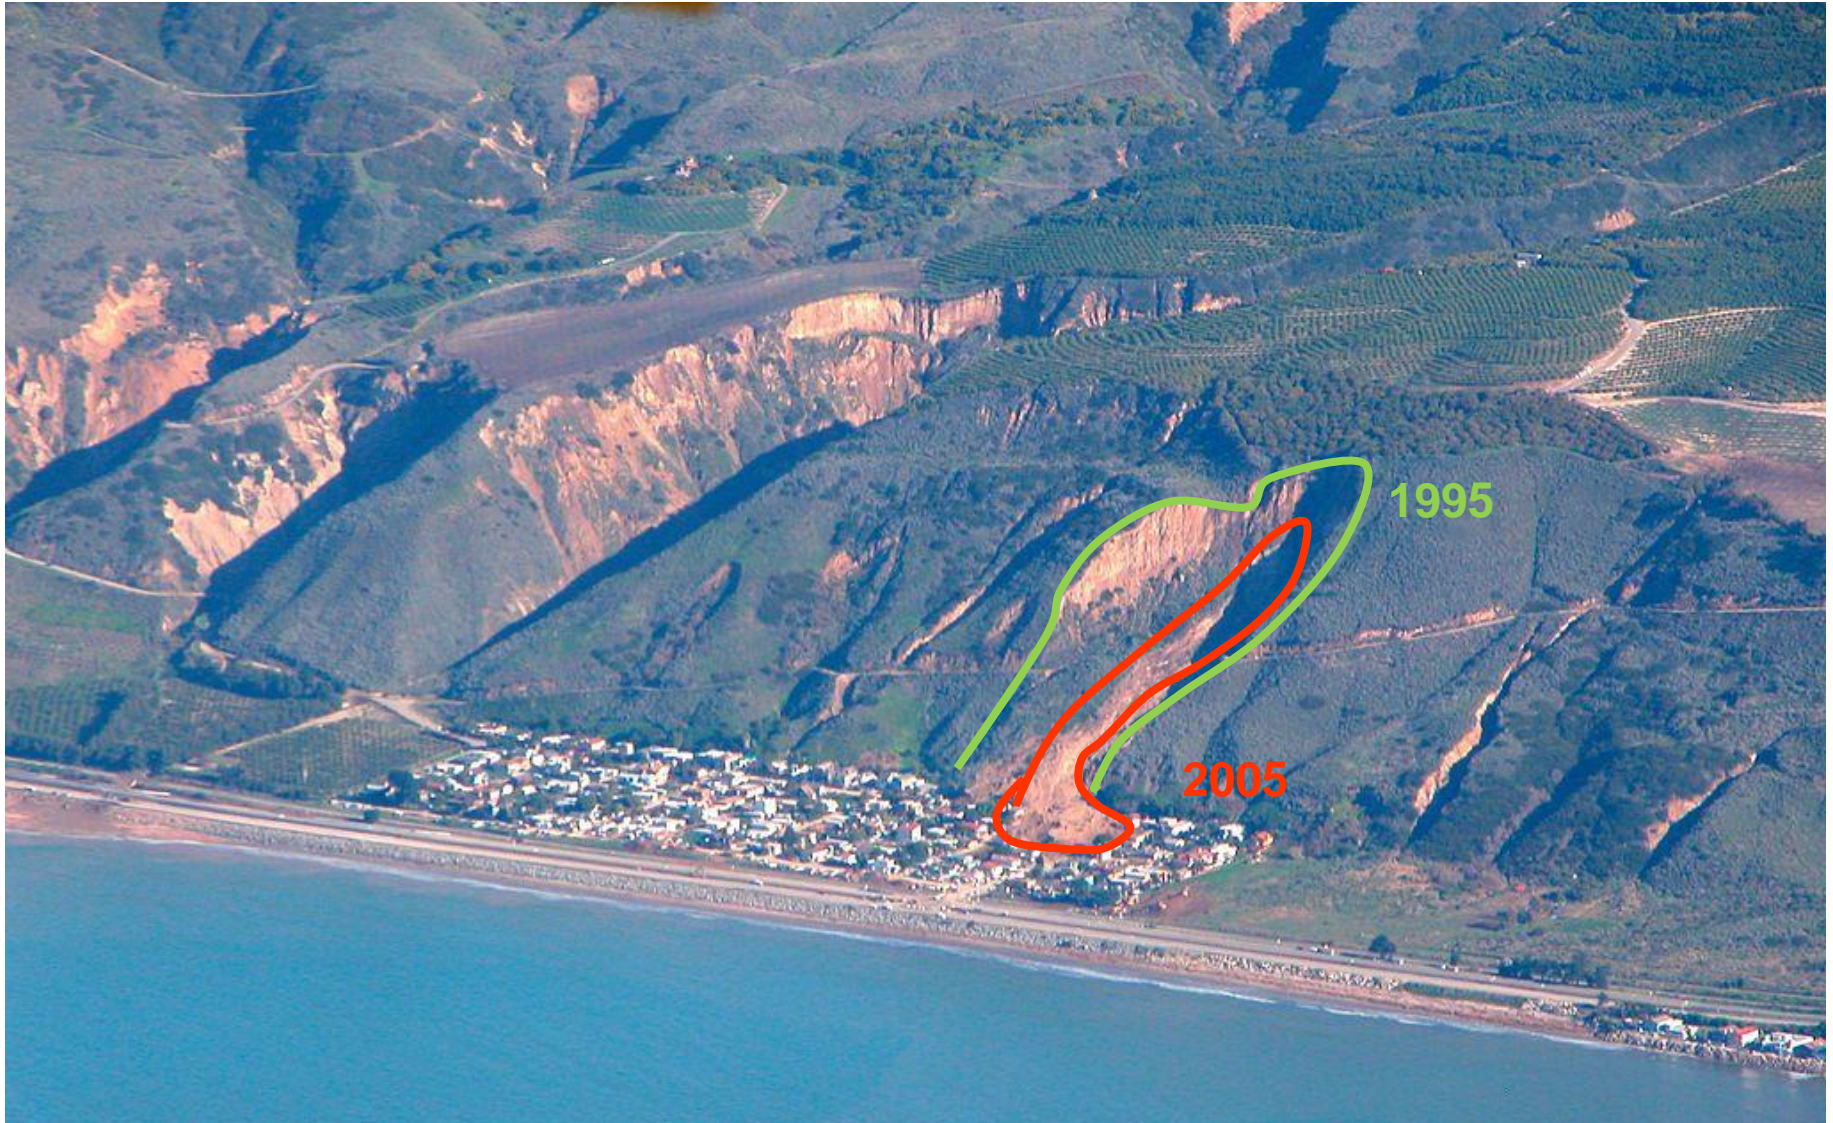
# La Conchita, California, 1996 and 2005 (Jibson, 2005)

Terrace of poorly indurated Tertiary marine sediment. Interlayered siliceous shale, siltstone, and sandstone.

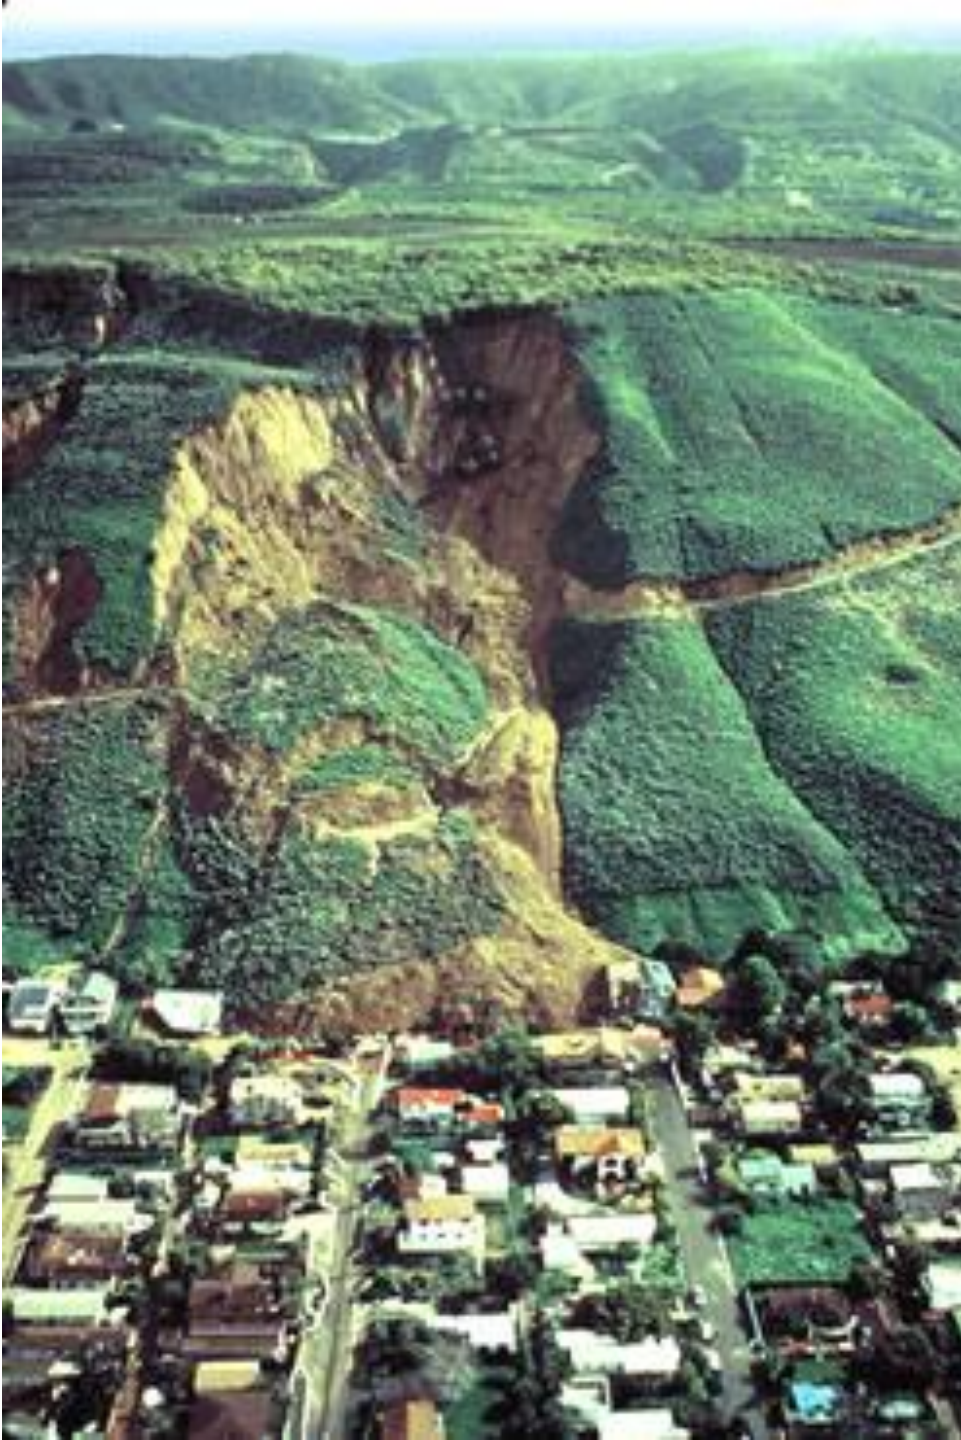
## 1995 event: earth flow

- Following spring with 100% above average precipitation.
- 1 month delay between precipitation and failure
- Moved “tens of metres in a few minutes” (slow-rapid)
- Houses damaged, but no injuries.

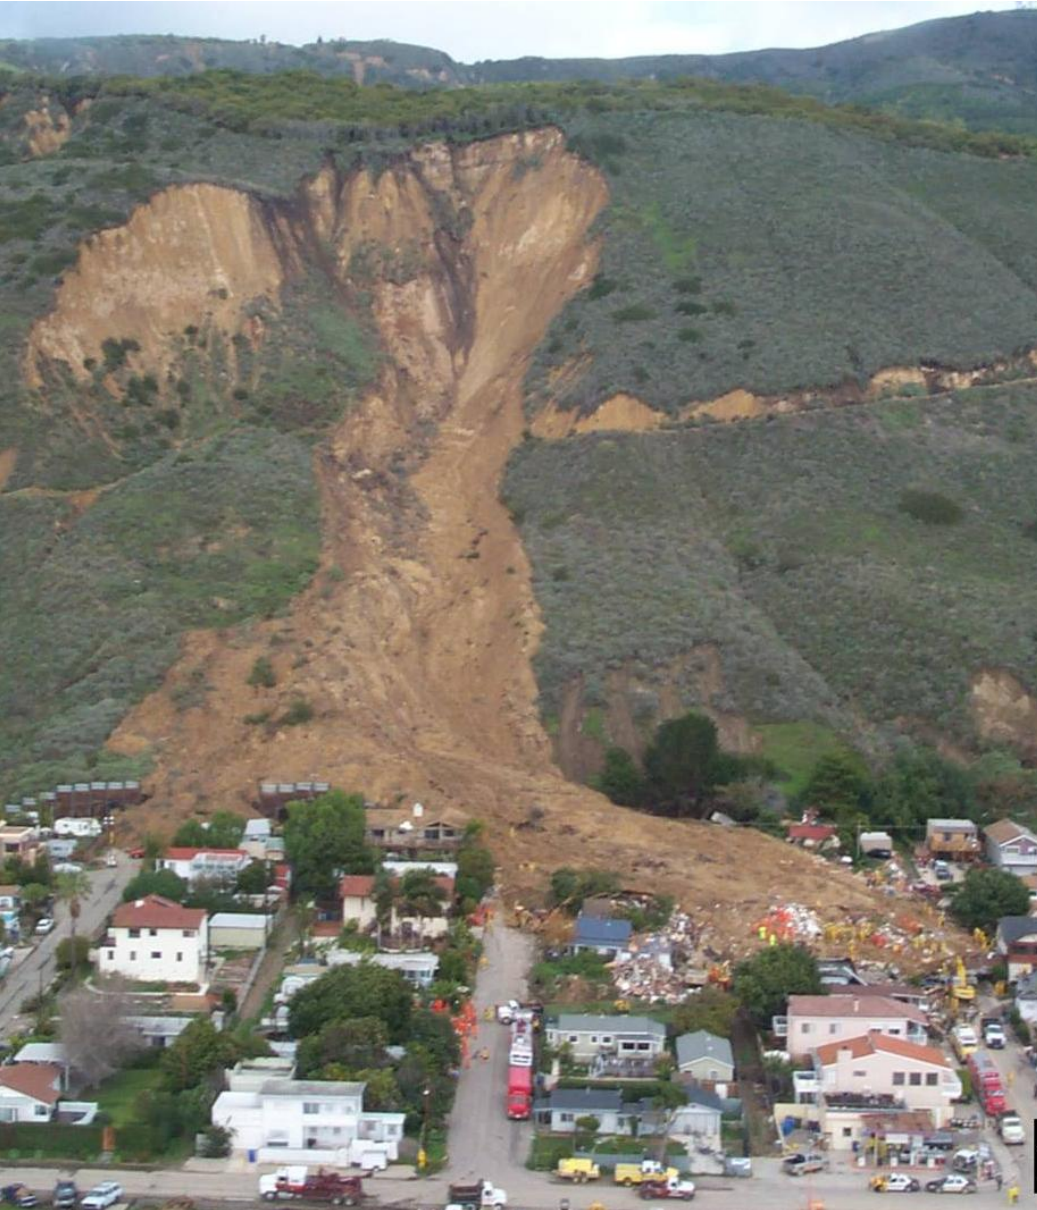
## 2005 event: flowslide

- Remobilized 1995 debris
- Following the day with maximum daily precipitation.
- Moved “tens of metres in a few seconds” (extremely rapid)
- Several houses destroyed, **10 fatalities.**

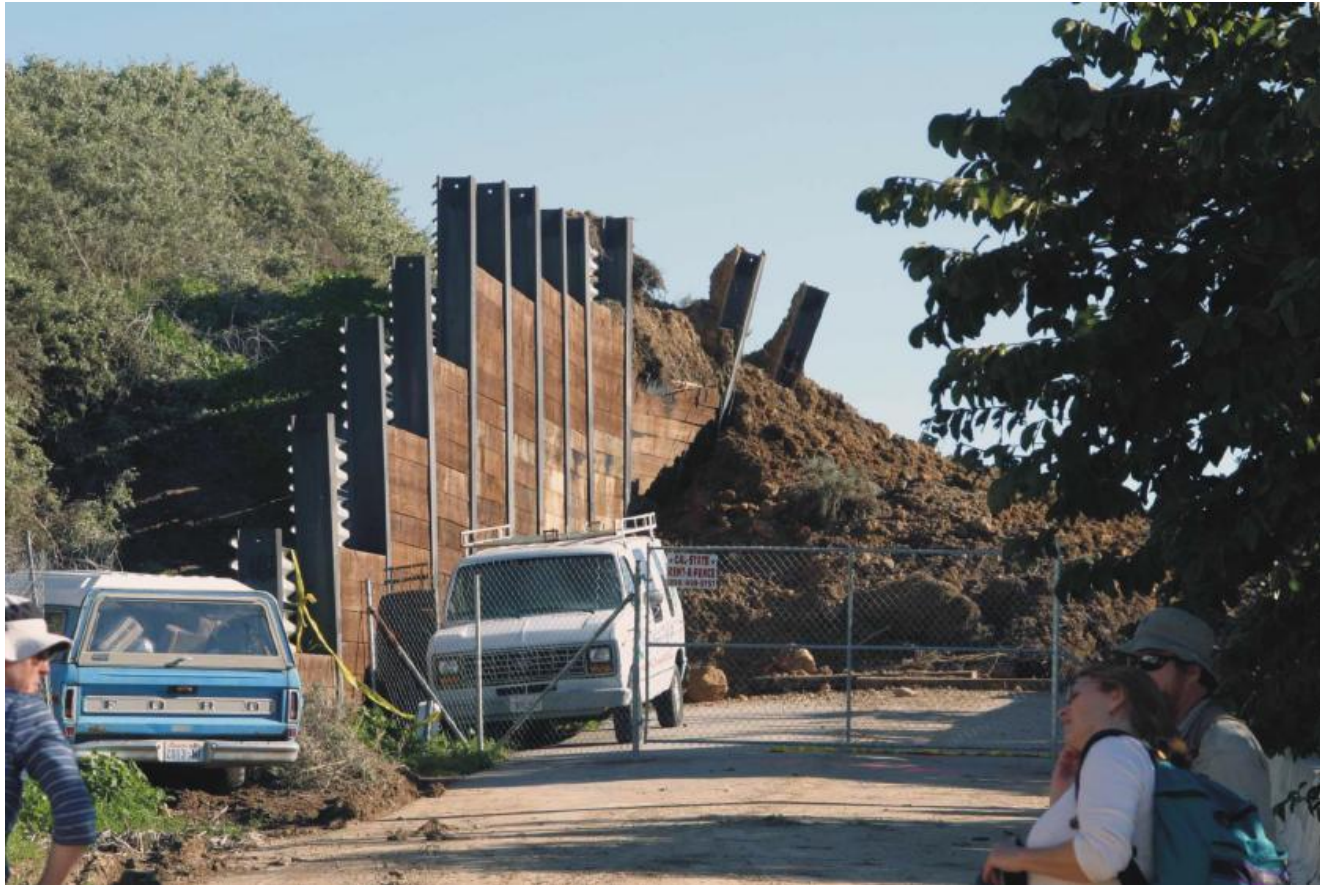
“A highly hazardous situation involving a two-phased landslide mechanism: (1) a saturated, highly fluid layer at depth on which the landslide mobilized that (2) carried a thick layer of drier, much more viscous material that effectively acted as a battering ram.” (Jibson, 2005)

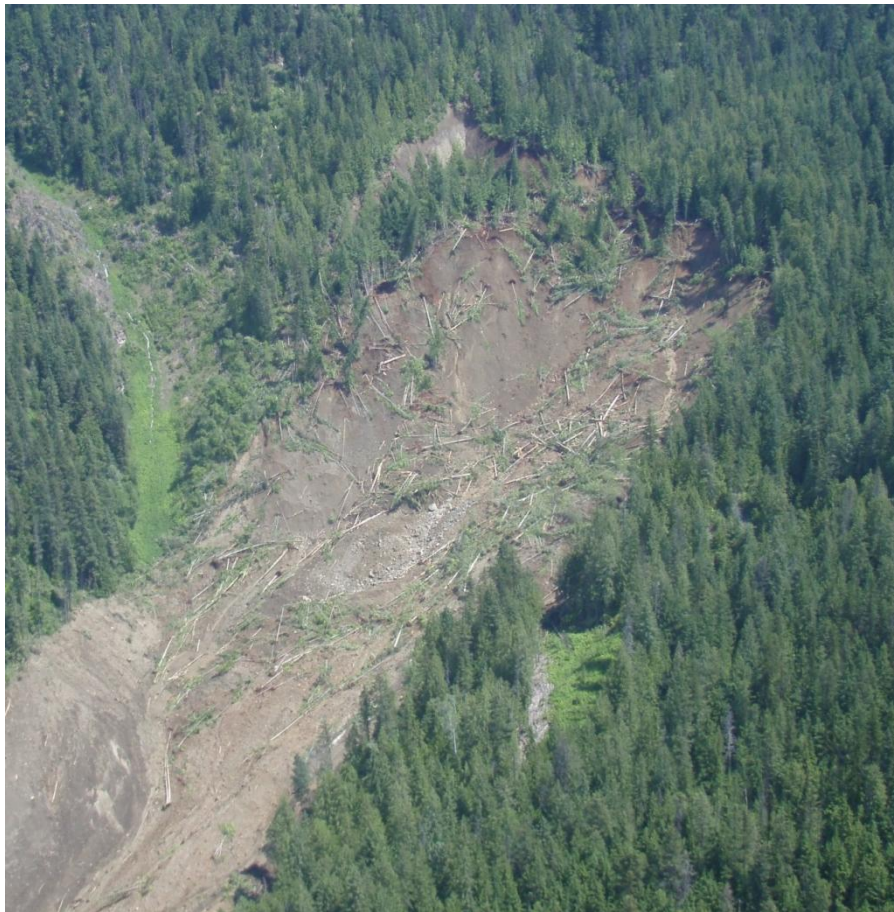
## Pre-event geomorphological mapping:

Source area is situated in a geomorphological unit described as sandy moraine and glacio-fluvial soil (kame deposit) – **Failing** (i.e. in an unstable condition). Stability Class III (out of 5)

Deep-seated compound silt slide  
320,000 m<sup>3</sup>

1:500 year rain on snowmelt

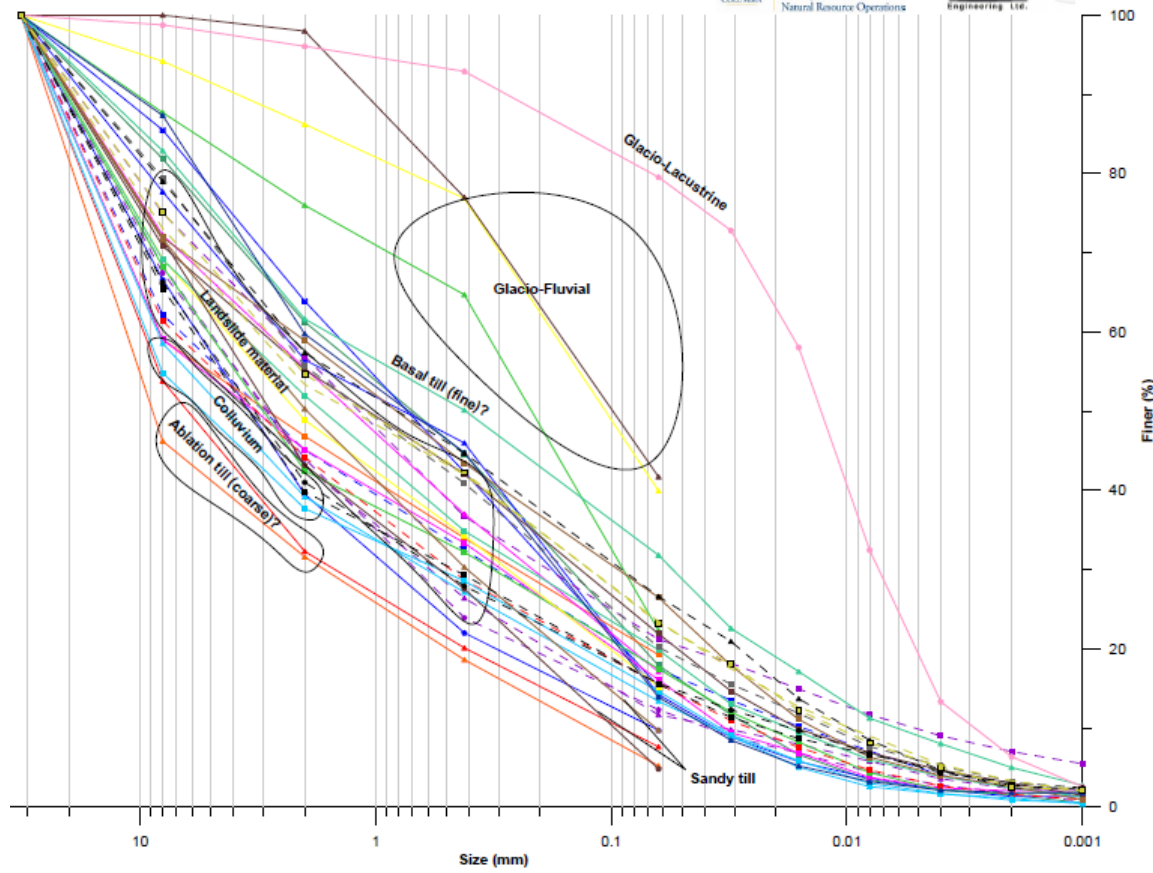
**Material: Interbedded glacial till and glacio-fluvial deposits, mostly silty sand in texture, mostly non-plastic, a few clayey silt interbeds, based on weak, unstable bedrock**

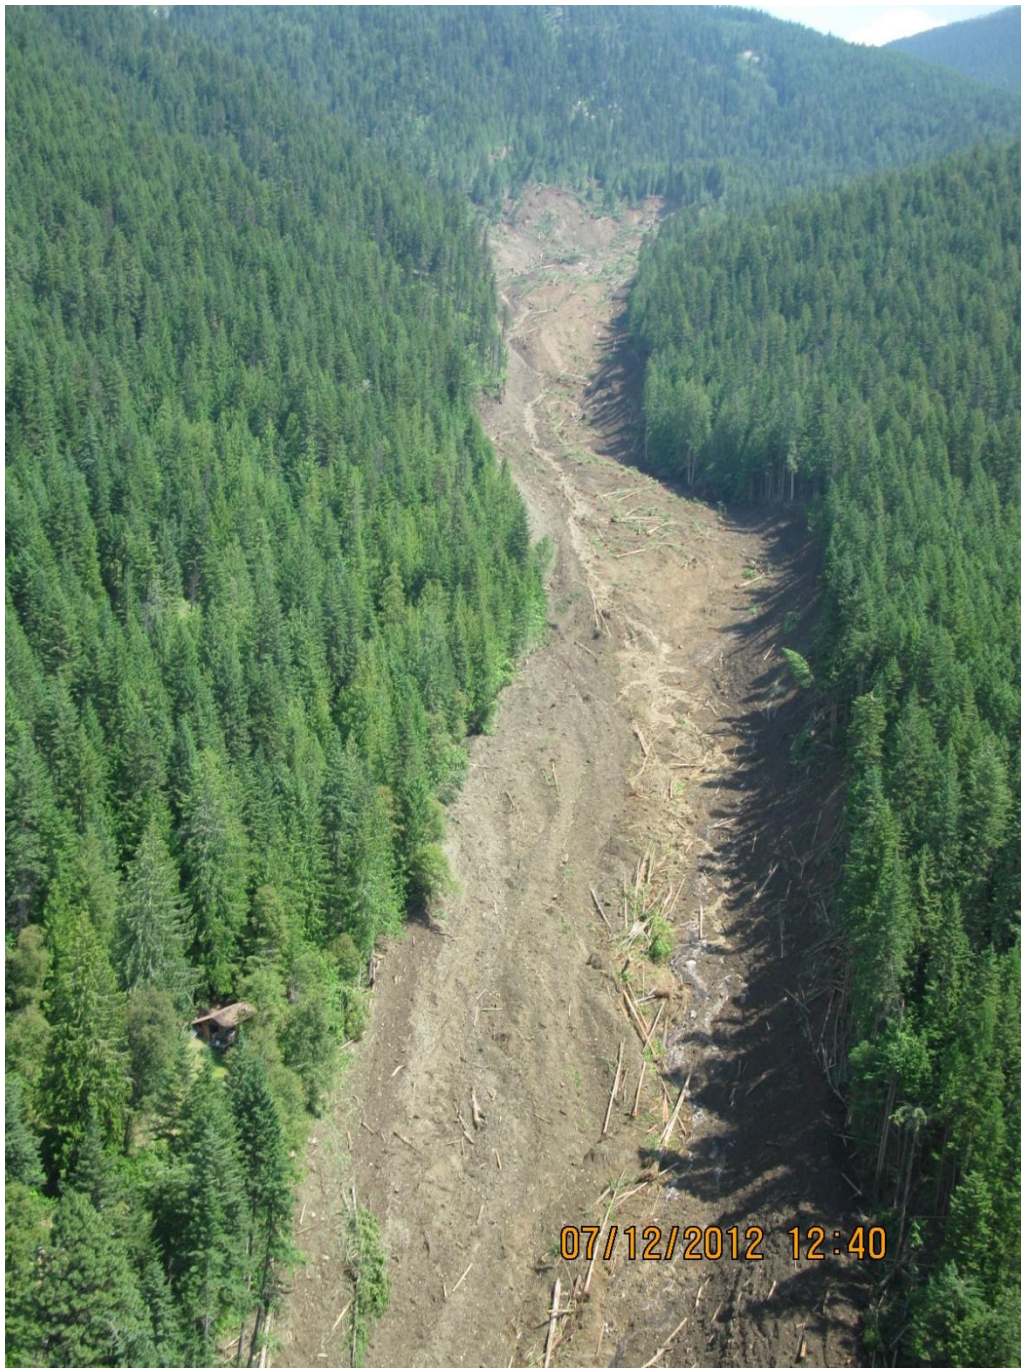
**Source volume:  
320,000 m<sup>3</sup>**

**Minor soil  
entrainment, large  
quantities of timber  
debris**

**Flow velocity from  
eyewitness  
accounts: > 20 m/s**

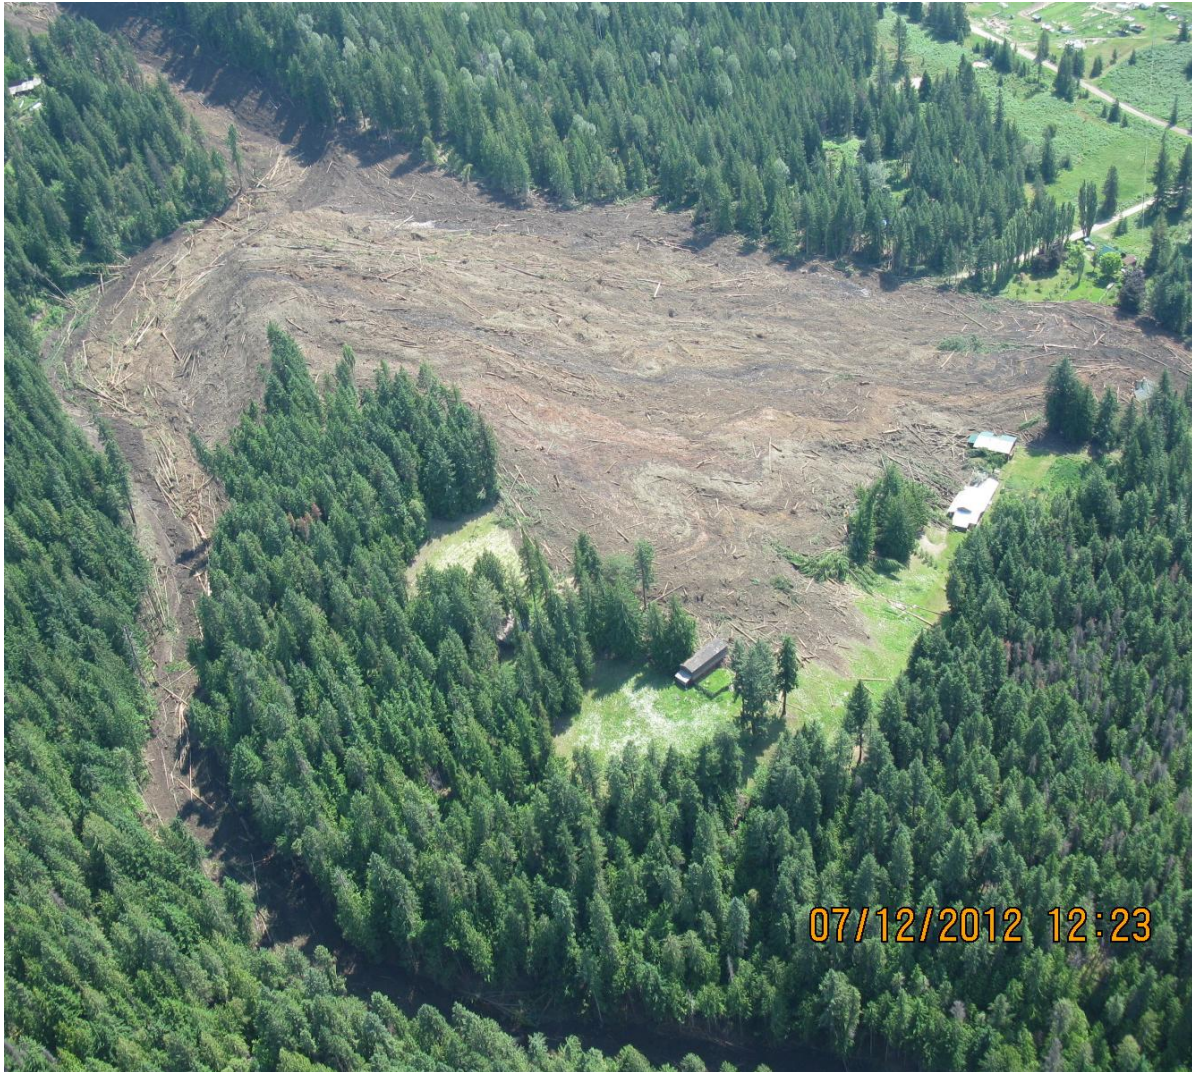
## Deposit:

6 houses  
destroyed,  
**4 fatalities**

This is the first  
landslide deposit  
on top of a glacio-  
fluvial terrace  
surface, over  
9,000 years old

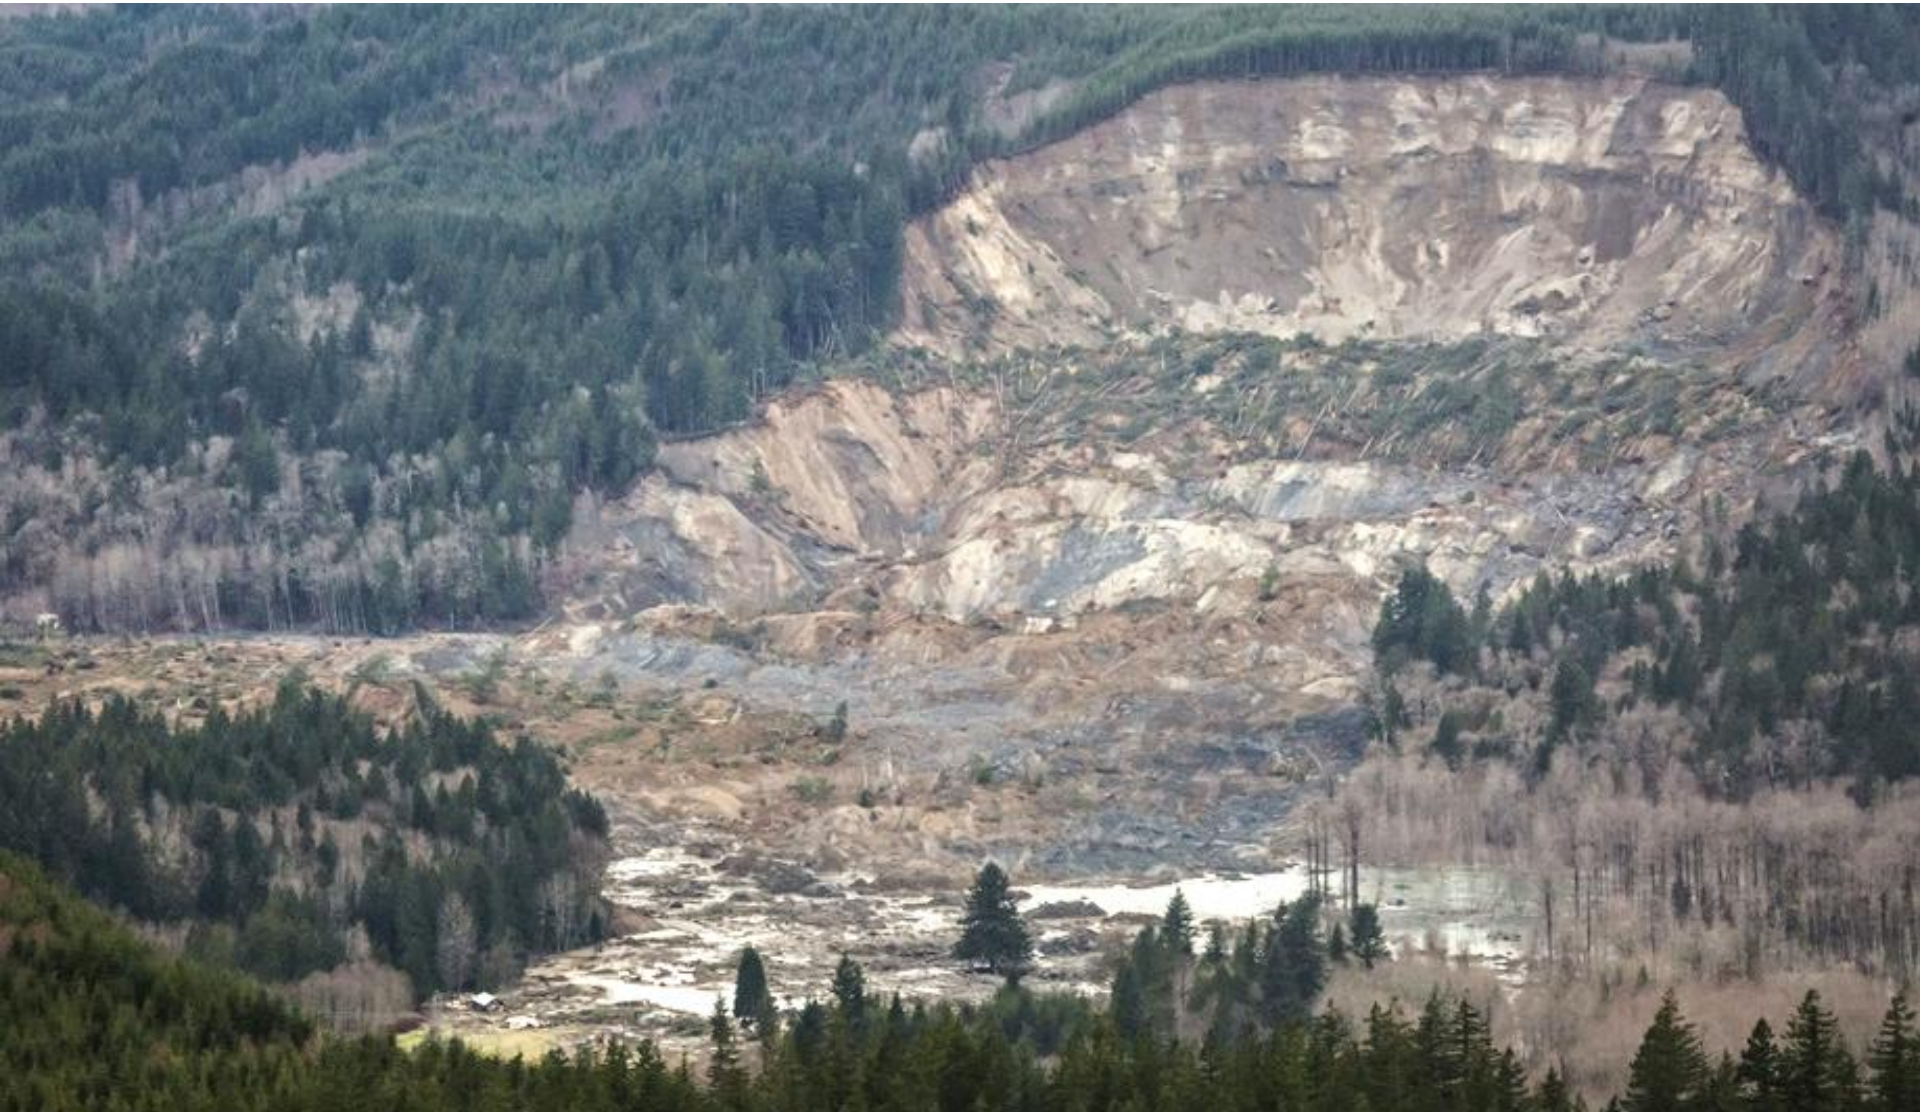
# Oso Slide, Northern Washington, USA, March 22, 2014

**7.6 million m<sup>3</sup>**

**Community destroyed, 43 fatalities, \$50 million cost**

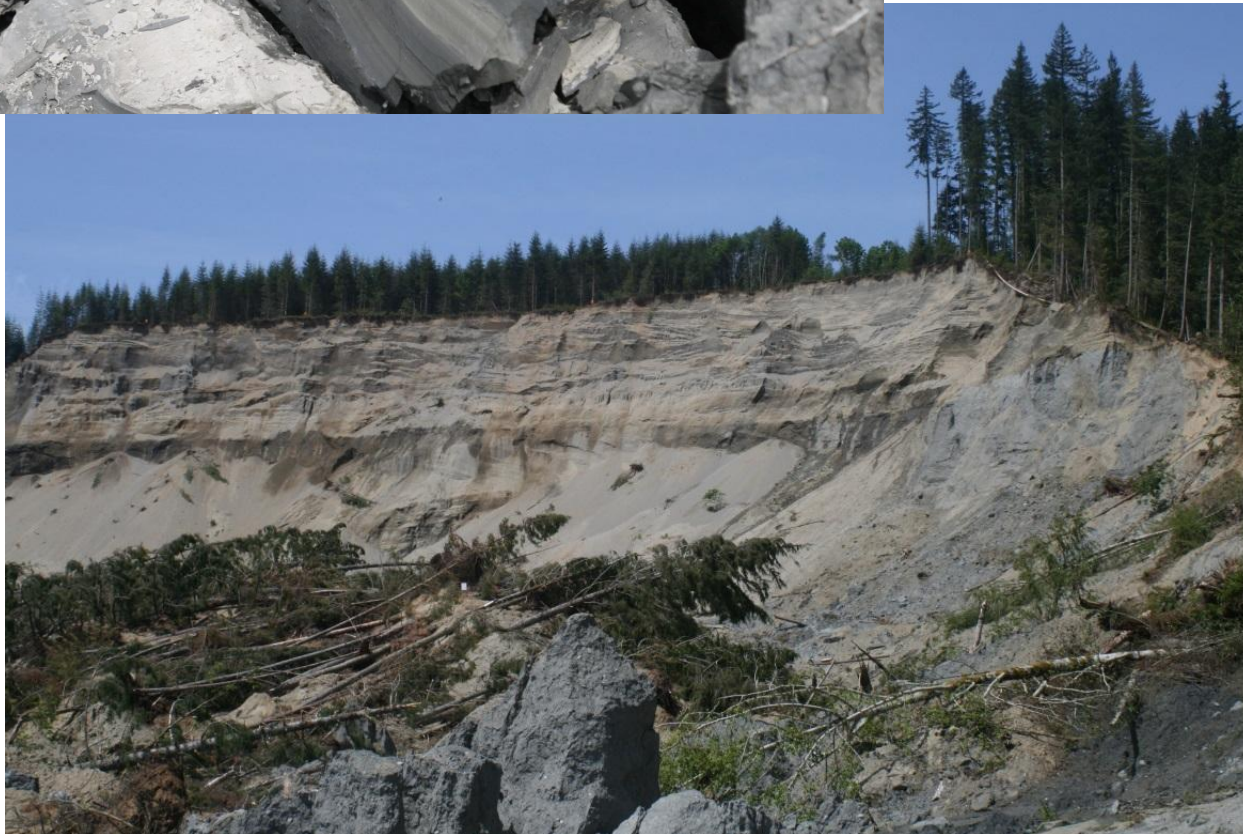
## Material:

Glacio-lacustrine clay and silt  
Described as “hard” in  
drillholes  
Collapsible??

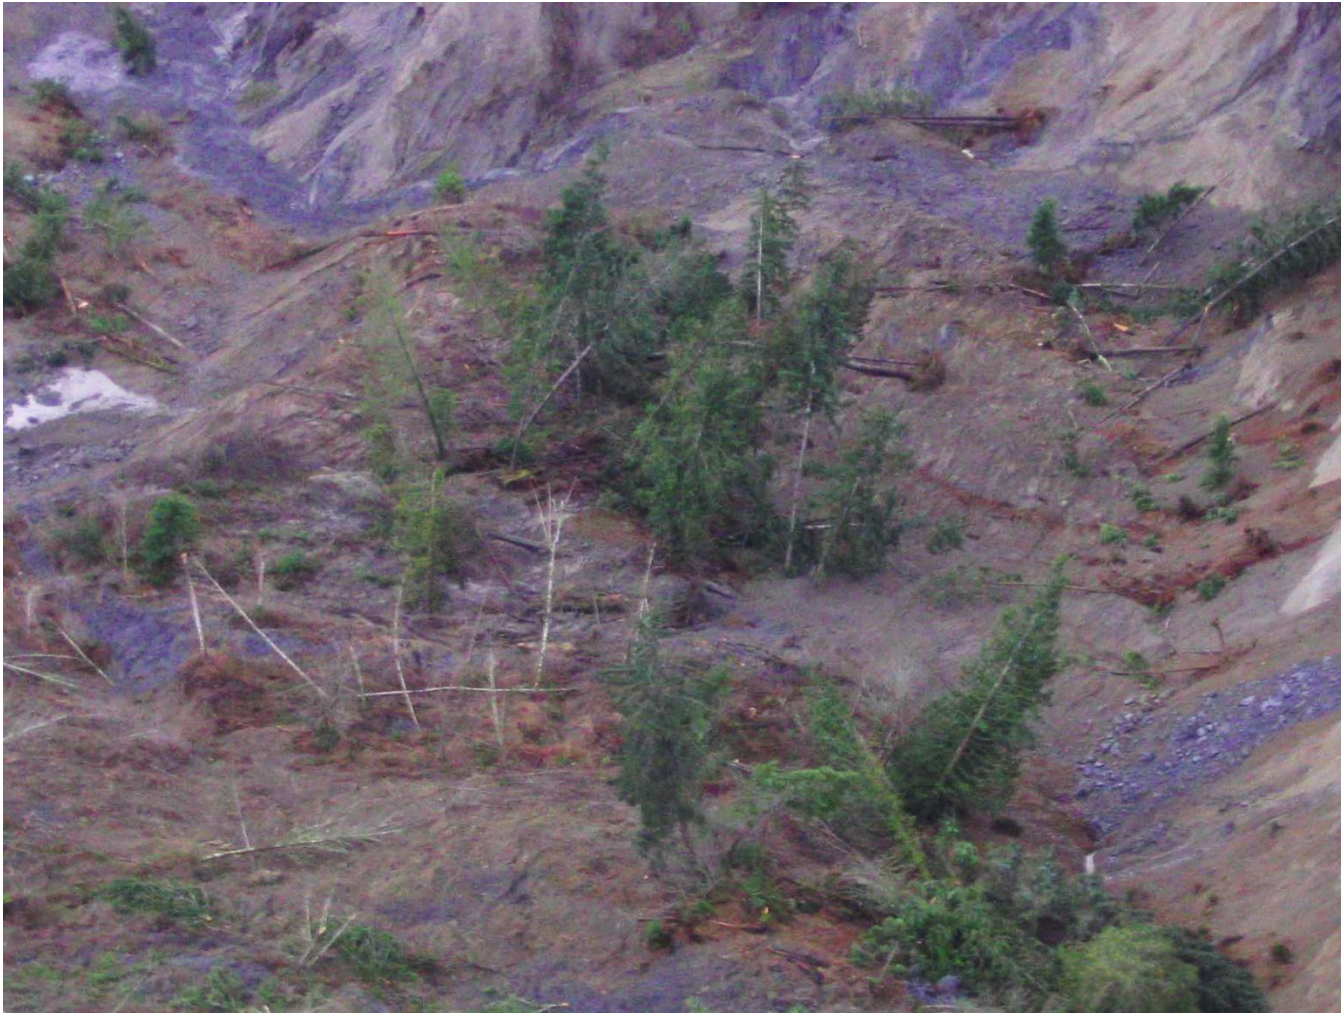
## **Material:**

Overlying  
sand and  
glacial till

**Colluvium from the 2006 and earlier slides. Liquefiable?**
