# Non-textbook Flowslides in Fine-grained Colluvium

Oldrich Hungr

University of British Columbia, Canada

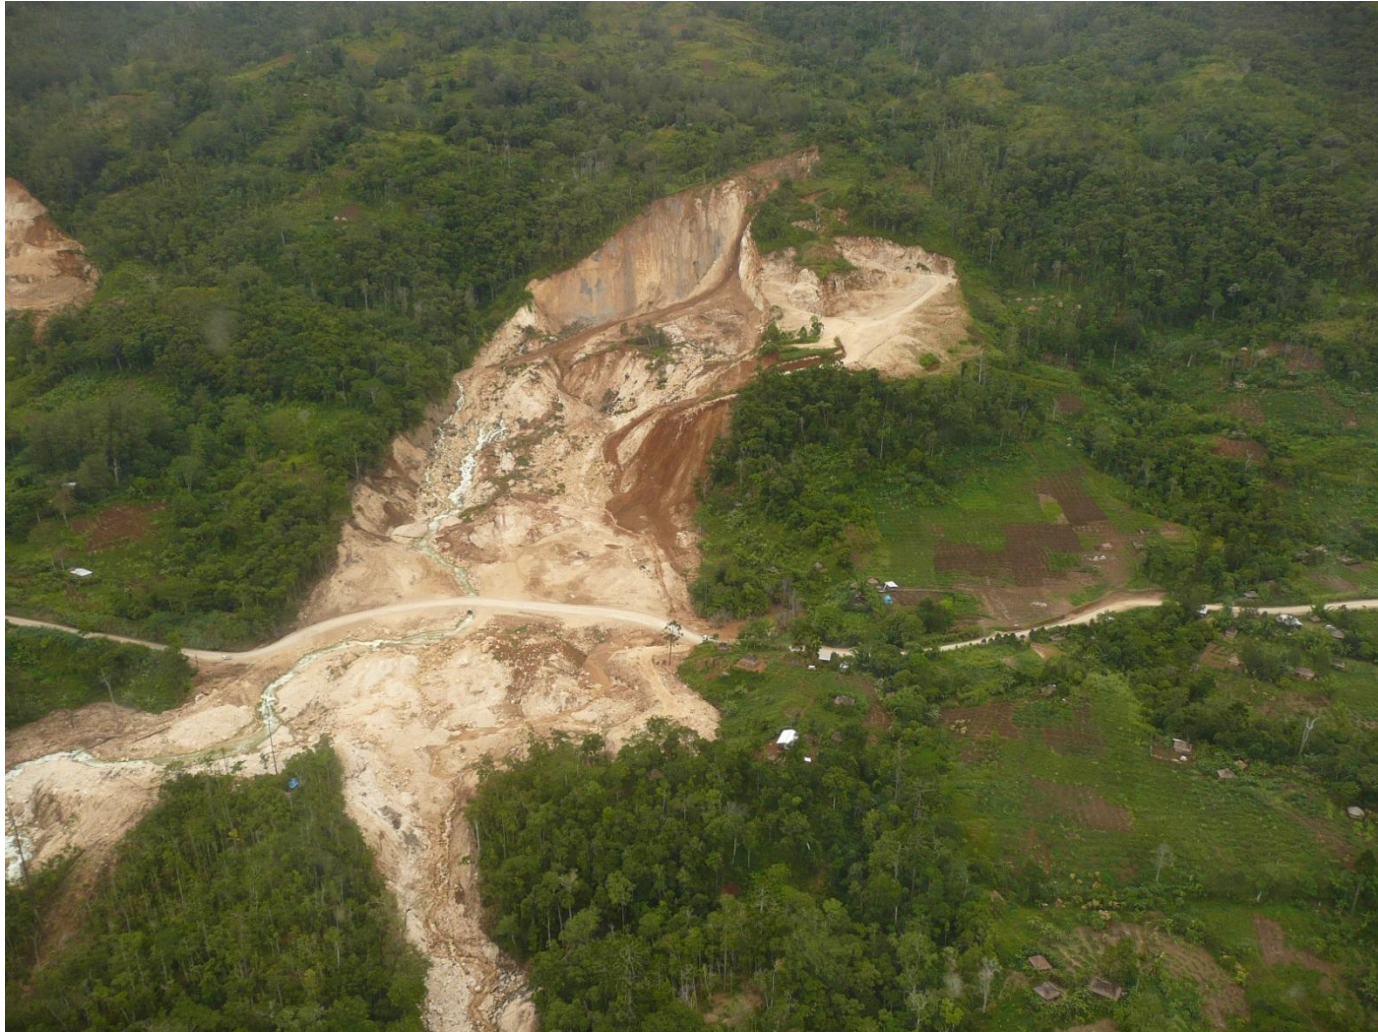
**Flowslide in Papua New Guinea?**

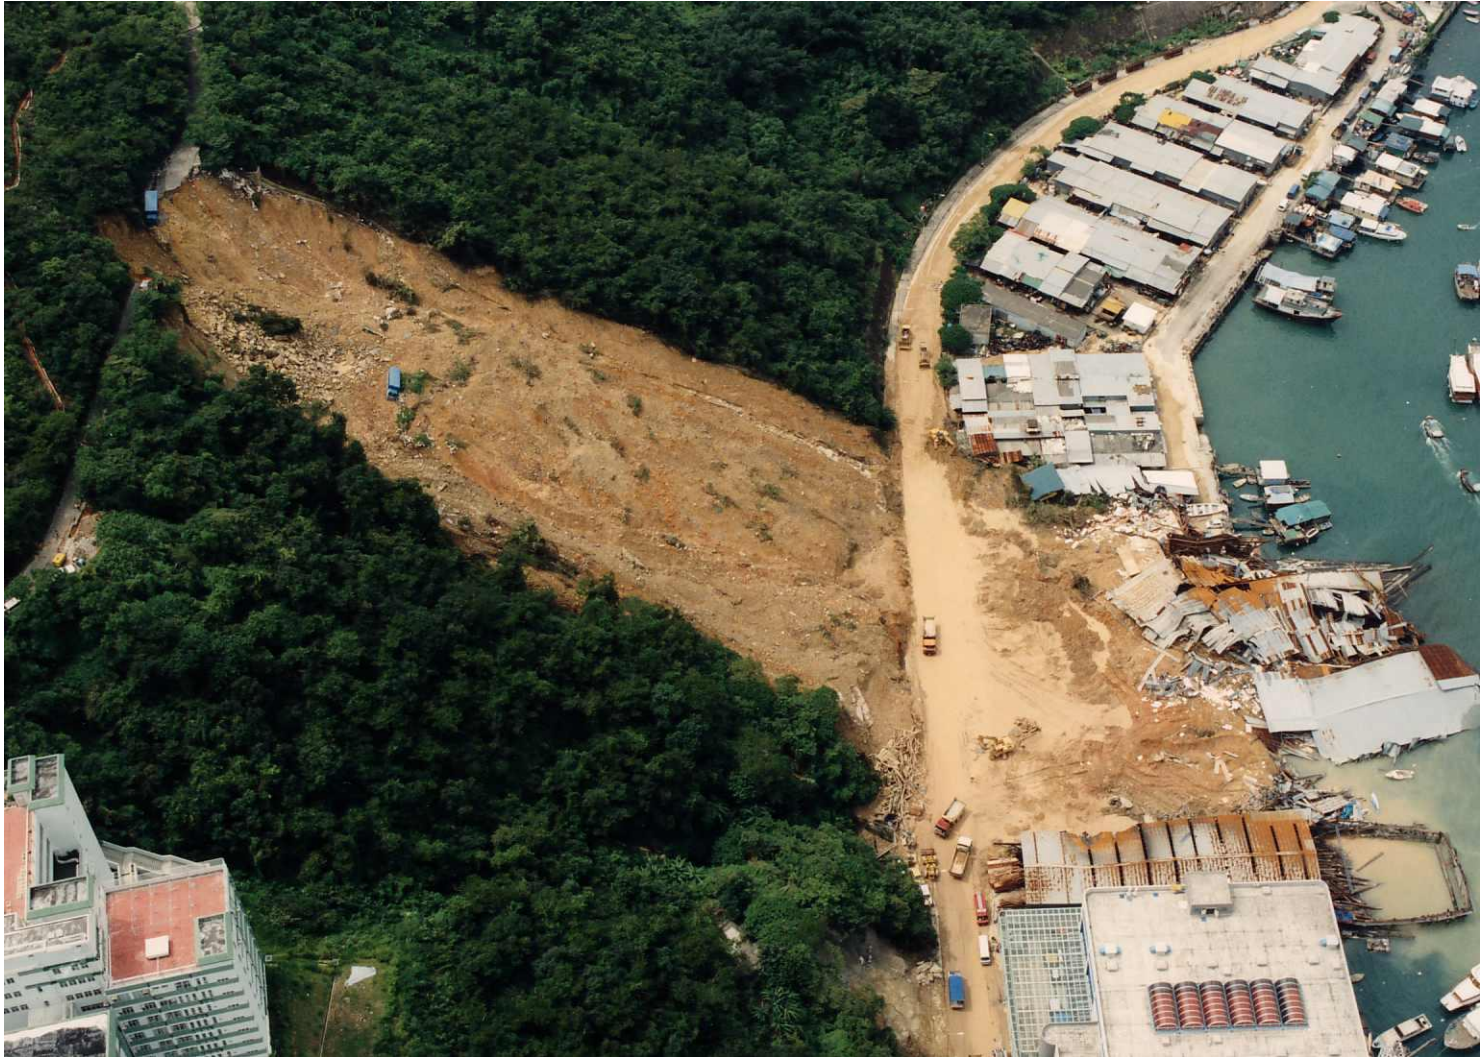
**Flowslide in Hong Kong?**
