# Land Instability in the Ironbridge Gorge

Chris Bullas

Principal Geotechnical Engineer

Telford & Wrekin Council

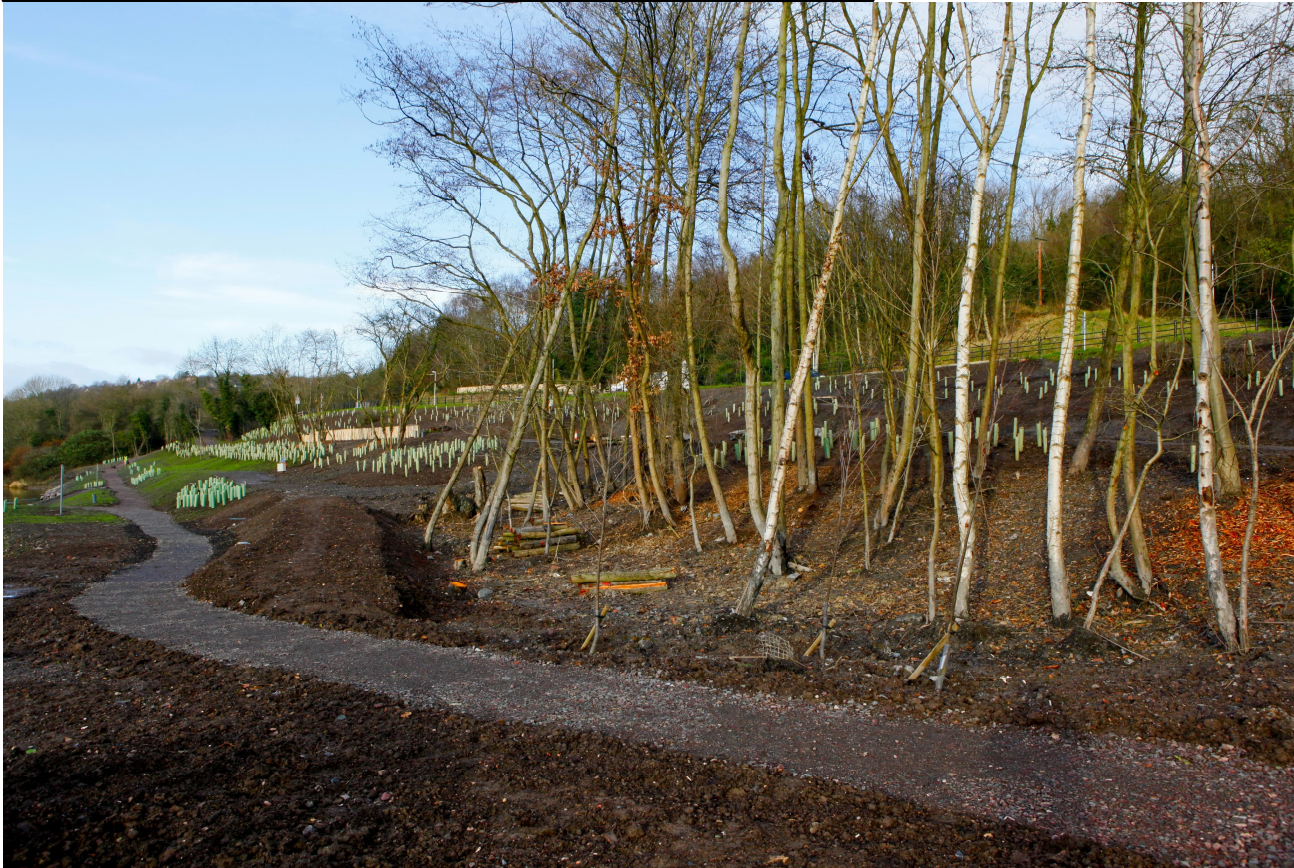
The Lloyds Phase 2 2008 Completion

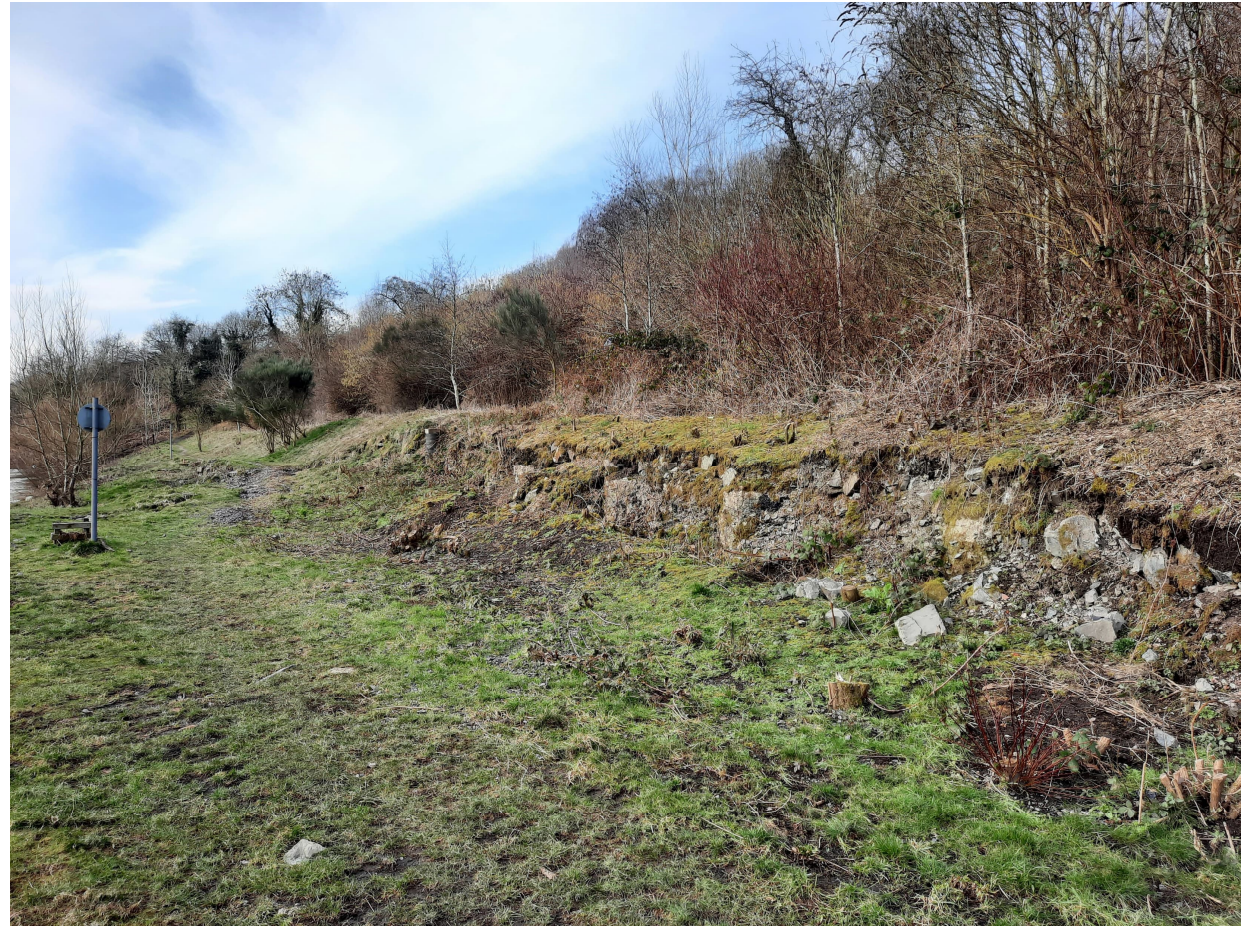
The Lloyds Phase 2 2009
