# **Instrumentation and Monitoring Feedback on Ground Movement Response during tunnelling activity through Mercia Mudstone Group Strata, on HS2 Project (Area North)**

**Geological Society of London - West Midlands Regional Group  
February Talk**

**Mr Ioannis Papadatos - Geotechnical Manager / Tunnels**

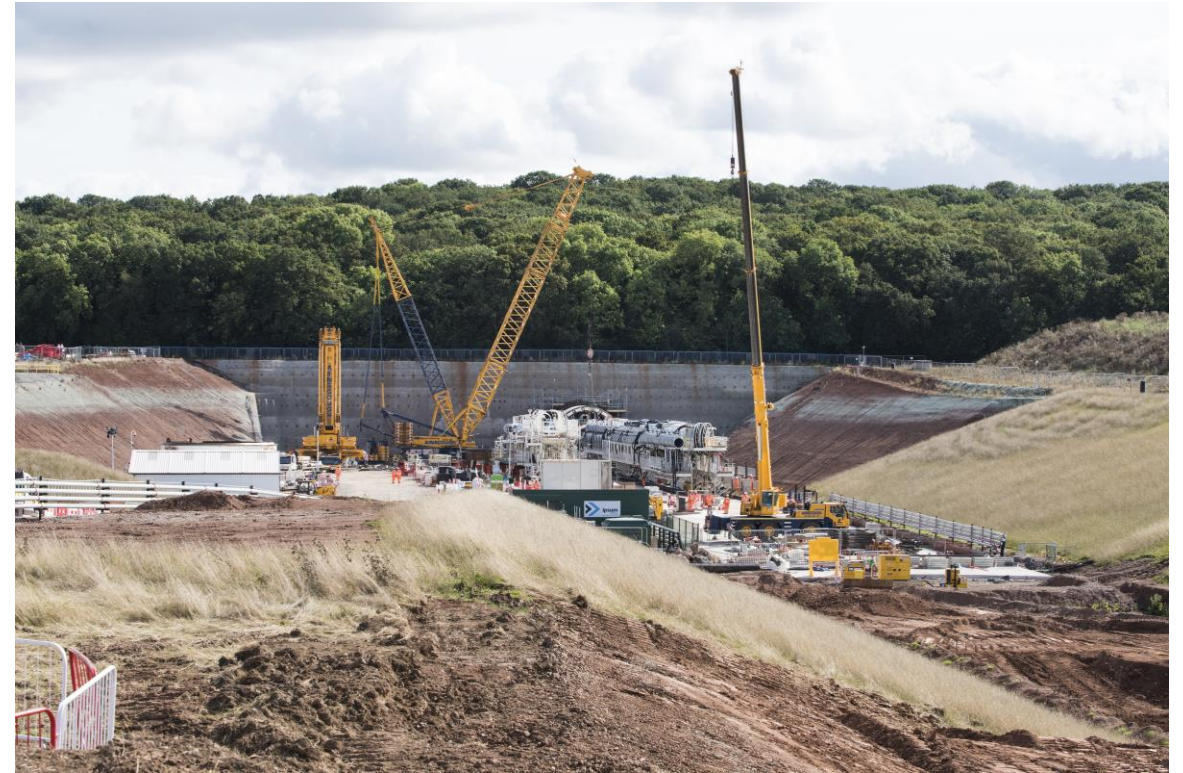
- 2no. single bore 1.6km (total 3.2km)
- 3no cross passages, connecting UP/DN Bore
- 1no.TBM (Variable Density®)-Dorothy
- Excavation diameter (TBM) 9.99m
- Internal diameter 8.80m
- Segmental lining 400mm thick of 2000mm nominal ring length
- Tunnel ring includes 7 + 1 (key) Steel fibre reinforced segments
- The construction of both Upline and Downline bored tunnels as well as the 3 SCL Cross passages is completed

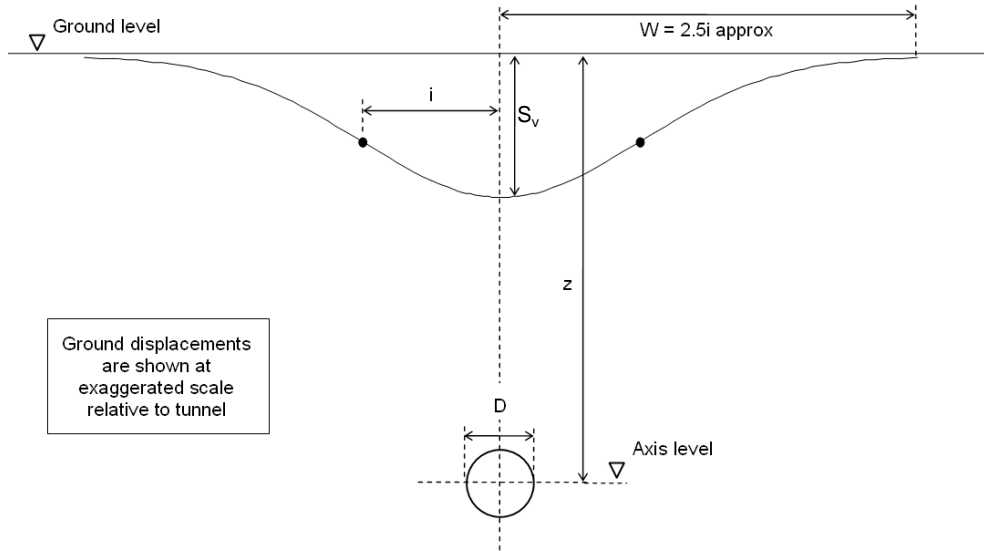
8.2.3 A value of trough width parameter,  $K = 0.5$  shall be adopted in London Clay, a value of  $K = 0.4$  shall be adopted in other geologies shown in Table 1.  $K$  values for "sands" should consider differences above and below the water table. Values of up to 0.5 can occur for wet sands.

8.2.4 Table 1 provides values of volume loss for various ground conditions and tunnel construction methods.

Volume Loss		London Clay	Lambeth Group	Chalk	Mercia Mudstone
Tunnel construction methods	Closed face tunnelling (earth pressure balance machine (EPBM) or slurry Tunnel Boring Machine (TBM))	1%	1%	1%	1%
	Open face tunnelling	2%	2%	2%	2%
	Sprayed concrete lining (SCL)	1.5%	1.5%	1.5%	1.5%

- The **ground surface settlement** induced by tunnel construction is commonly described by a Gaussian inverted curve in the transverse direction (by O'Reilly & New, 1982) and a cumulative Gaussian curve in the longitudinal direction (by Attewell & Woodman, 1982) has been calculated in line to HS2 technical Standards.
- A **volume loss of 1%** has been assumed for the TBM bored tunnels and 1.5% for the SCL cross passages.
- A **trough width parameter of 0.4** is adopted for all tunnel elements.

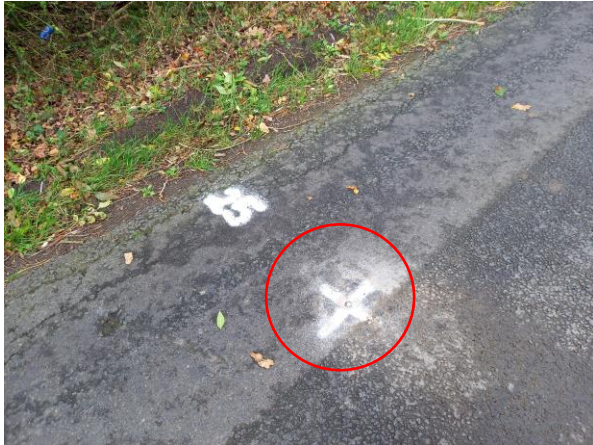
Levelling stud installed hard paved areas

## Levelling Studs for Hard and Soft Ground

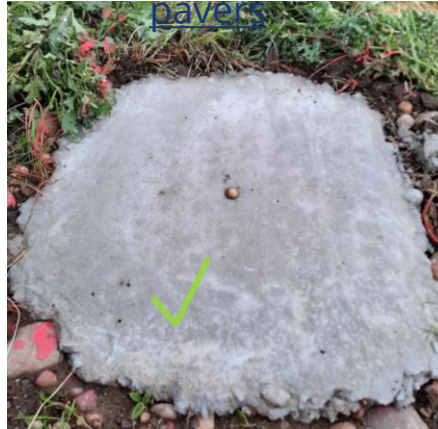
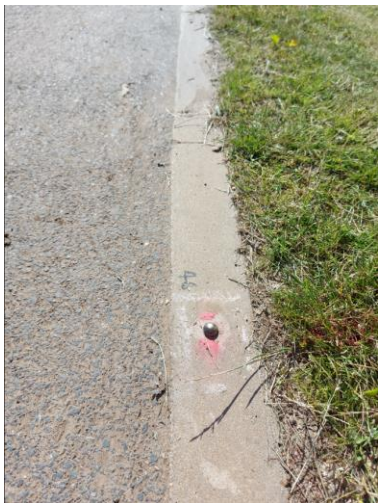
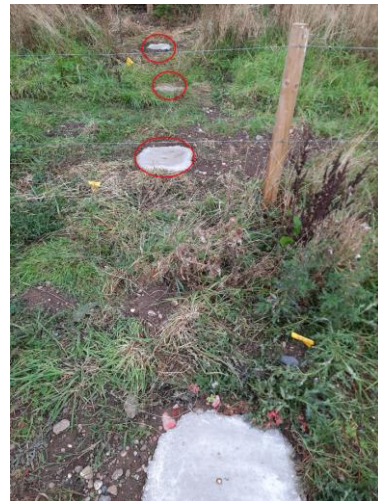
Levelling stud installed soft Ground

Survey anchor for Soft Ground to mitigate seasonal variations  
Depth can vary between 0.4m and 1m

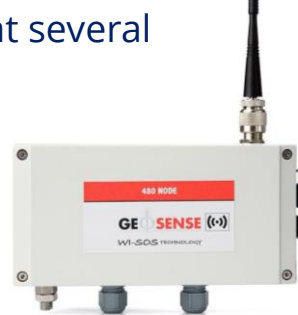
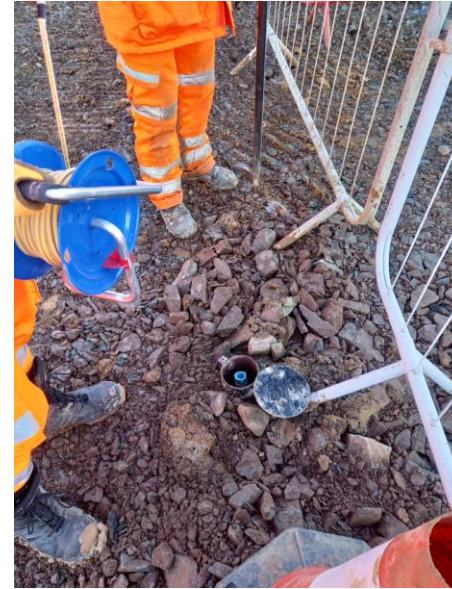
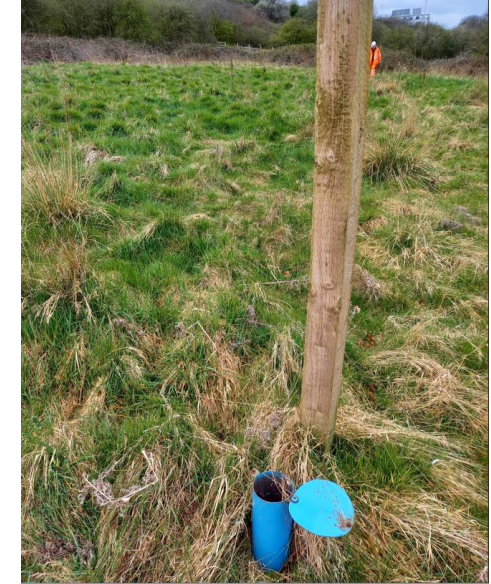
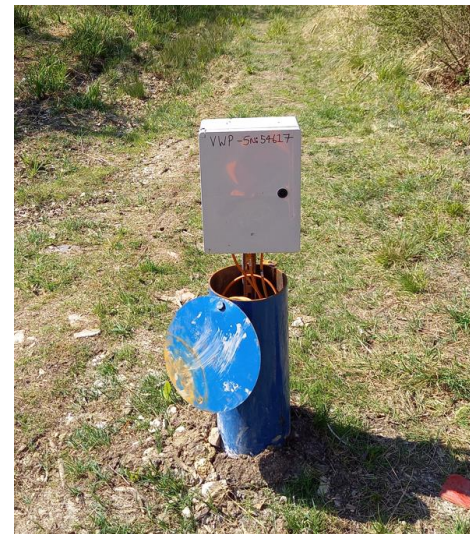
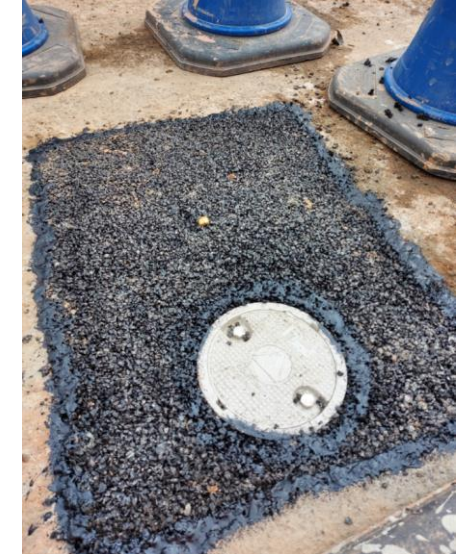
**Borehole inclinometer (IM)** : instrument designed to measure the horizontal deformations at depth.

**Borehole extensometer (XM)** : instrument designed to measure the vertical displacements at depth.

**Standpipe piezometer (PS)** : open tube / well installed in the ground and allowing to measure directly the ground water level.

**Fully-grouted borehole piezometer (PV)** : grouted borehole equipped with one to 4 piezometer sensor(s) installed at several depths.

Most of borehole Instruments were set **as Automated** transferring monitoring data through Gateways to the project online Monitoring Database.

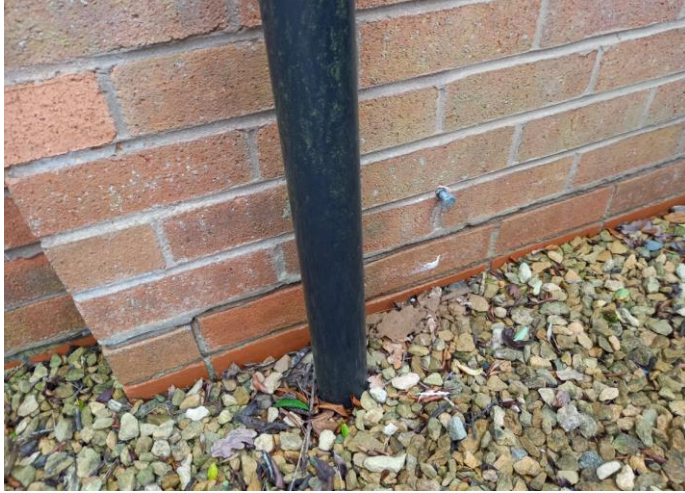
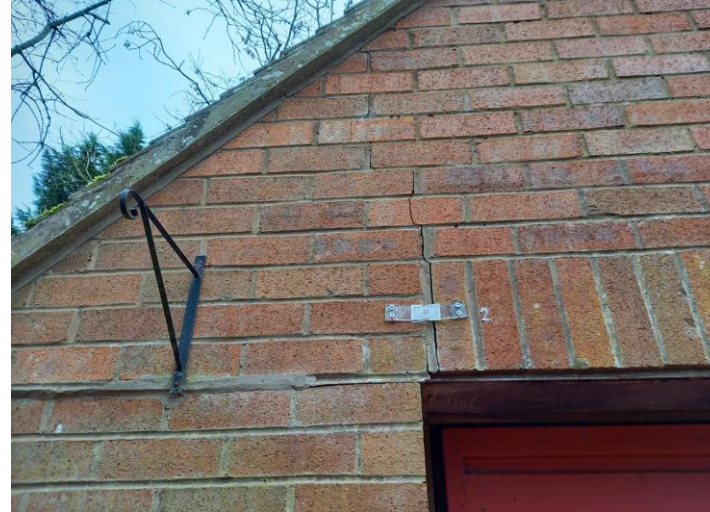
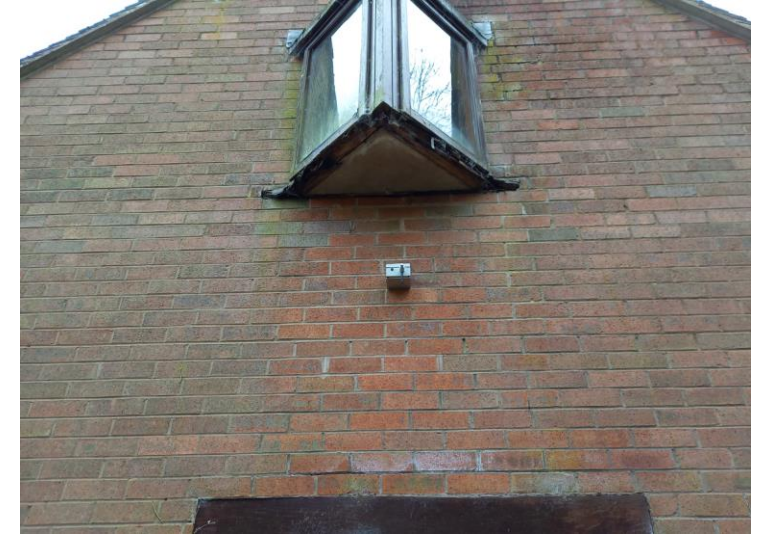
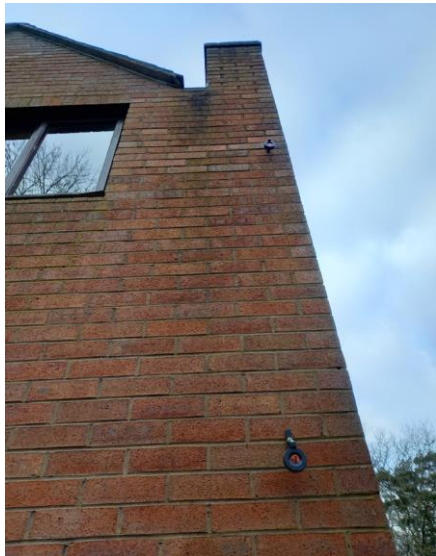
- Levelling studs at buildings lower walls
- Prisms at building façades
- Crack meters (where cracks identified)
- Triaxial automated Tilt Meters

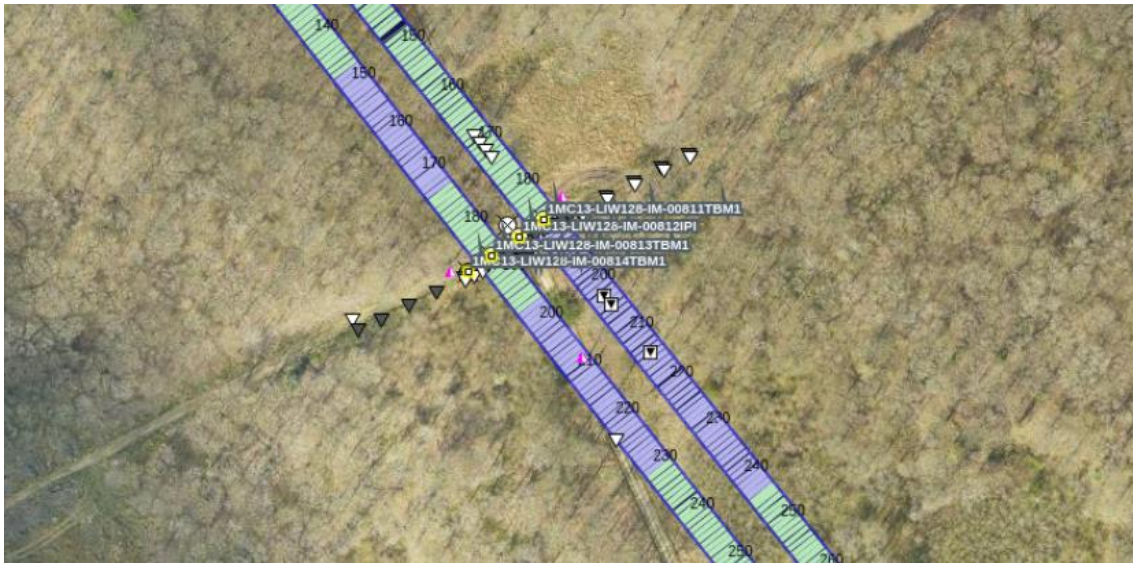
Typical Monitoring array with:  
 (a) Levelling points (b) Extensometers (c) Inclinometer (d) Piezometers

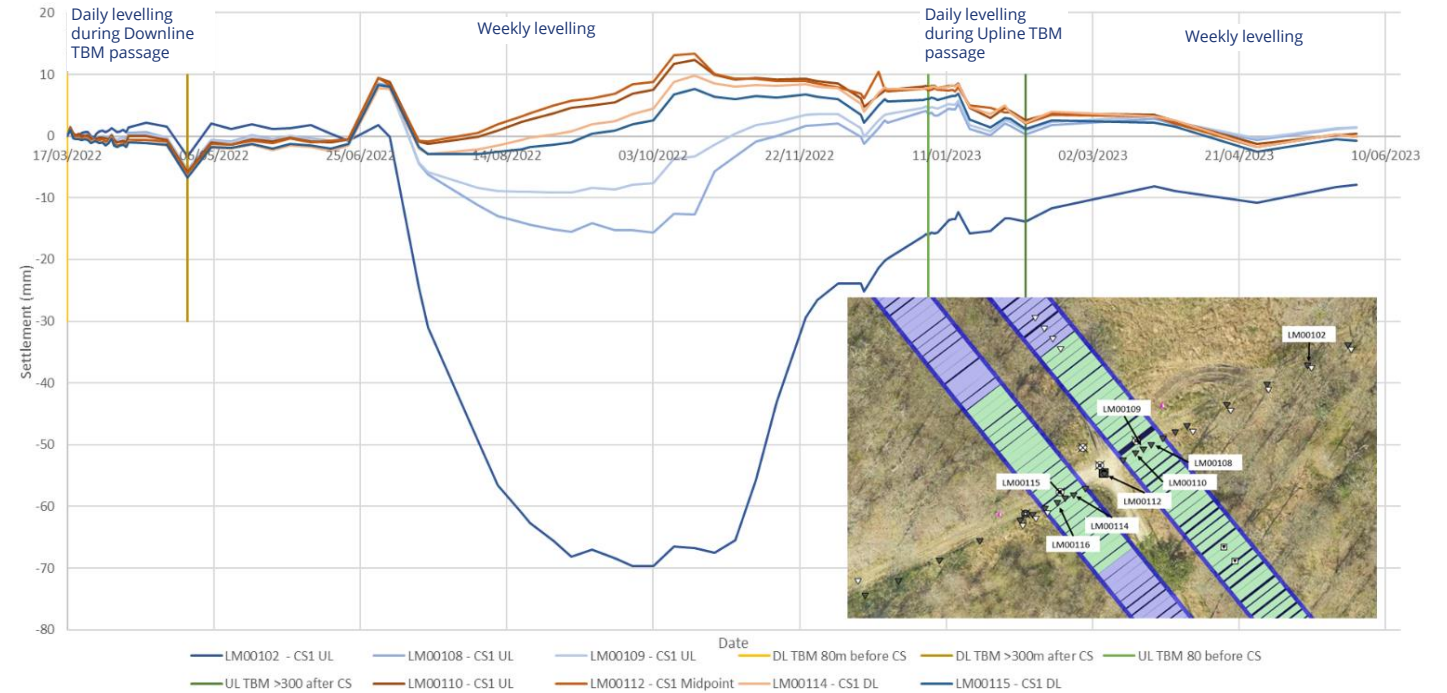
## Seasonal Variation of surface soft ground

- On Ancient Woodland more than a year of levelling at CP1 - indicates that the impact of the shrink-swell behaviour is significant, and of a much larger magnitude than the tunnelling induced movement.
- To mitigate that deep survey anchors were added for TBM2 and also implemented on Bromford Tunnel

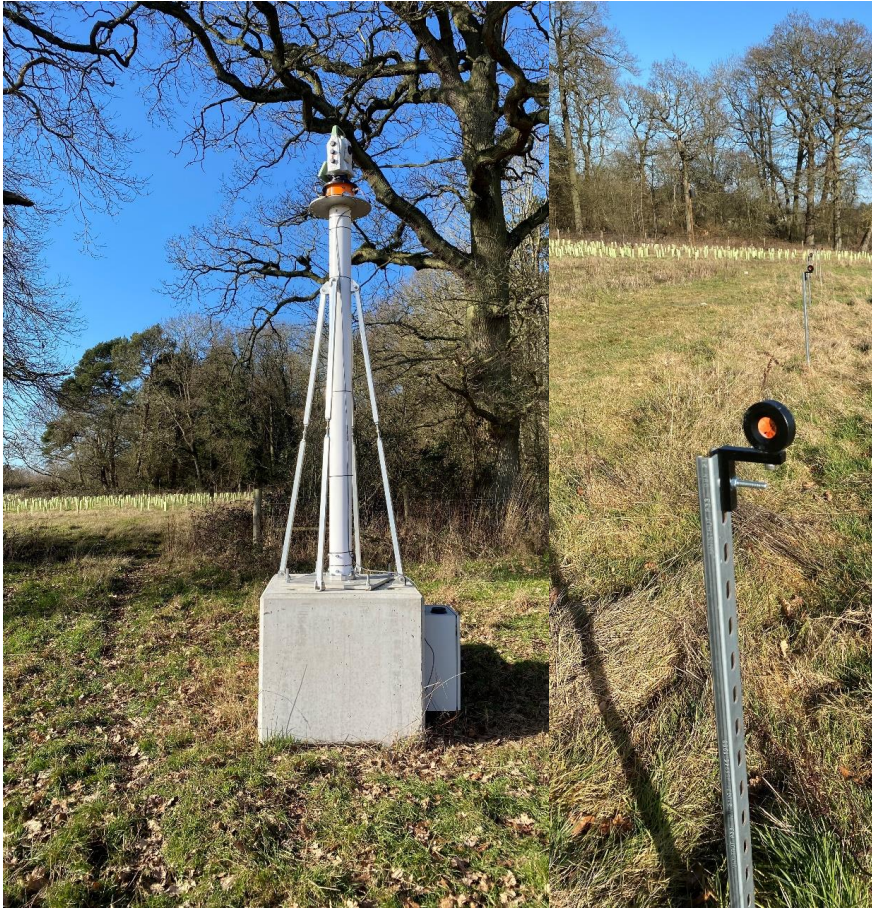
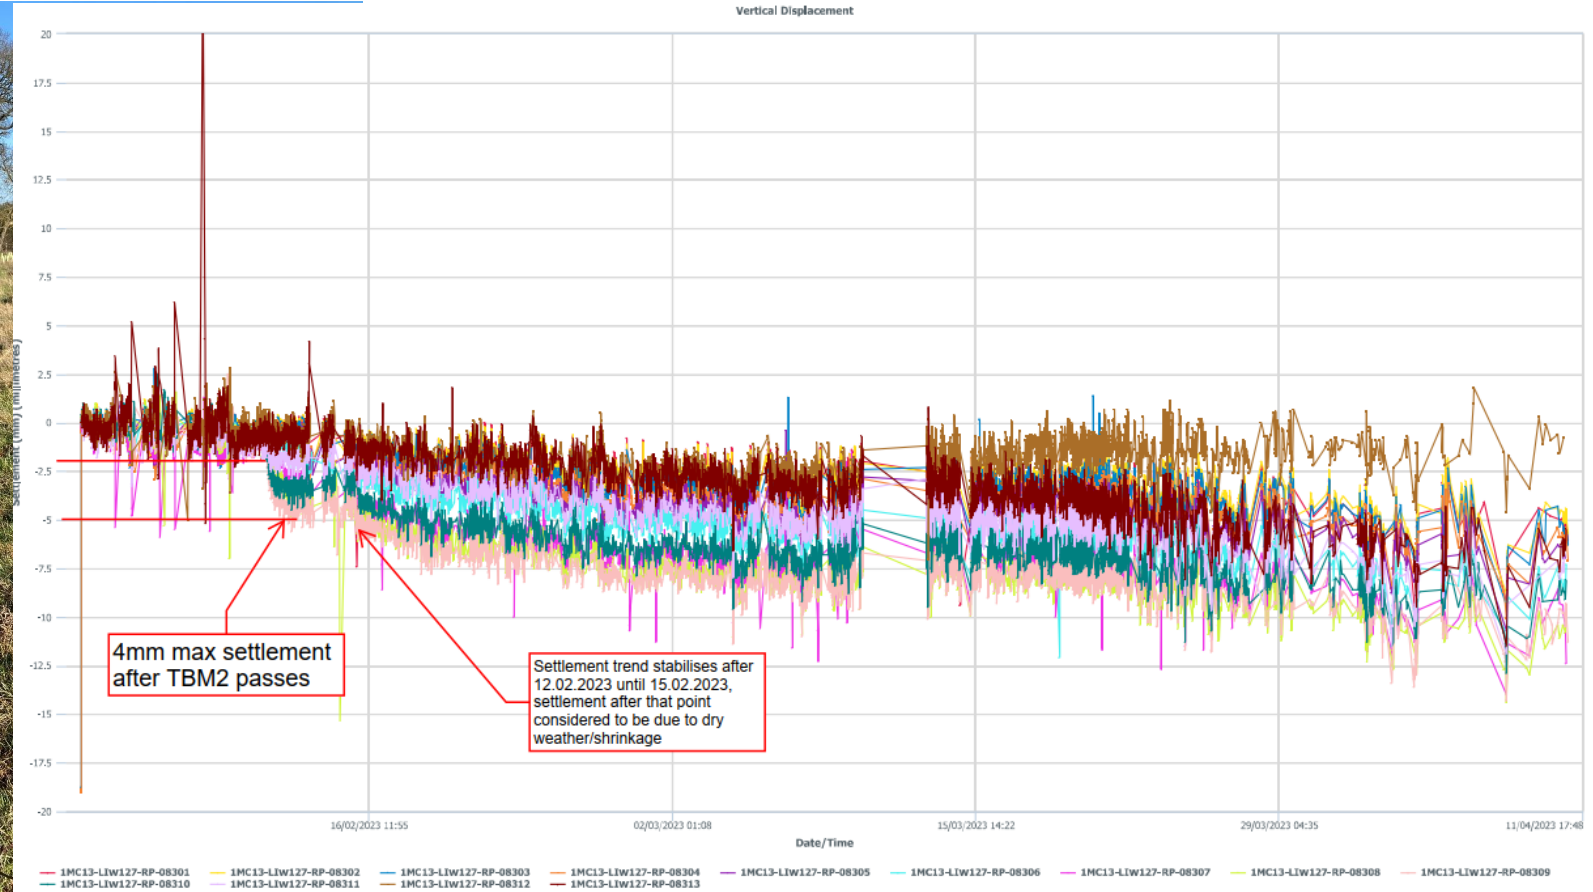
Automated Total Station (ATS) with hourly data monitoring frequency transferring data online to Monitoring Database

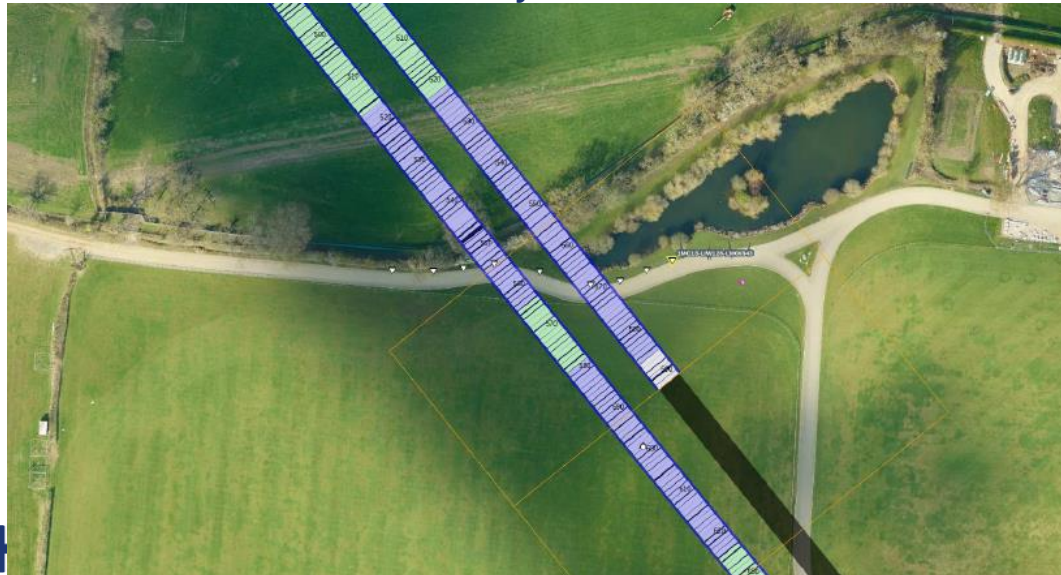
Typical Monitoring array with:  
**Levelling points**

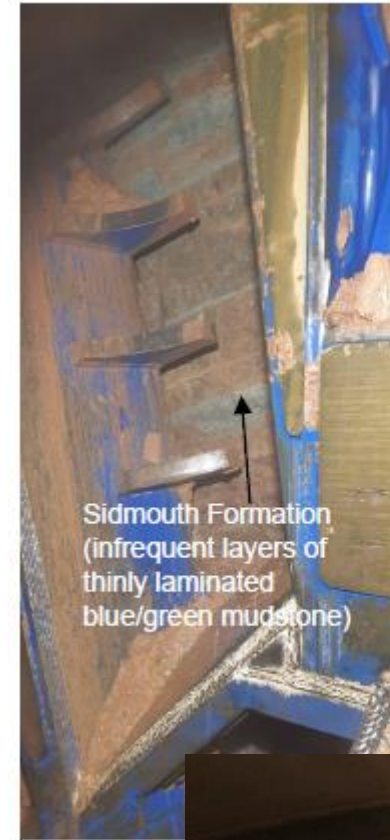
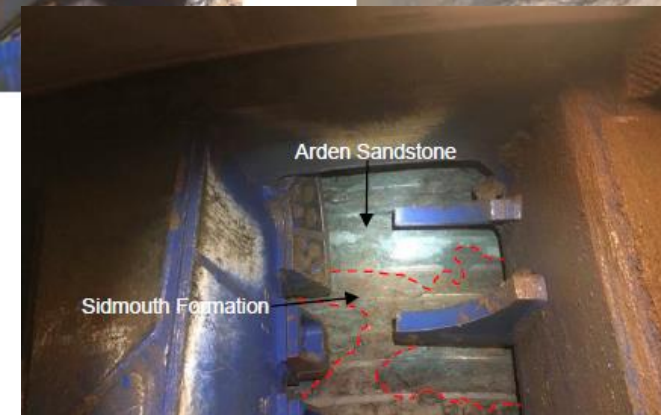
Chainage : 128+600  
 Ring: 12  
 Cover: 8m

Geology:  
 MMG mix conditions  
 Sidmouth formation and  
 on top Arden sandstone

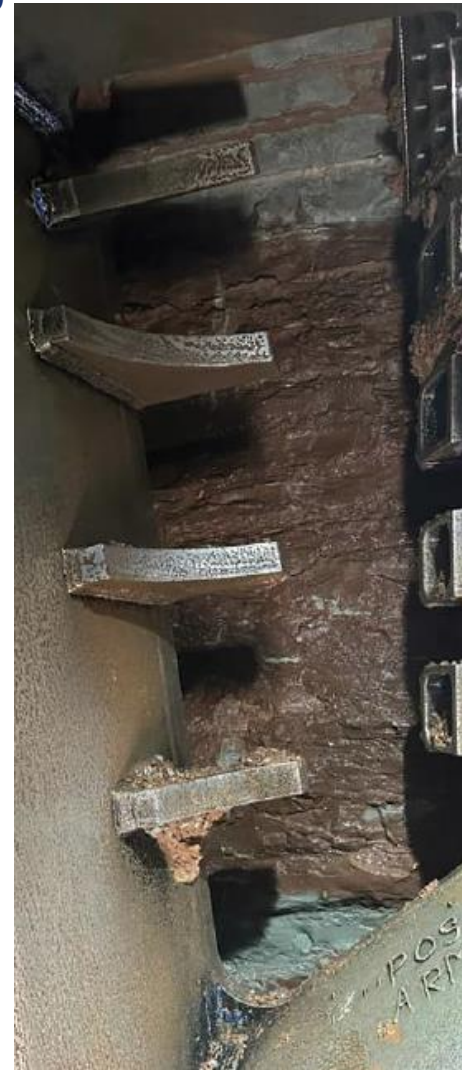
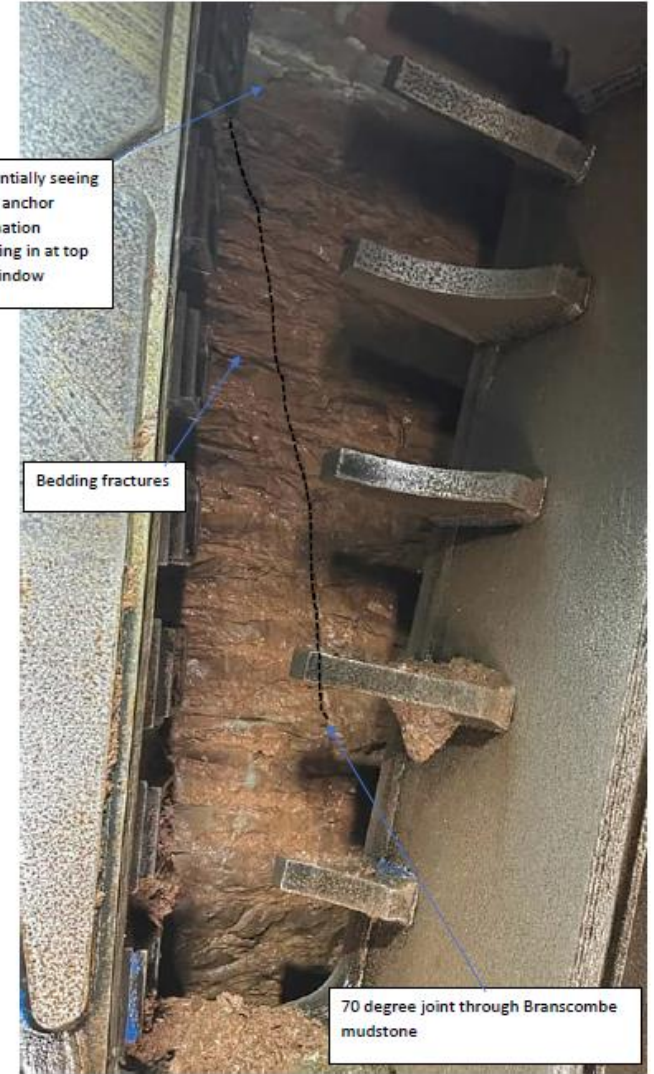
Chainage : 128+850  
 Ring: 390  
 Cover: 27m

Geology:  
 MMG Branscombe  
 formation

Potentially seeing  
 blue anchor  
 formation  
 grading in at top  
 of window

Bedding fractures

70 degree joint through Branscombe  
 mudstone

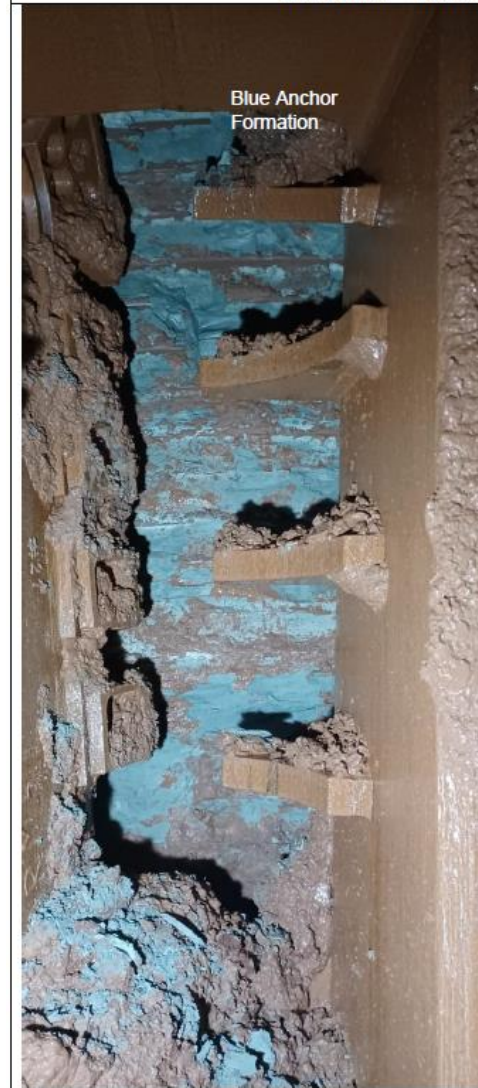
Blue Anchor Formation / Wet conditions

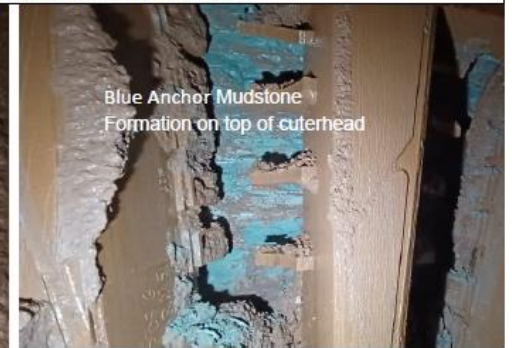
Blue Anchor Mudstone Formation on top of cutterhead

Branscombe Formation at Middle cutterhead

Top and Middle Cutterhead levels  
 Blue Anchor and Branscombe Formation

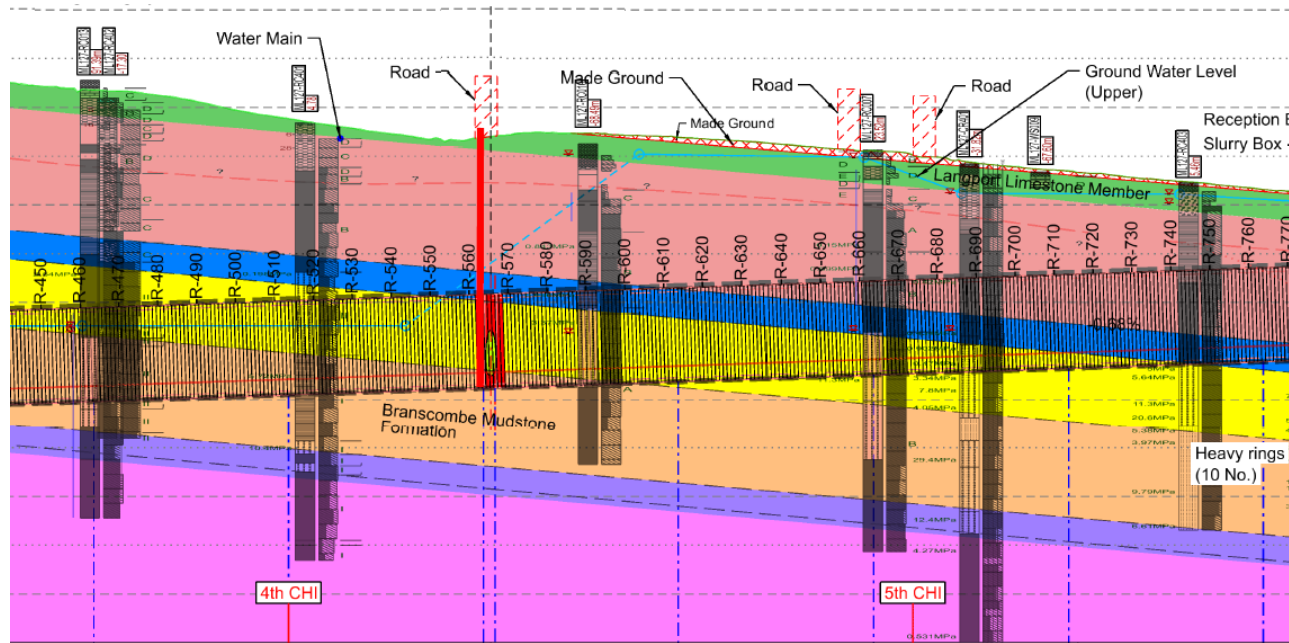
*LIW Tunnel – Cutterhead Intervention Photos*

**Chainage : 127+780**  
**Ring: 564**  
**Cover: 21m**

**Geology:**  
**MMG mix conditions**  
**Blue Anchor on top**  
**Branscombe Mudstone below**

**Westbury Formation – Blue Anchor Contact**

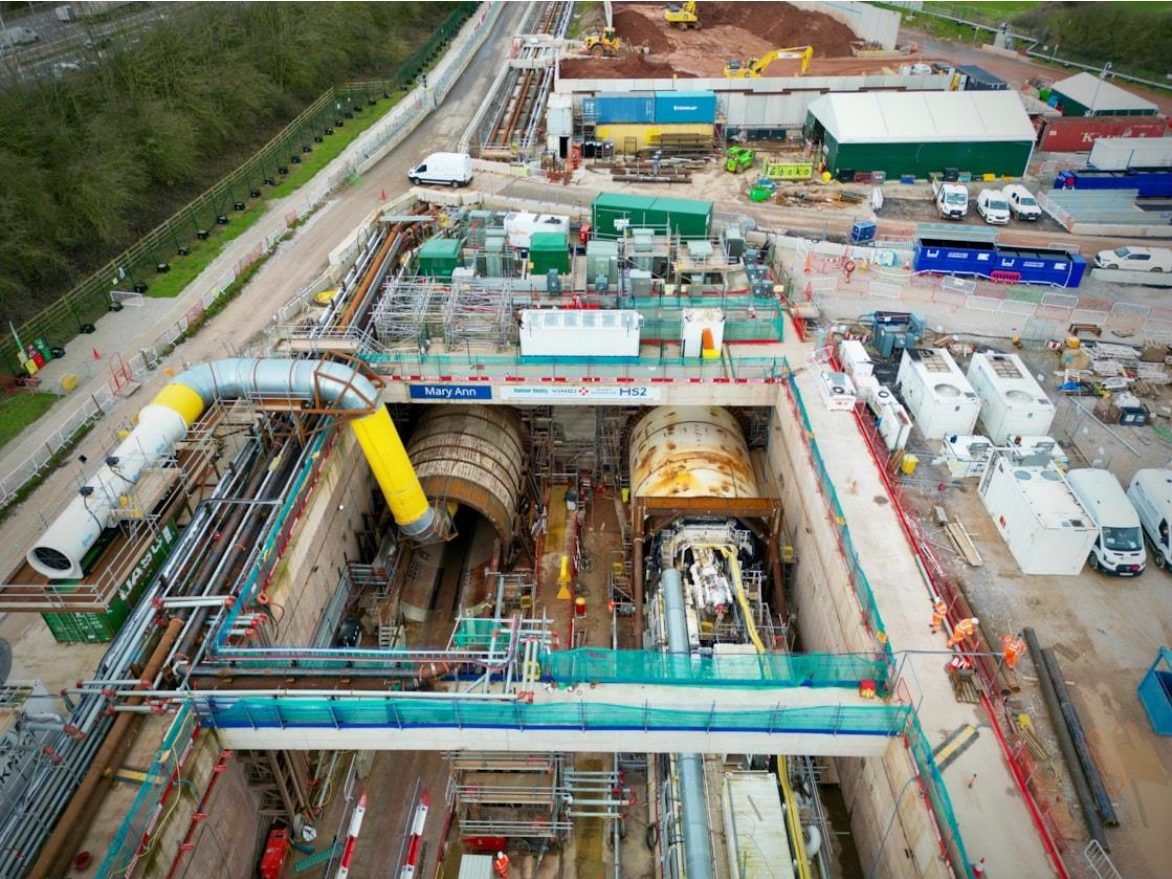
- 2no. 5.8km (total 11.6km)
- Downline 78% completed
- Upline 49% completed
- 2 no. TBM (Variable Density®)
- 13 no. cross passages
- Excavation diameter (TBM) 8.60m
- Internal diameter 7.55m
- Intermediate Shaft (20m diameter)

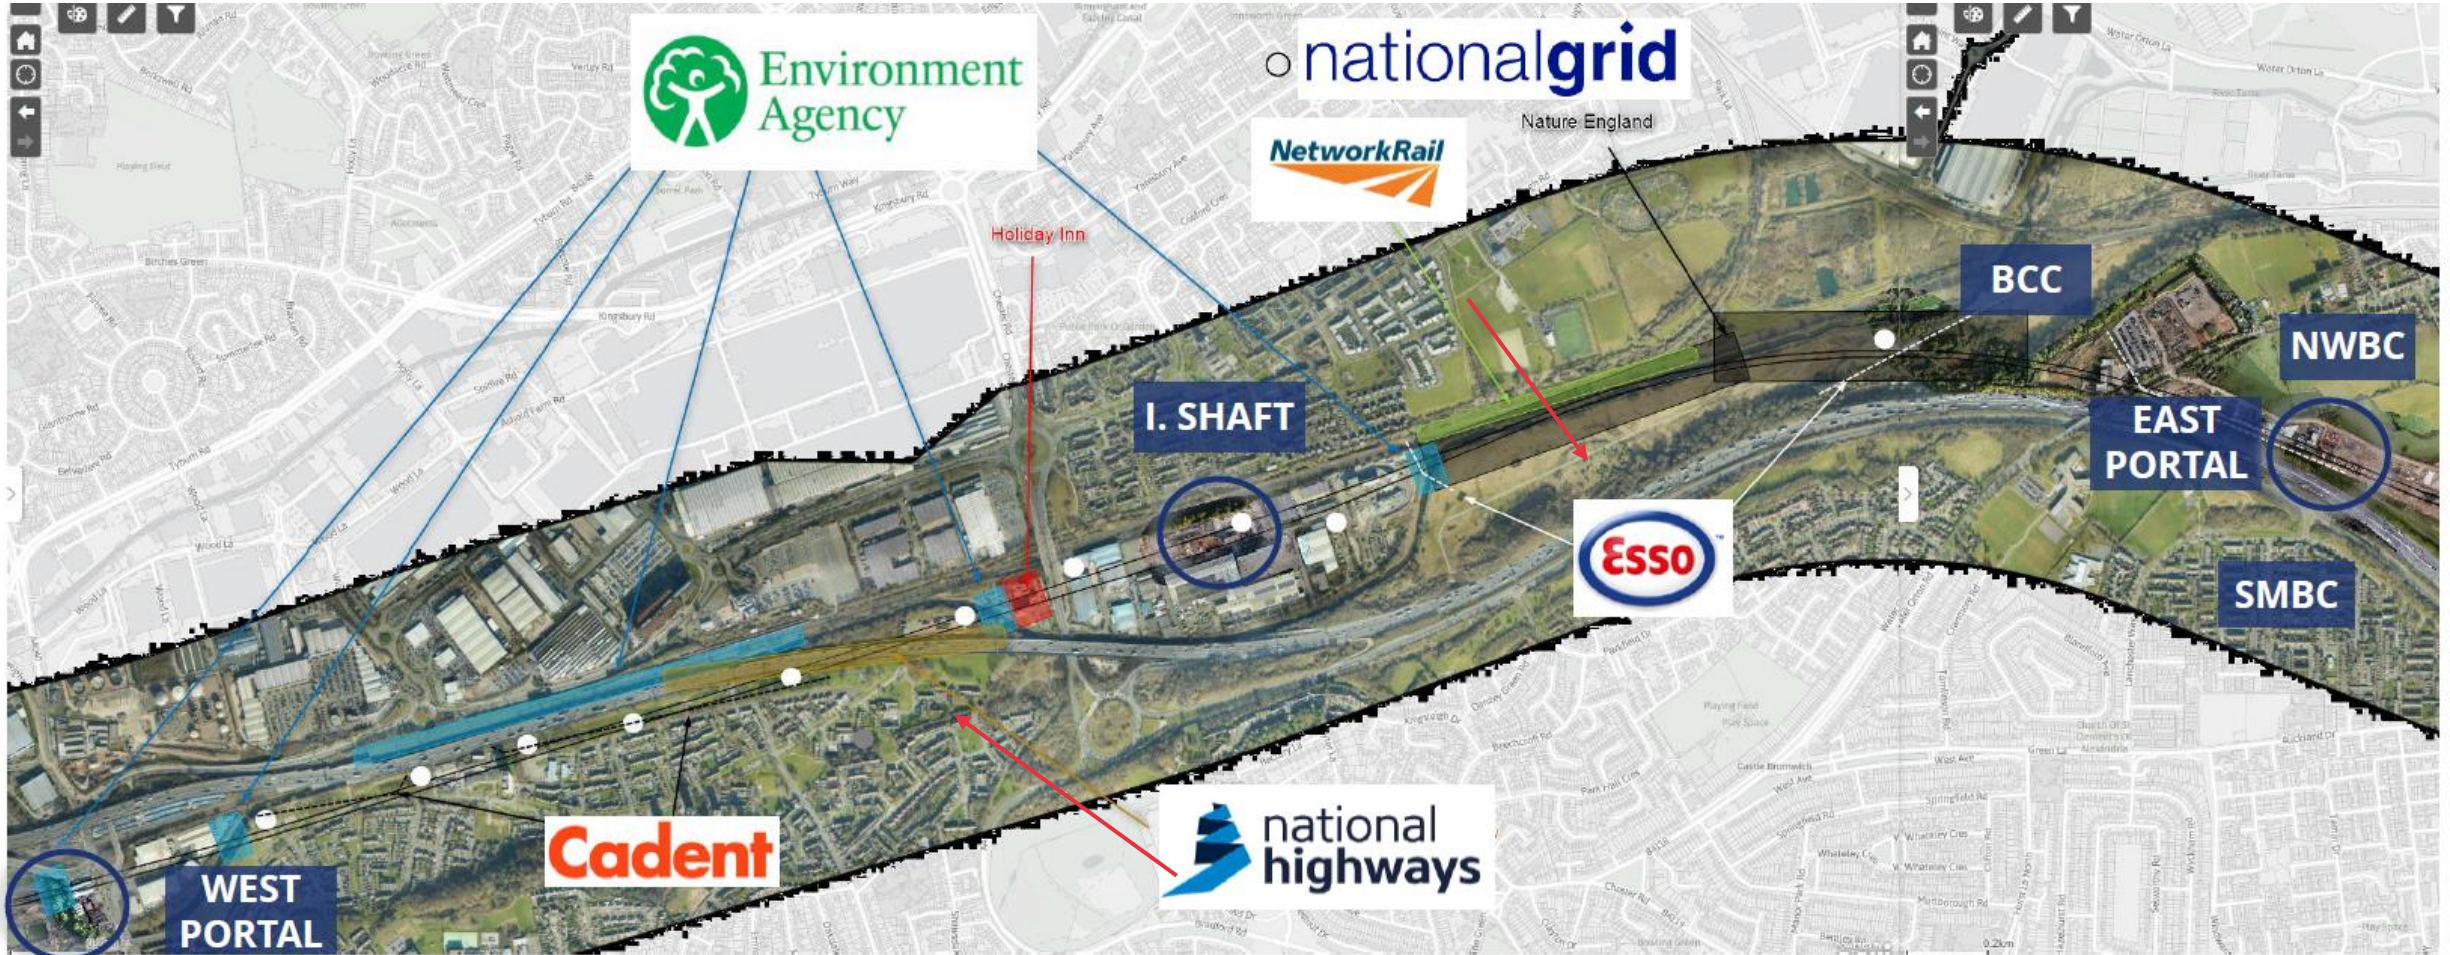
# Bromford tunnel – Key Asset Owners with Tunnel Influence Zone (ZOI)

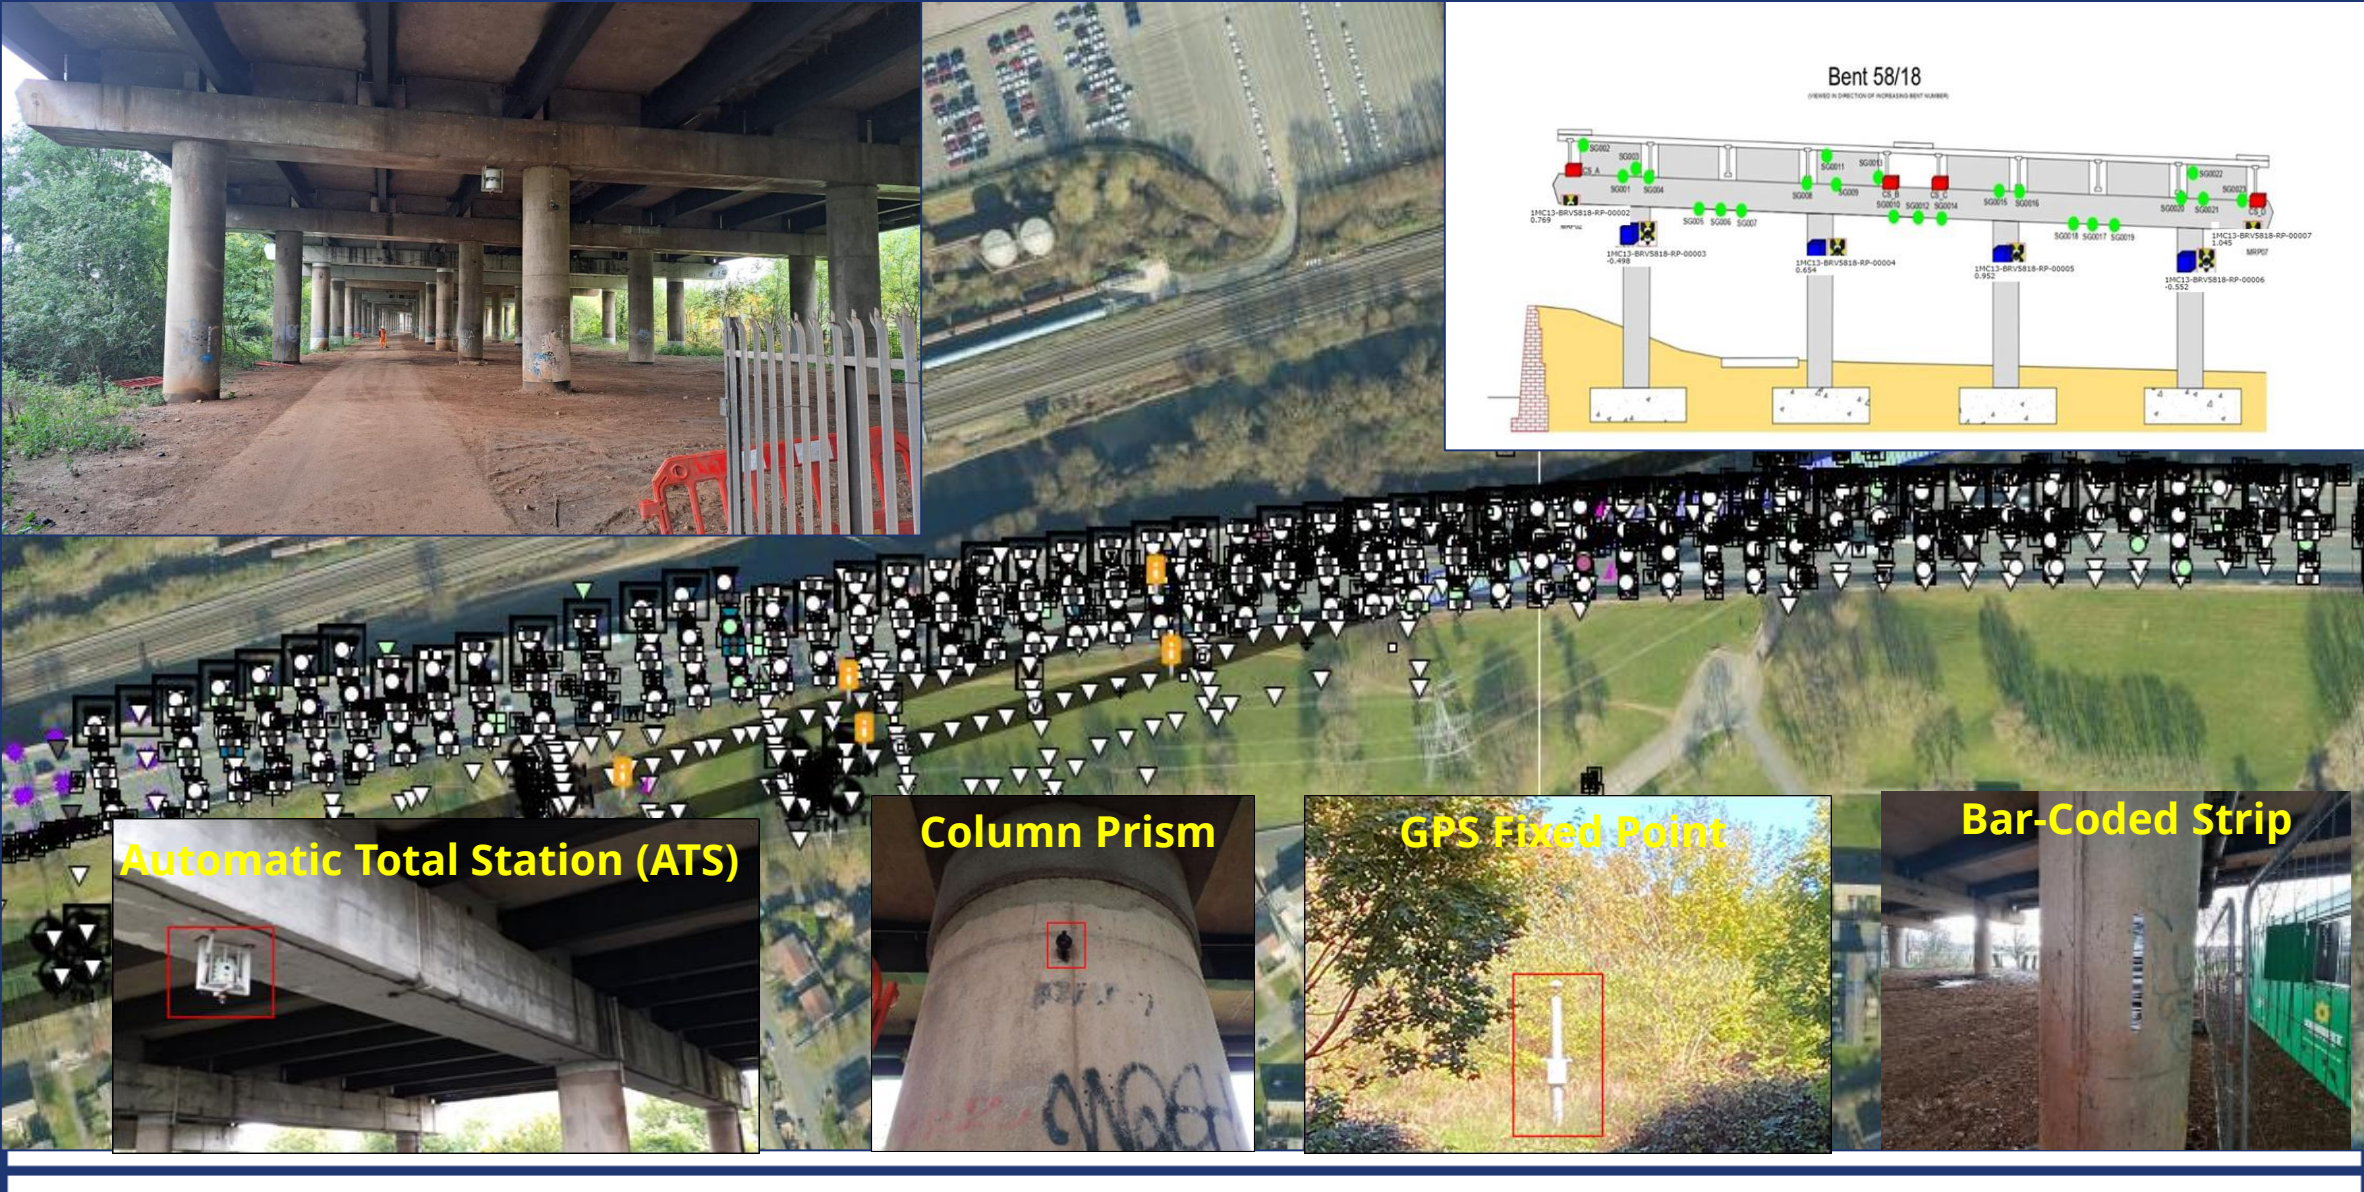
# M6 Viaduct: Structural Monitoring Instrumentation

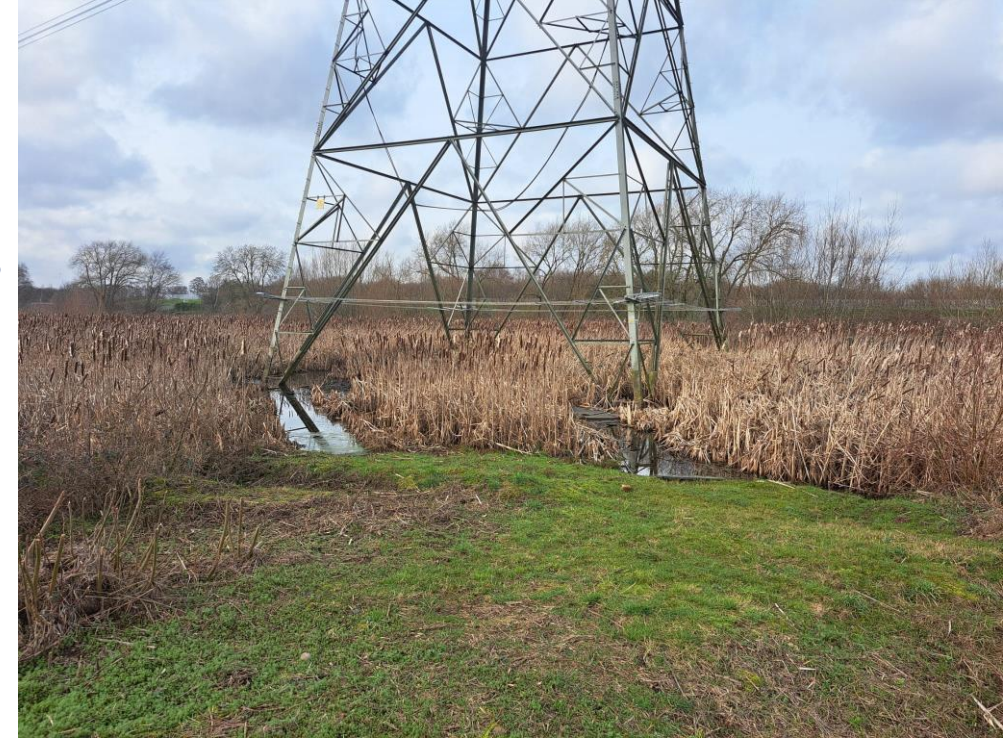
- Precise Manual levelling with Retro Reflective Targets or Levelling studs installed on each leg.
- Automatic Monitoring with Triaxial Tilt Meters on each leg.

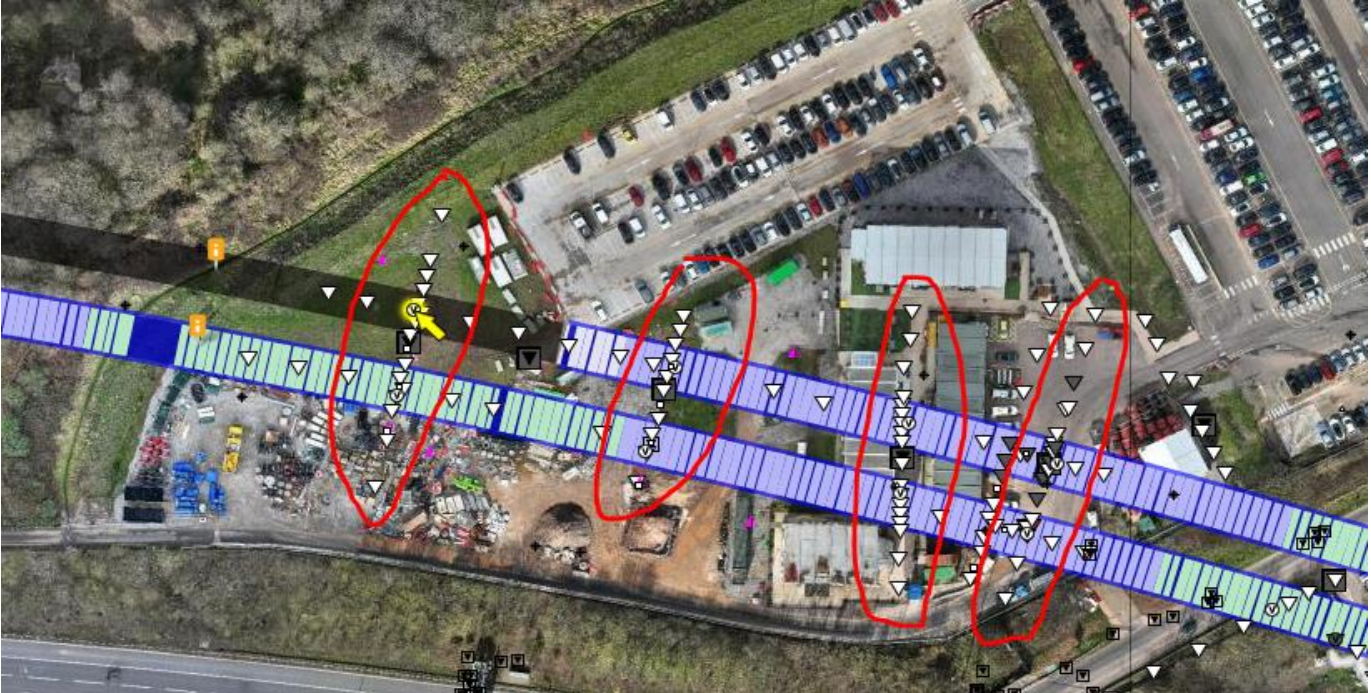
# Greenfield levelling readings at TBM Verification Zone - VL~0.10%

--- GTROUCH\_Array07\_Upline(0.25% Volume loss)    --- GTROUCH\_Array07\_Upline(0.35% Volume Loss)    --- GTROUCH\_Array07\_Upline(0.5% Volume Loss)  
 --- Array\_07(14/07/2024 10:00)    --- Array\_07(18/07/2024 10:00)    --- Array\_07(17/07/2024 10:00)    --- Array\_07(16/07/2024 10:00)    --- Array\_07(15/07/2024 10:00)

--- GTROUCH\_Array08\_Upline(0.25% Volume loss)    --- GTROUCH\_Array08\_Upline(0.35% Volume Loss)  
 --- GTROUCH\_Array08\_Upline(0.5% Volume Loss)    --- Array\_08(21/07/2024 23:00)    --- Array\_08(20/07/2024 06:00)  
 --- Array\_08(19/07/2024 06:00)    --- Array\_08(18/07/2024 05:00)    --- Array\_08(17/07/2024 02:00)  
 --- Array\_08(16/07/2024 02:00)    --- Array\_08(15/07/2024 02:00)    --- Array\_08(14/07/2024 01:00)
