Operational responses to geotechnical asset failures impacting on transportation infrastructure.

BEAR Scotland North West Trunk Road Maintenance – efficient management of geotechnical emergencies.

27 October 2017

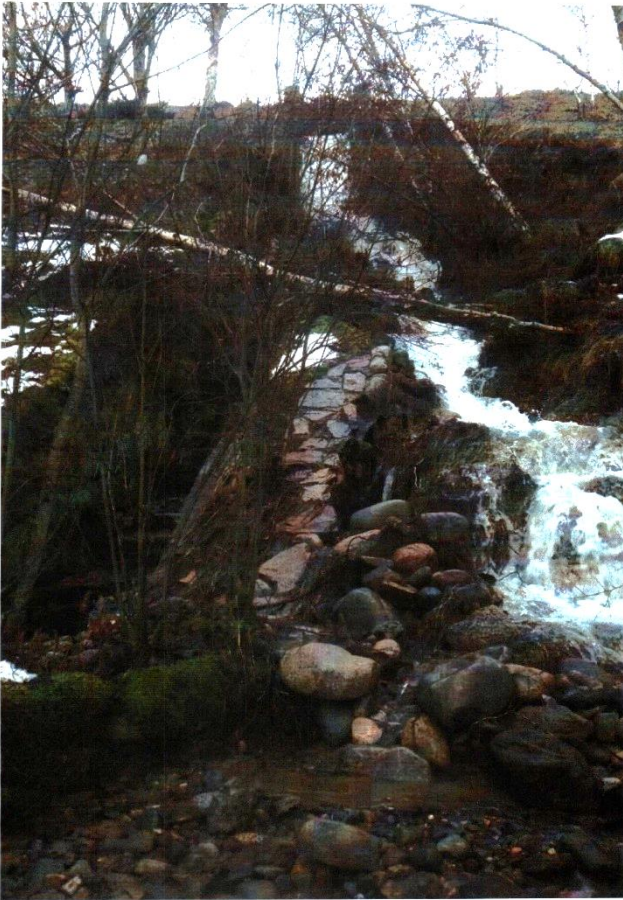
Pre failure

- Cause: embankment washout failure
- Date: 22 December 2014
- Scale: failure ~10m high and 10m to 20m wide
- Failed section of embankment 30+ years old
- Quantity of imported material ~5,000t
- Cost of remedial repair ~£80k

A9 Loch Insh – pre and post failure
