Track Monitoring Data Systems for Evaluation of Earthworks Instability

*Ian Payne – Senior Asset Engineer (Geotechnics)
Jonathan Garelick – Asset Engineer (Geotechnics)
Jason Lund - On Track Machine Engineer*

26th October 2017

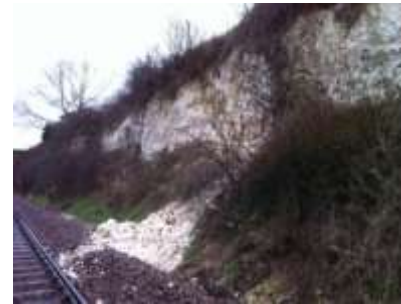
Chalk Slope instability
Coalpit Cutting 2013

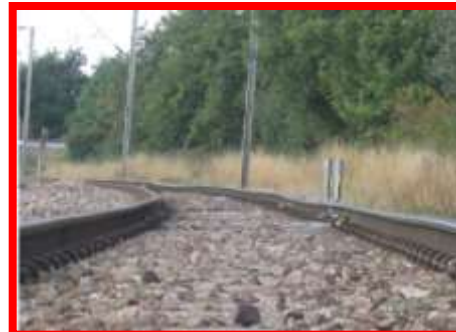
Clay Desiccation Track instability
Great Bentley 2009
