The Periglacial Legacy: Landslide Stabilisation on the M25

Fleur Loveridge & John Perry
Engineering Group Forum 23rd November 2011

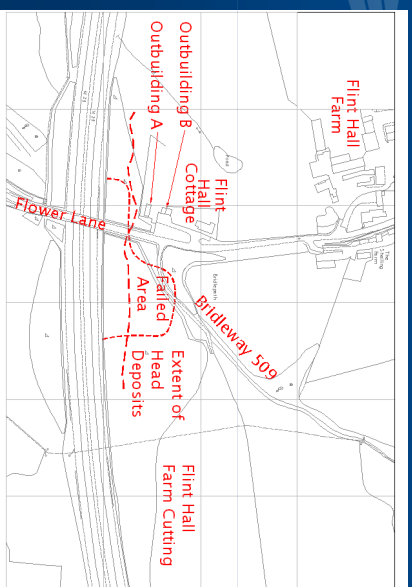
Introduction: Plan of site

- 19-20th Dec 2000: Major landslide on N side of M25
- Gault Clay cutting only 11 degrees
- Effected hard shoulder and adjacent over-bridge
- Potential to cause closure of anticlockwise carriageway
- Need for fast track approach

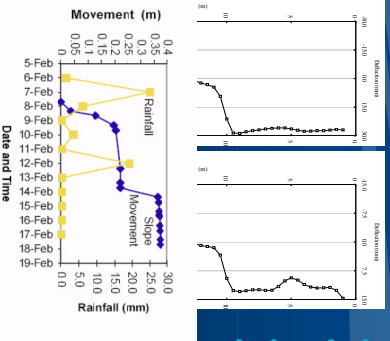
Monitoring

- 15 no. inclinometers
- 34 no. standpipe and 2 no. ww piezometers
- 94 No. slip indicators
- bridge monitoring - tiltmeter, crackmeter, temperature, surveying

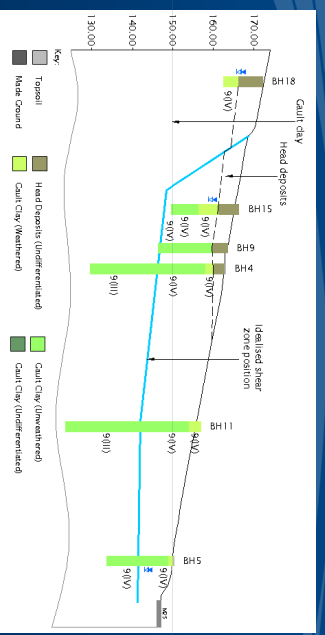
Geological Model

- Only possible in shored pits
- Allowed Identification of:
 - Slip surface
 - Gault / Head Interface
 - Ice wedges
 - Desiccation cracks

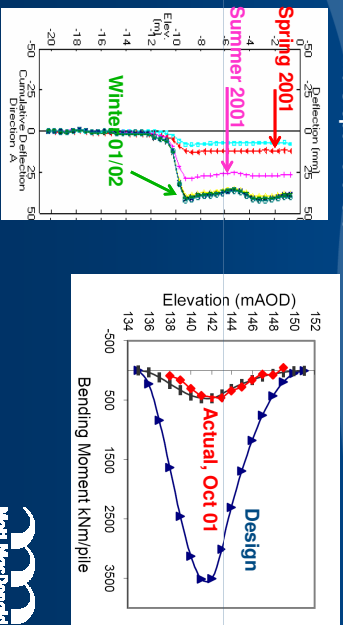
Pile Bending Moments

Mobilisation during First Winter

BH4 Mid Slope Borehole
