Remedial Works at Frongoch Lead and Zinc Mine

3. Phase 3 Remediation – AECOM

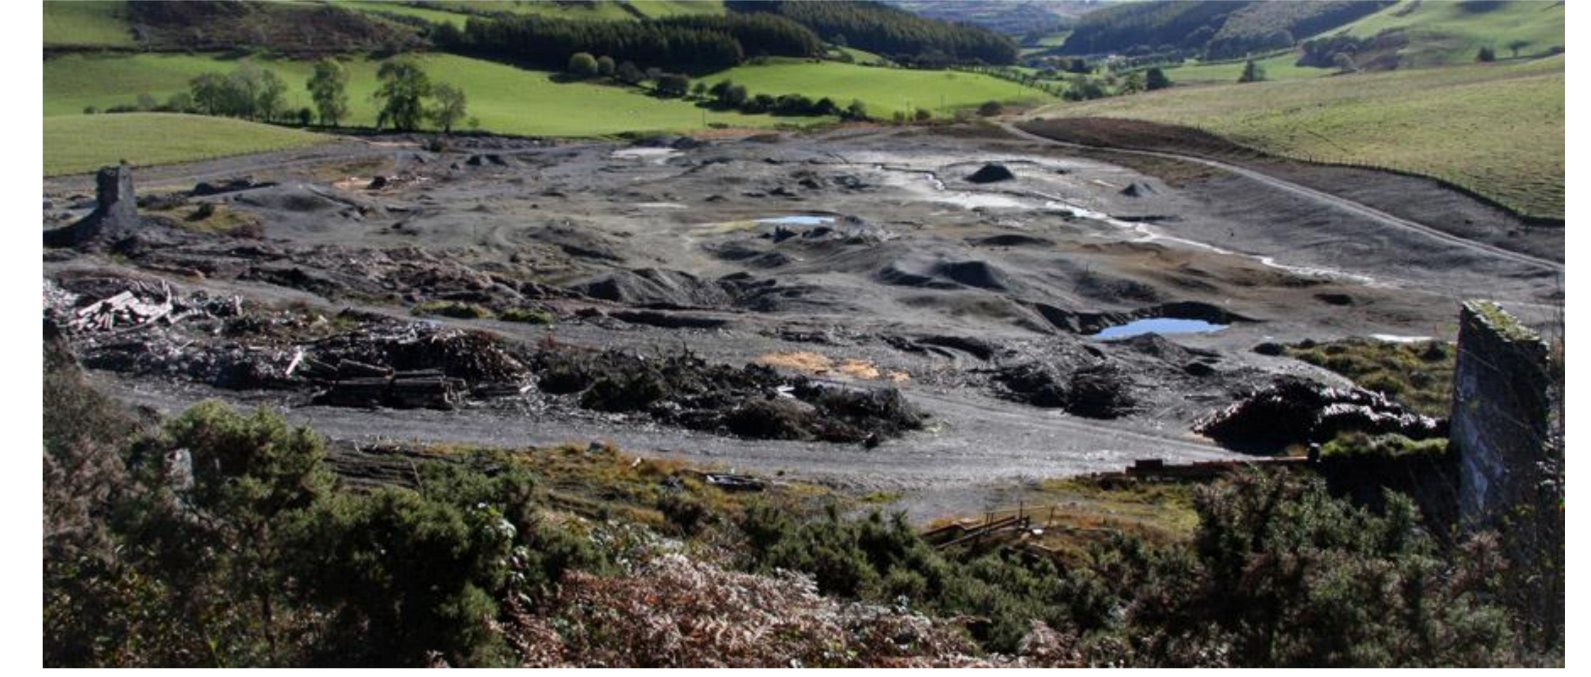
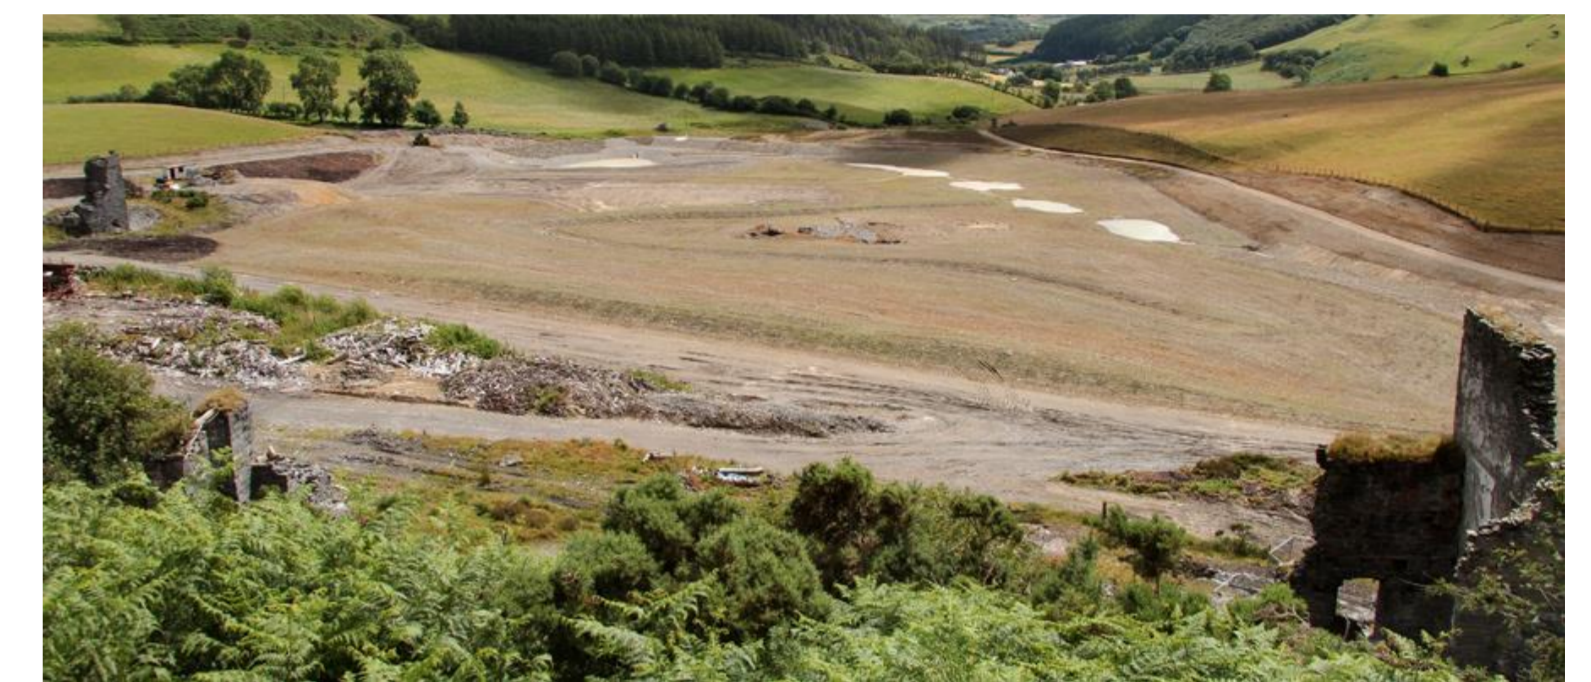
Figure 2. Frongoch Mine (above) prior to remediation in 2010, and (below) post Phase 2 remediation in 2015 (www.aspectsofwales.co.uk/frongochinfo.htm).

Phase 1 remediation, completed in 2013, focused on the construction of a catchment channel located on the perimeter of the mine, acting to capture surface runoff and divert it away from areas of potential contamination to a lined flood attenuation pond.

During Phase 2 remediation, completed in 2015, waste dumps were re-shaped and capped with a low permeability clay cap to prevent water ingress, and restoration soils to encourage re-vegetation. Further catchment channels and a series of linked ponds were constructed, creating a wetland habitat and to further control surface runoff.

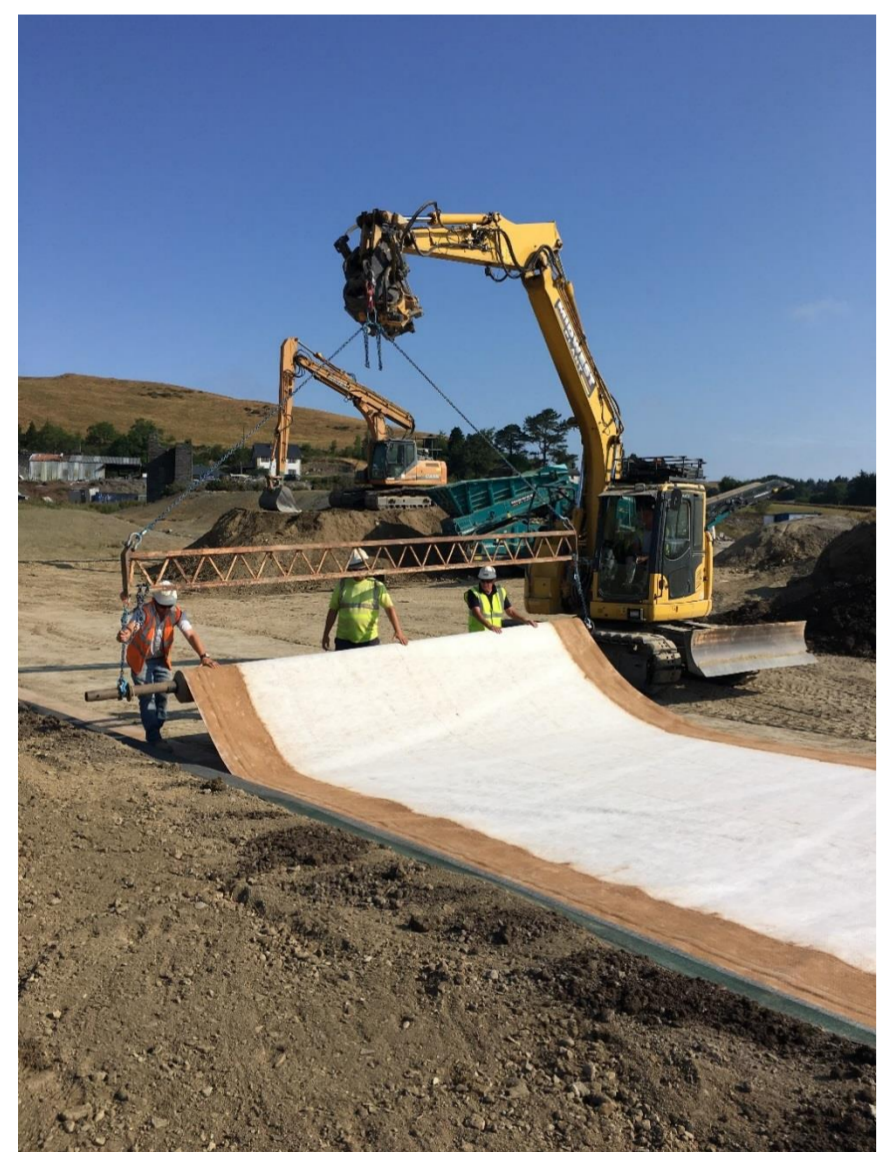
Figure 3. Deployment of the geosynthetic clay liner using a suspended I-beam and excavator.

Prior to deployment of the geosynthetic clay liner, the underlying surface had to be prepared by scouring and proof rolling the ground surface to remove any angular material that may cause potential puncture. Each liner was installed using a suspended I-beam to minimise roll deformation and subsequently covered with a 100mm blinding layer of material, followed by a further 200mm of screened material. The final covering was an organic rich restoration soil to encourage vegetative growth across the site.

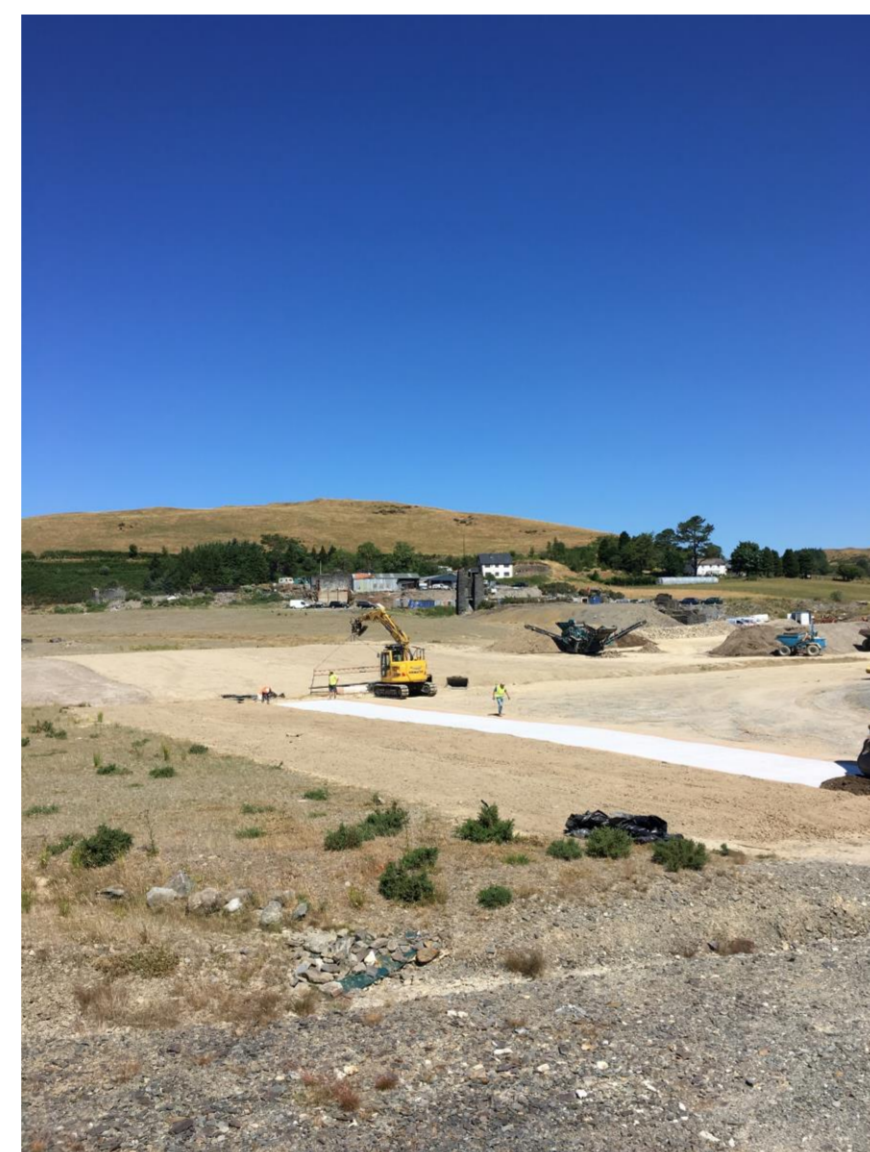
Figure 4. The full extent of the geosynthetic clay liner once deployed.

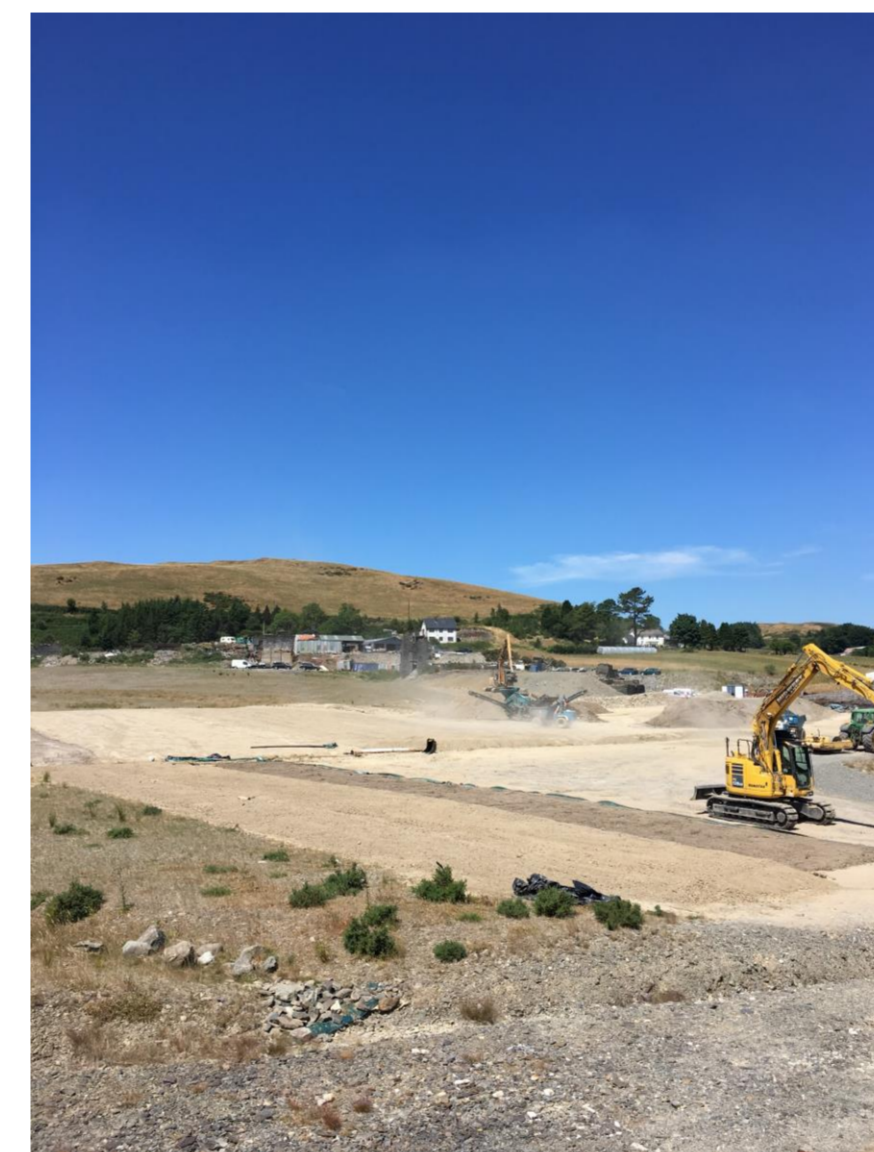
Figure 5. Covering the geosynthetic clay liner with a minimum 100mm blinding layer of material to inhibit the potential for puncture or damage by angular material.

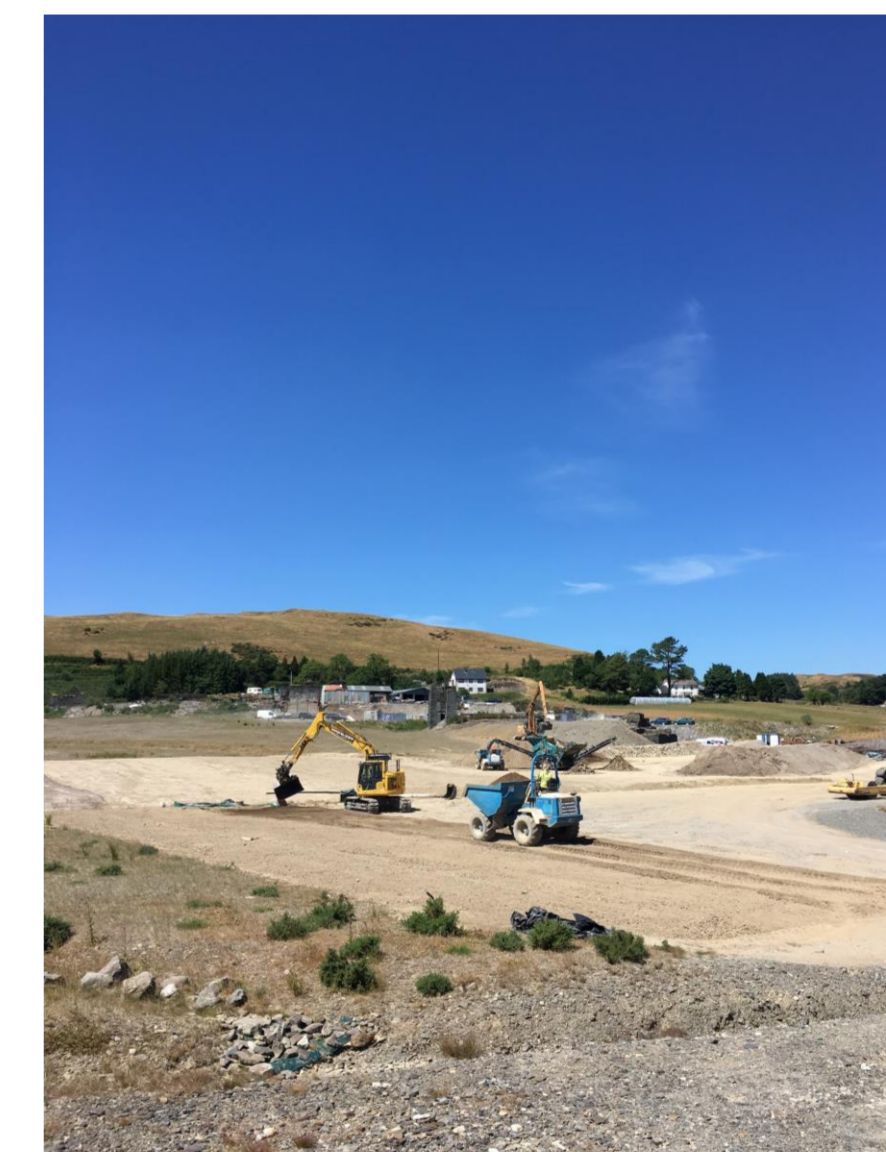
Figure 6. Fully covering the liner with a minimum of 300mm material before vehicular access. A final 50-100mm restoration soils cover the liner to encourage vegetative growth.
