Geohazard risk assessment and asset management along railway corridors

BGC: Matt Lato, Pete Quinn, Mark Pritchard, Mike Porter and Sarah Newton
IOC: Dominique Sirois

Origins of Cambio_{Rail}

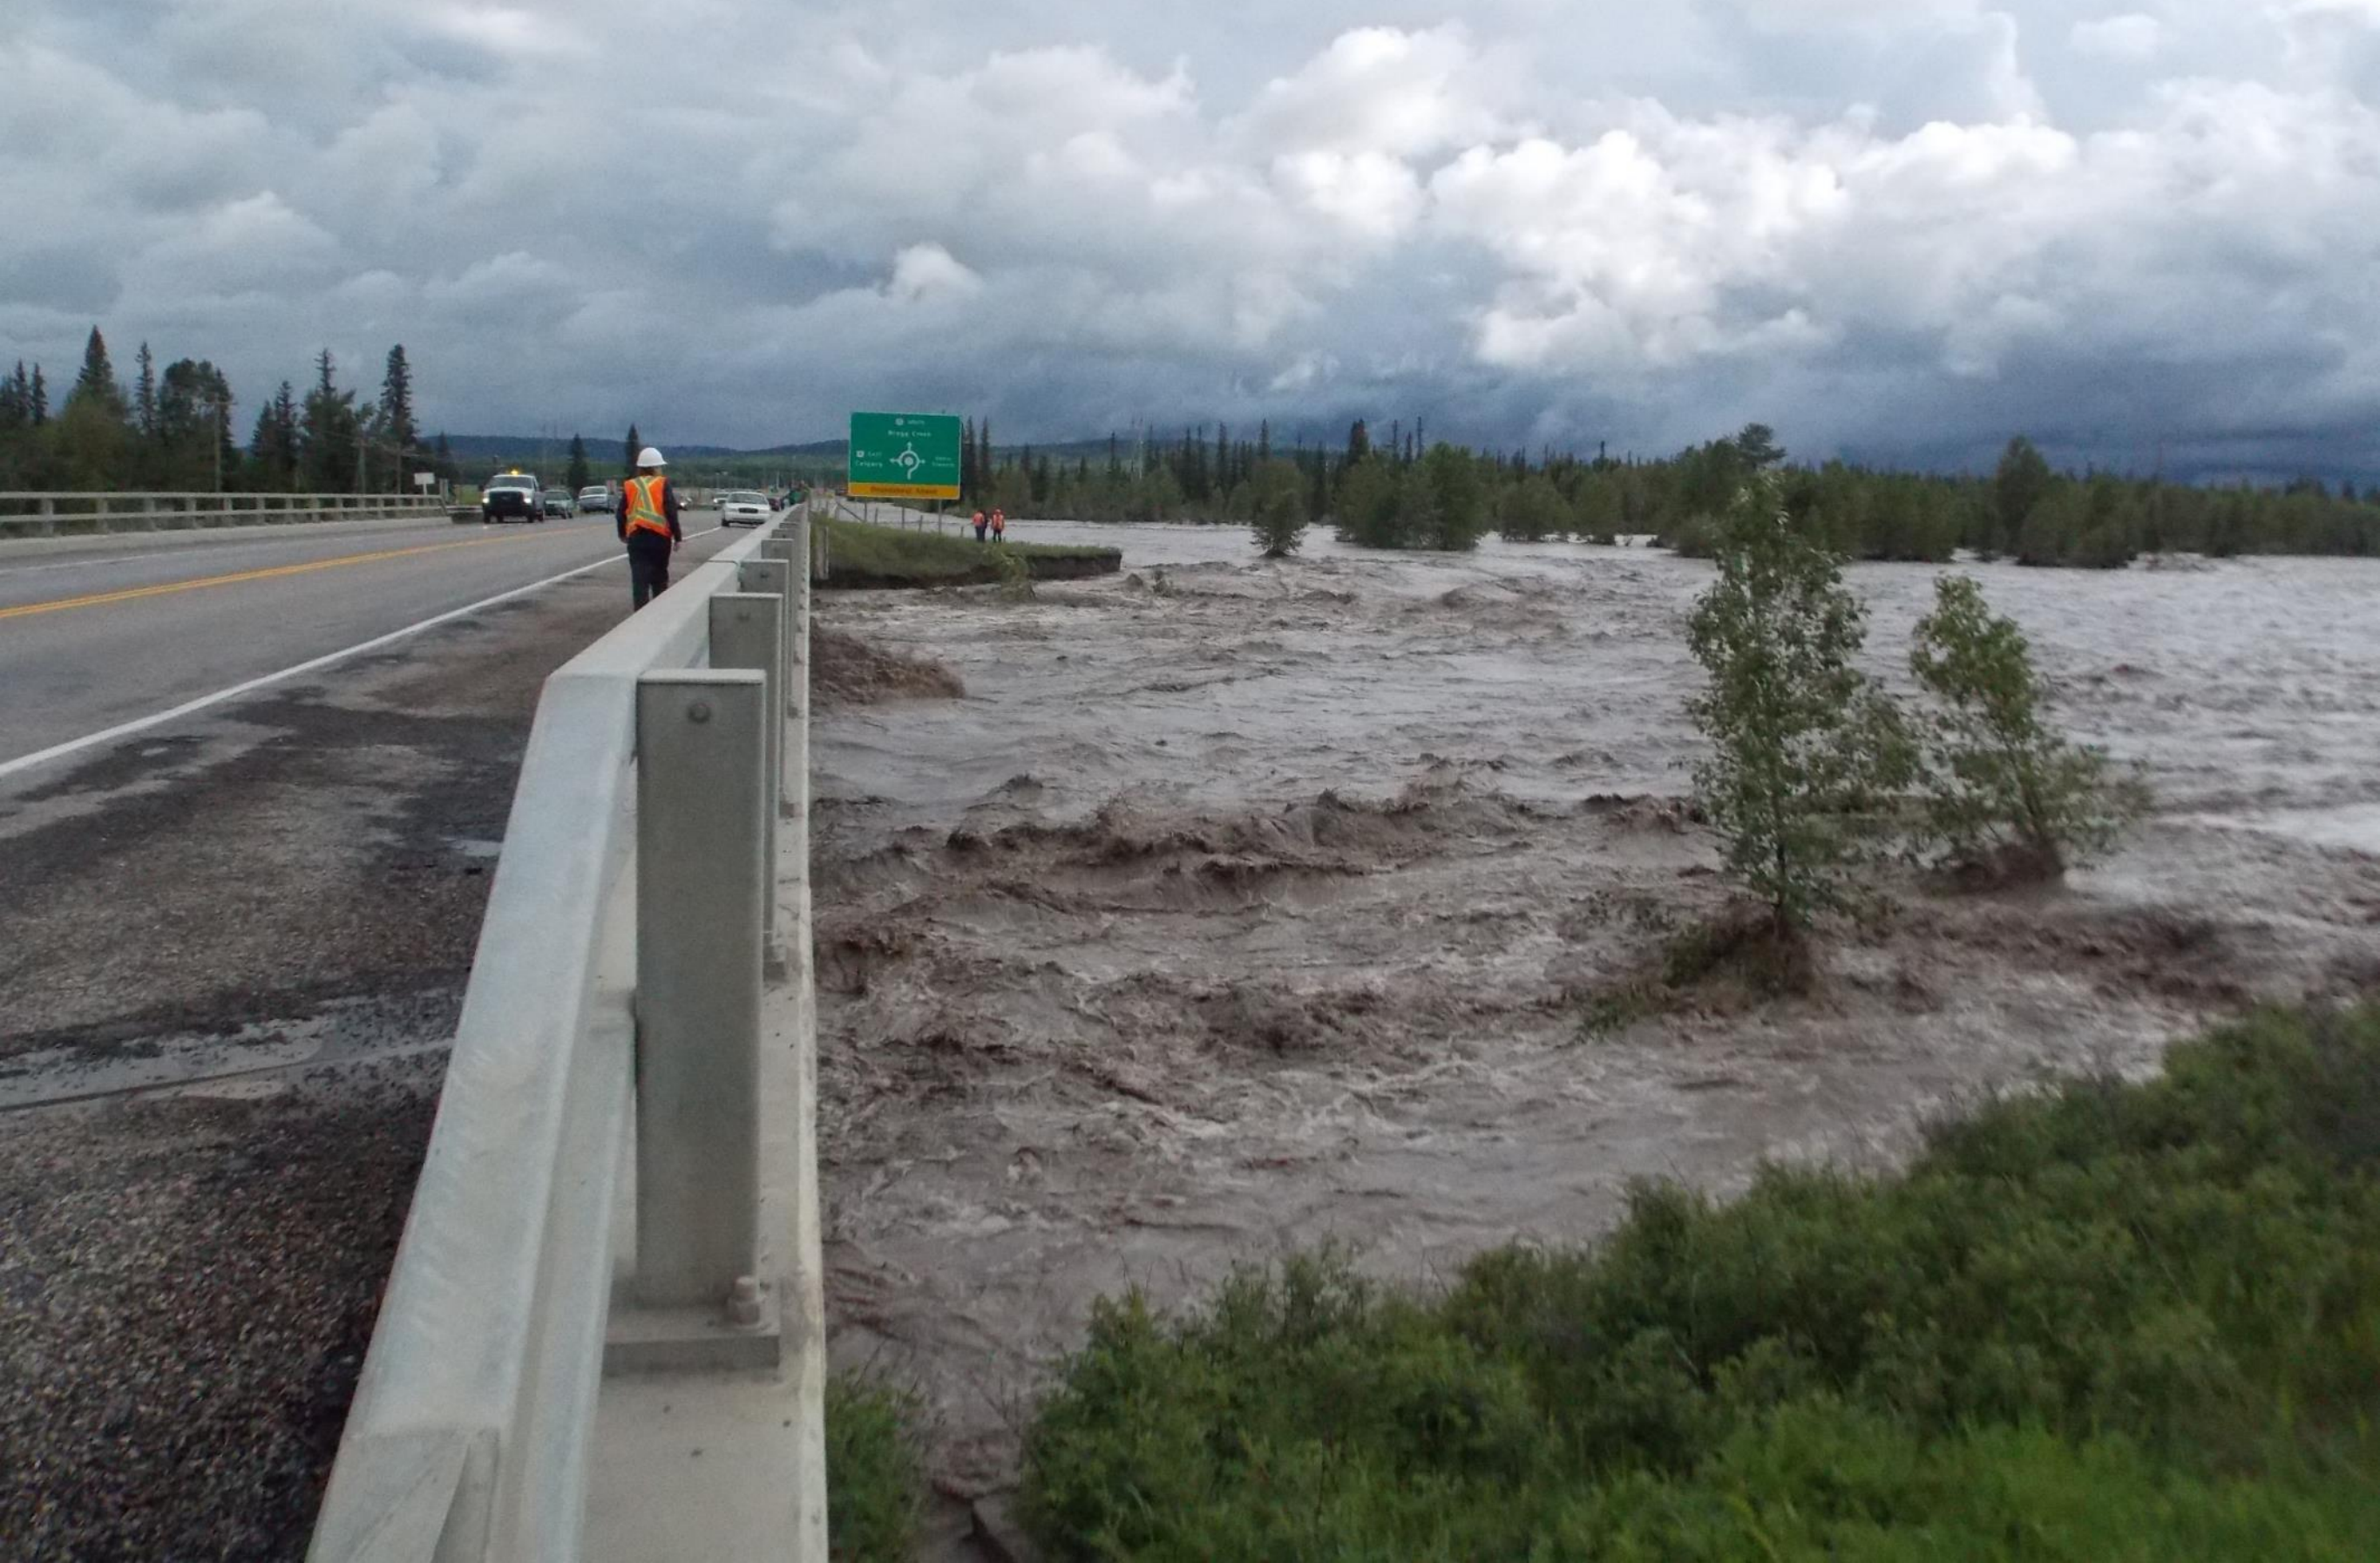
The RNT is used to automate FFA calculation and support real-time flood monitoring for pipeline water crossings.

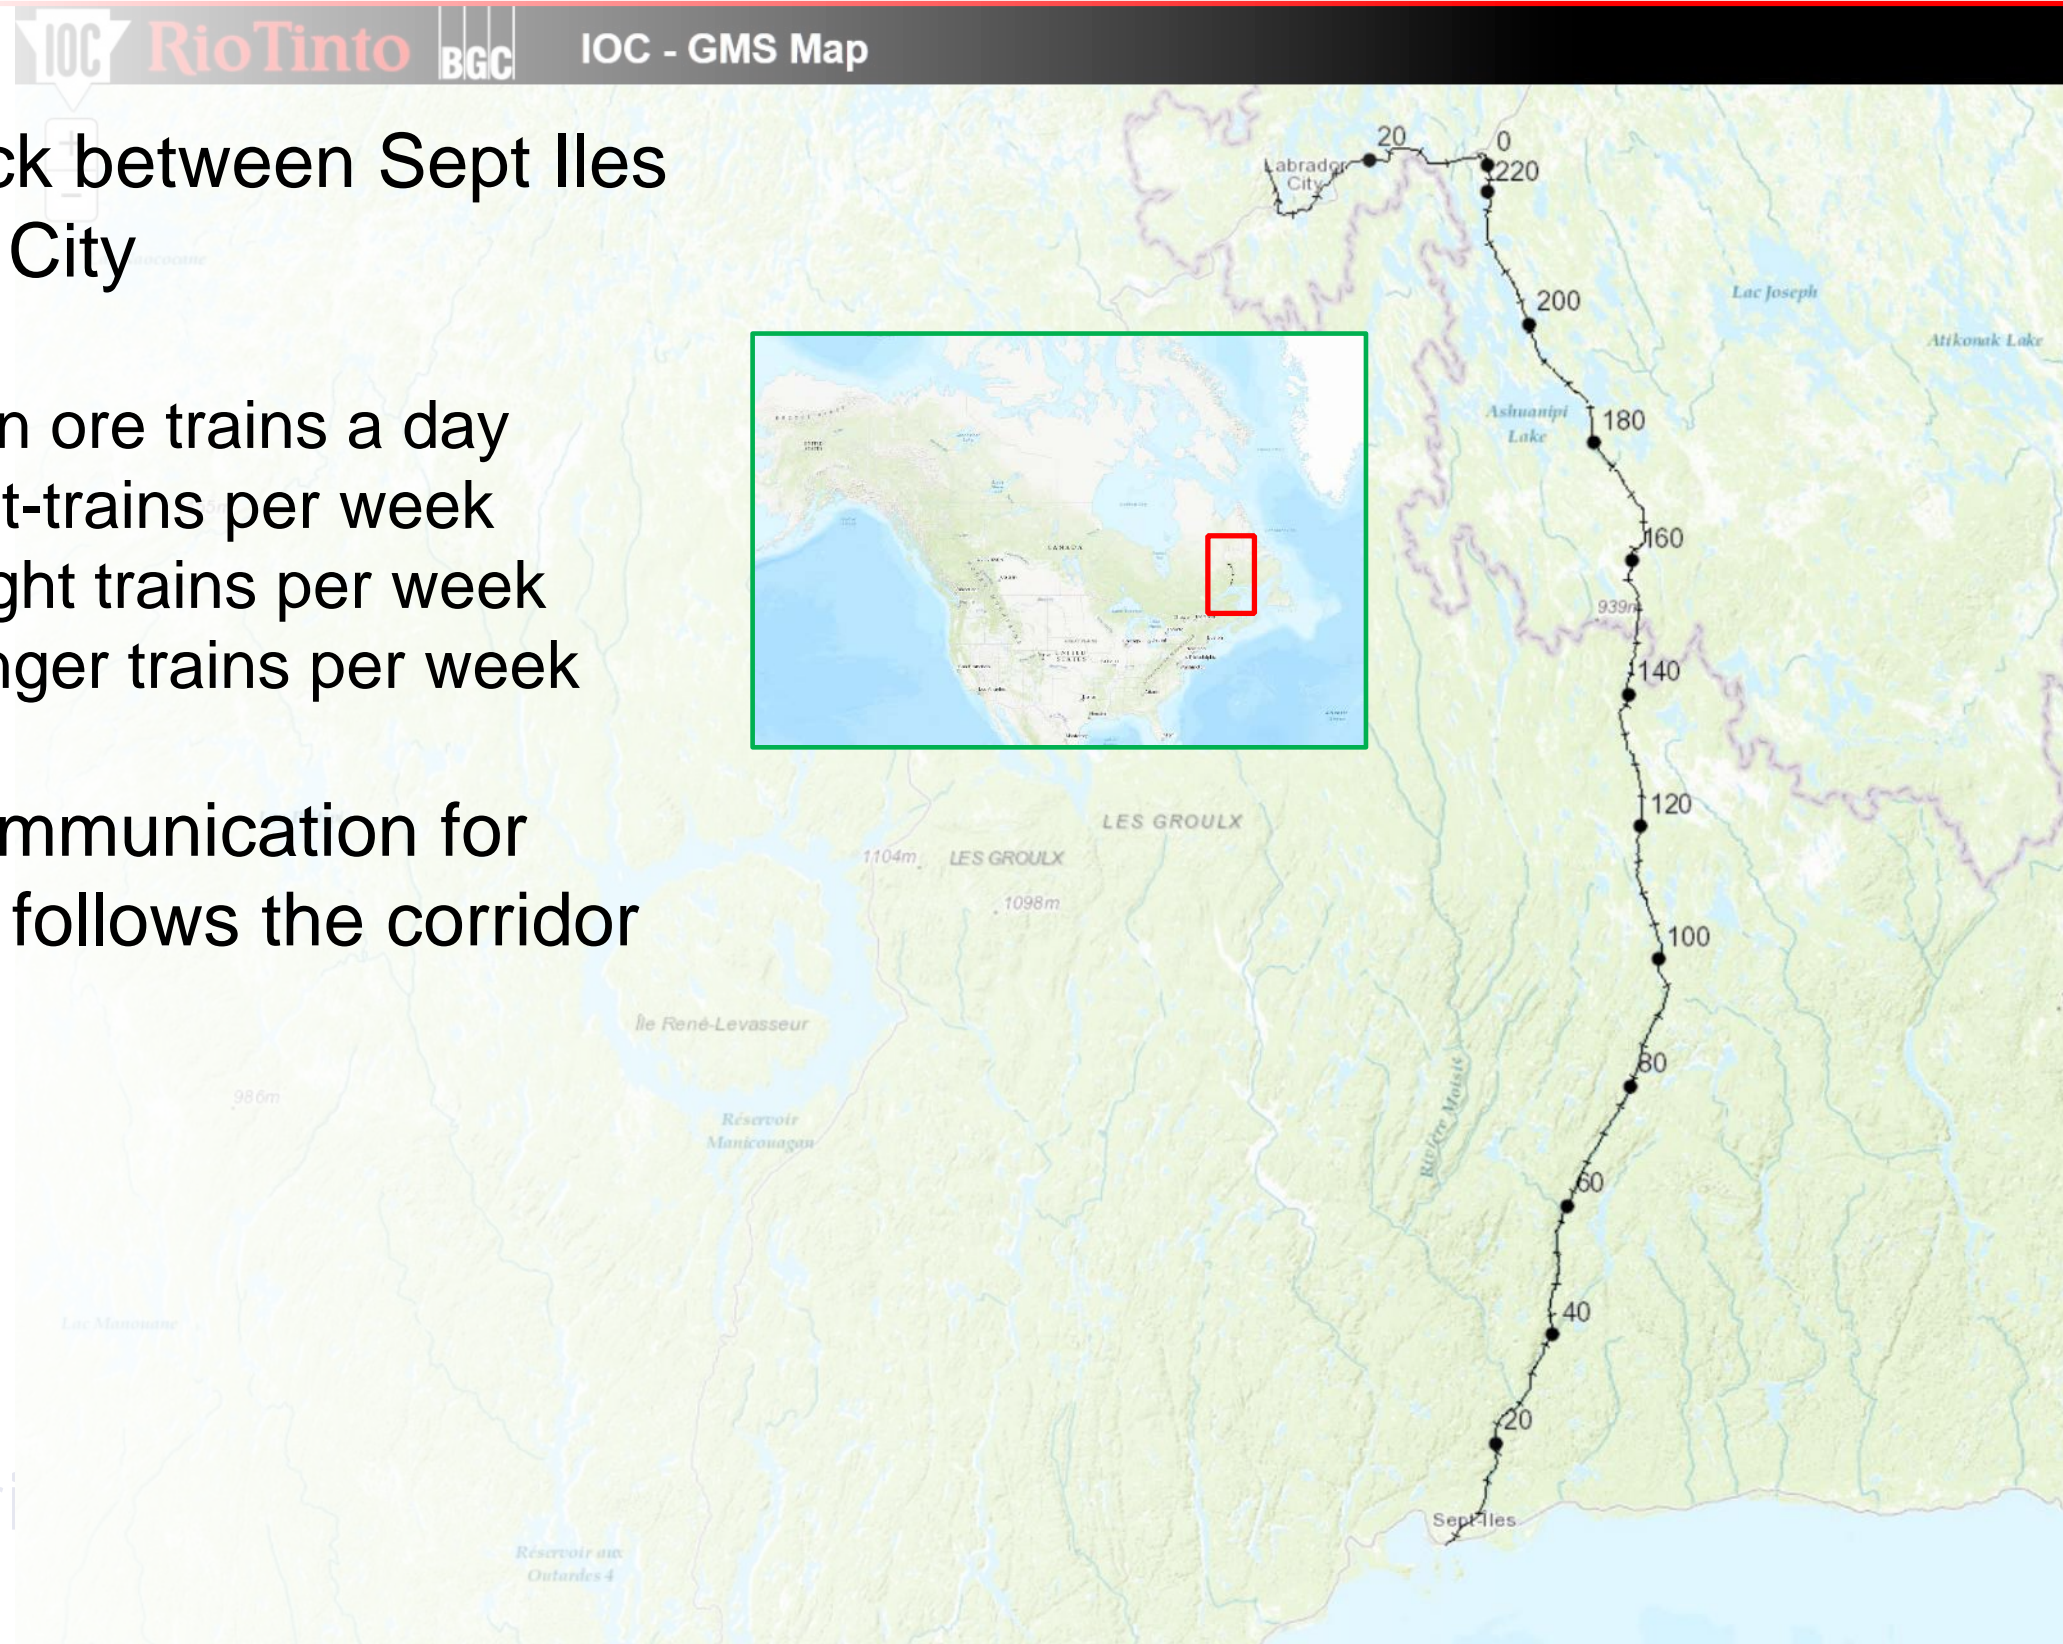
The QNS&L railway line

- 420 km of track between Sept Iles and Labrador City
- Daily traffic
 - Ten to fifteen ore trains a day
 - Two fuel unit-trains per week
 - Multiple freight trains per week
 - Four passenger trains per week
 - Work trains
- Fibre-optic communication for Labrador City follows the corridor

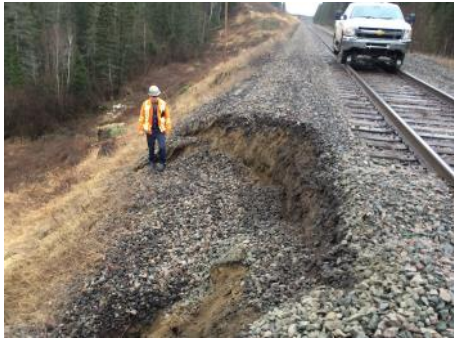
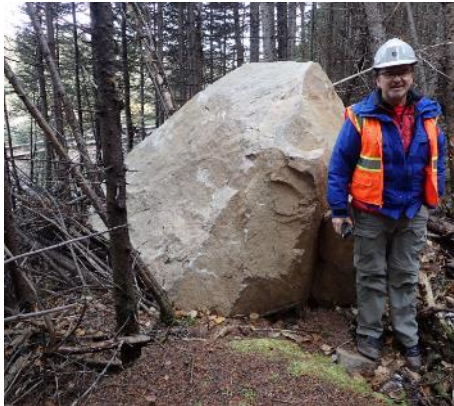
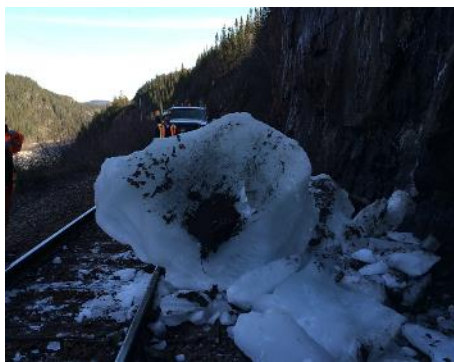
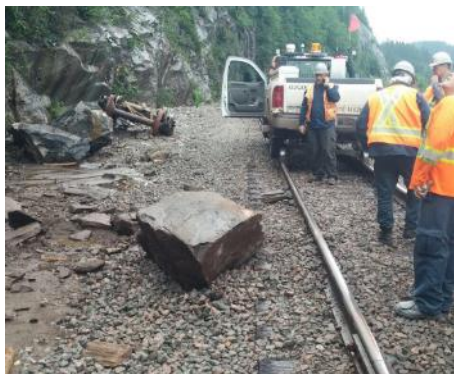
Cambio_{Rail}: geohazard event database

- Events are input into a webform with photos by track forces
- Events are sent to Engineering for review and approval
- Location of events are plotted on the map
- Data can be easily imported from existing records

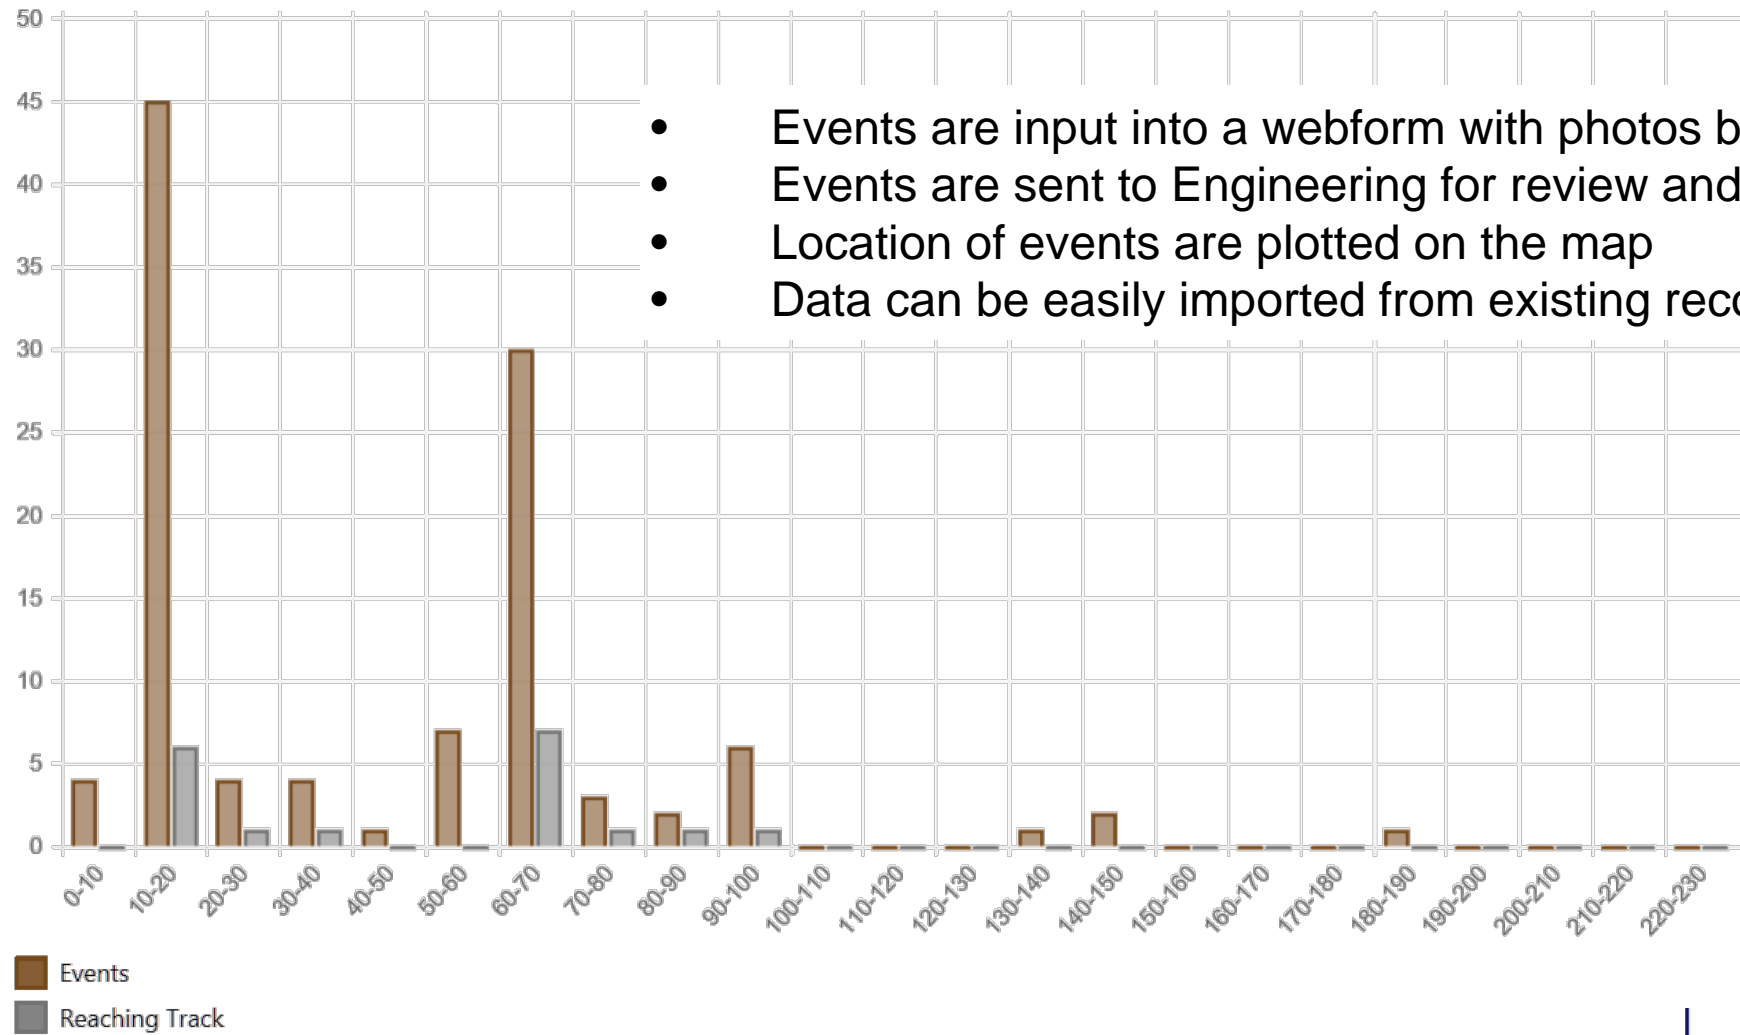
Graph Type:
 Events per Mileage Interval Interval Width: (miles)
 Events per Month
