◀ Evolution of ground risk management and engineering mitigation measures for tunnelling through the wall of a drift filled hollow in the City Of London

◀ Authors: John Davis Crossrail & GCG

◀ Roser Soler Pujol BBMV

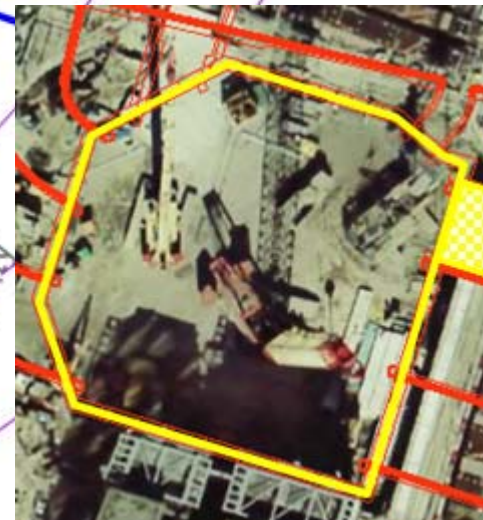
Base of RTD as known at post demolition / pre-box construction stage

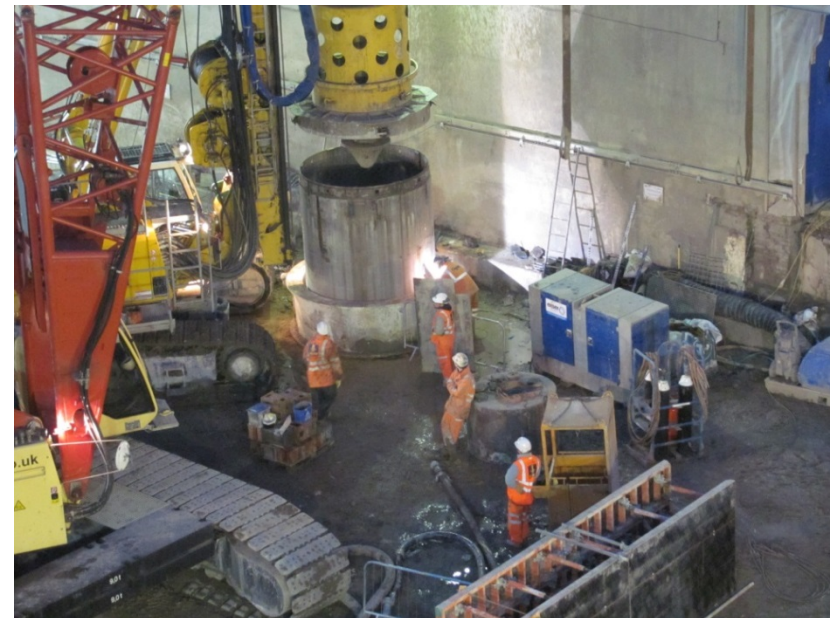
Pile removal clues

- The top of London Clay in a temporary works CFA contiguous piled wall on the south side of the Box was much deeper in places than anticipated (circa 98 matd)
- Existing CFA piles that supported the demolished building were to be removed – they were irregularly oversized in the ‘deep’ RTD (circa 1000 to 1200mm compared to the 900mm design diameter)
- Minor casing base/piping failures occurred during pile removal – these are attributed to the presence of clay layers within the predominantly permeable sandy DFH infill.

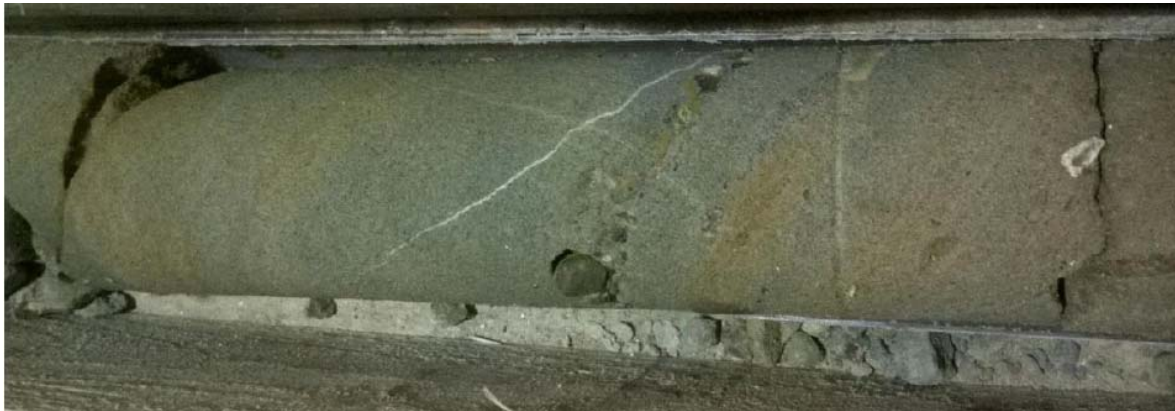
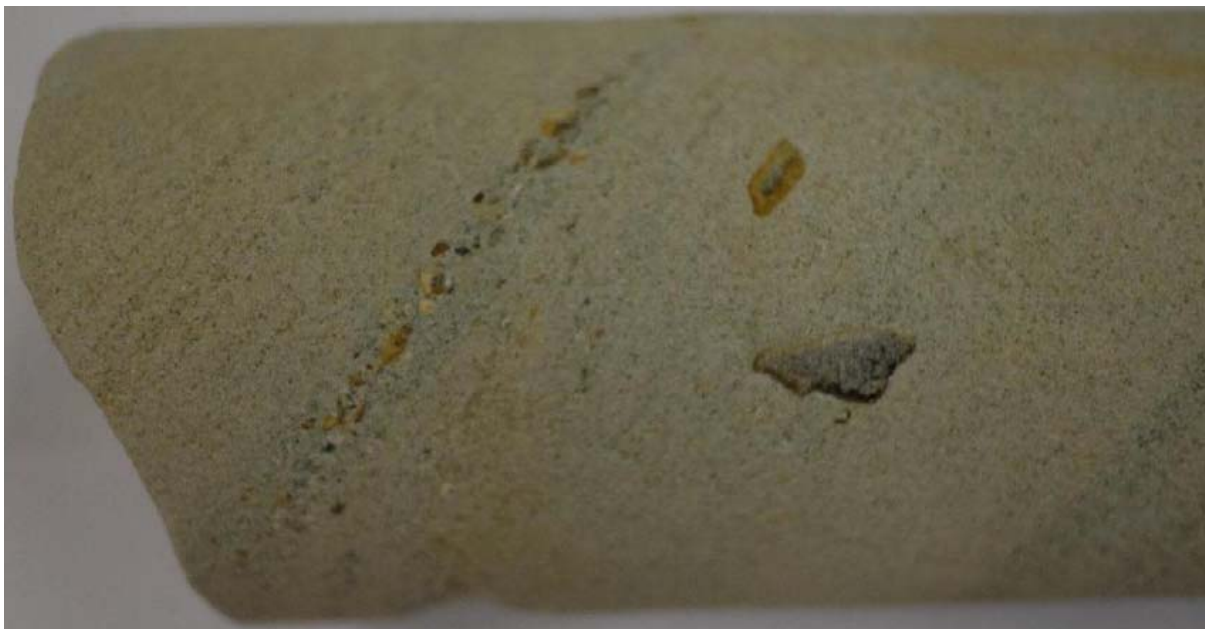
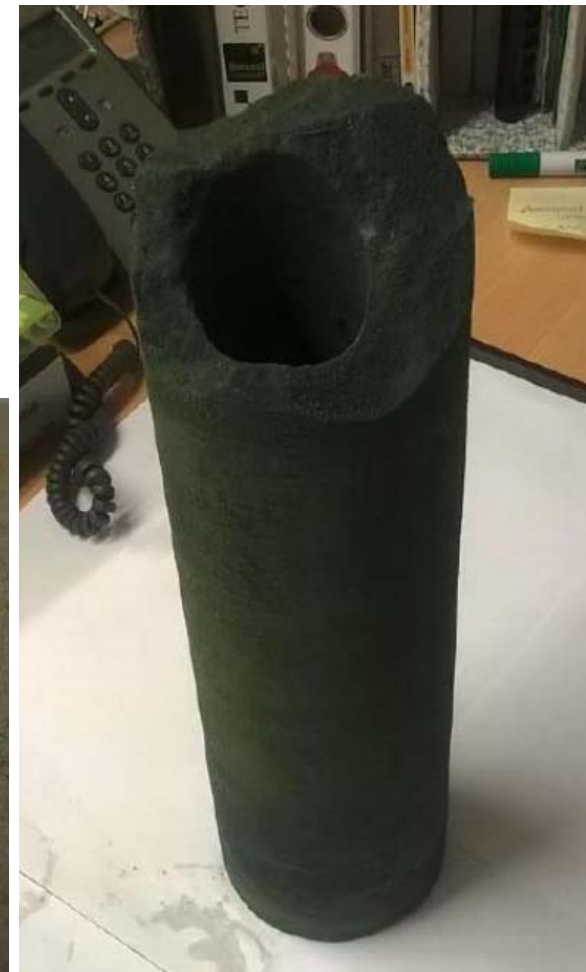
Electra House Grouting validation investigation

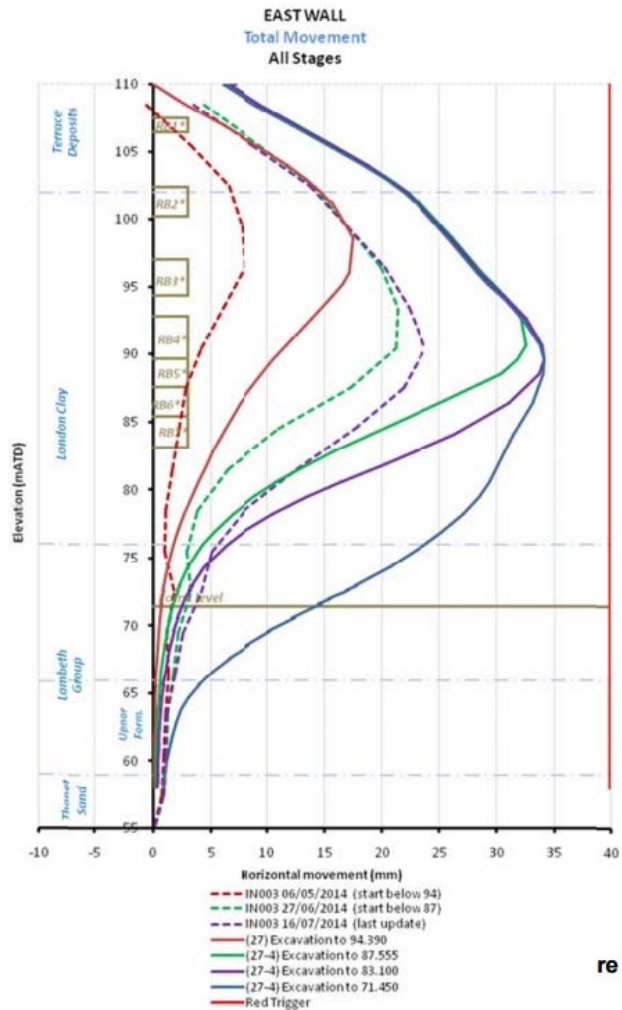
Grouting & Moorgate Box East wall oddities

- Possible grouting related movements of the East wall of Moorgate Box ?
- Much greater movements of the Eastern wall of the Box during Box excavation compared to the other walls.
- Ingress of displaced 'grouty' water into the Northern Line Tunnels in the London Clay.

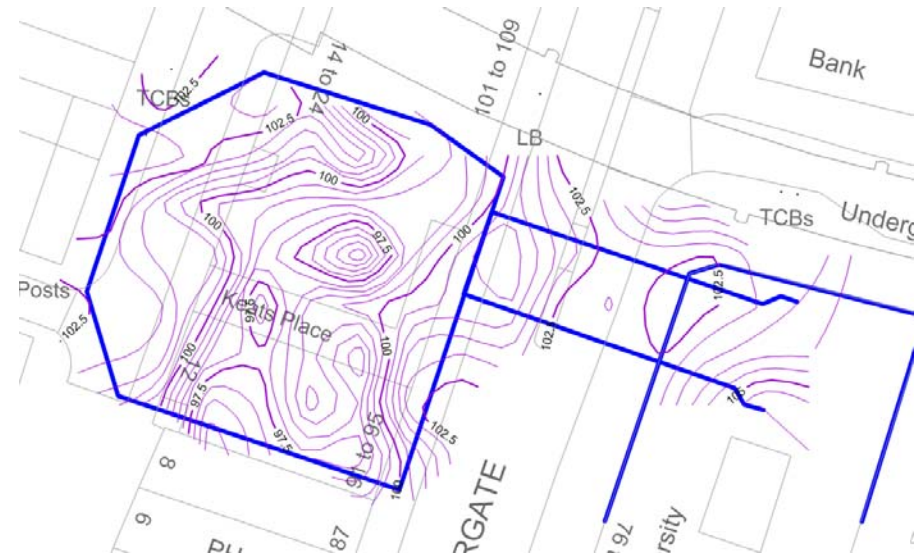
Impact on Tunnelling ?

Steep internal slopes in DFH,
'lumpy' DFH base
= historic DFH slope failure ?

Might explain larger E wall
movements (higher than anticipated
LC earth pressures)

Any resulting fissures might provide
grout/water pathways to the NL

Increased risk of 'greasy backs' in
the LC – risk especially increased if
tunnelling from east to west where
release surfaces might overhang
the face.

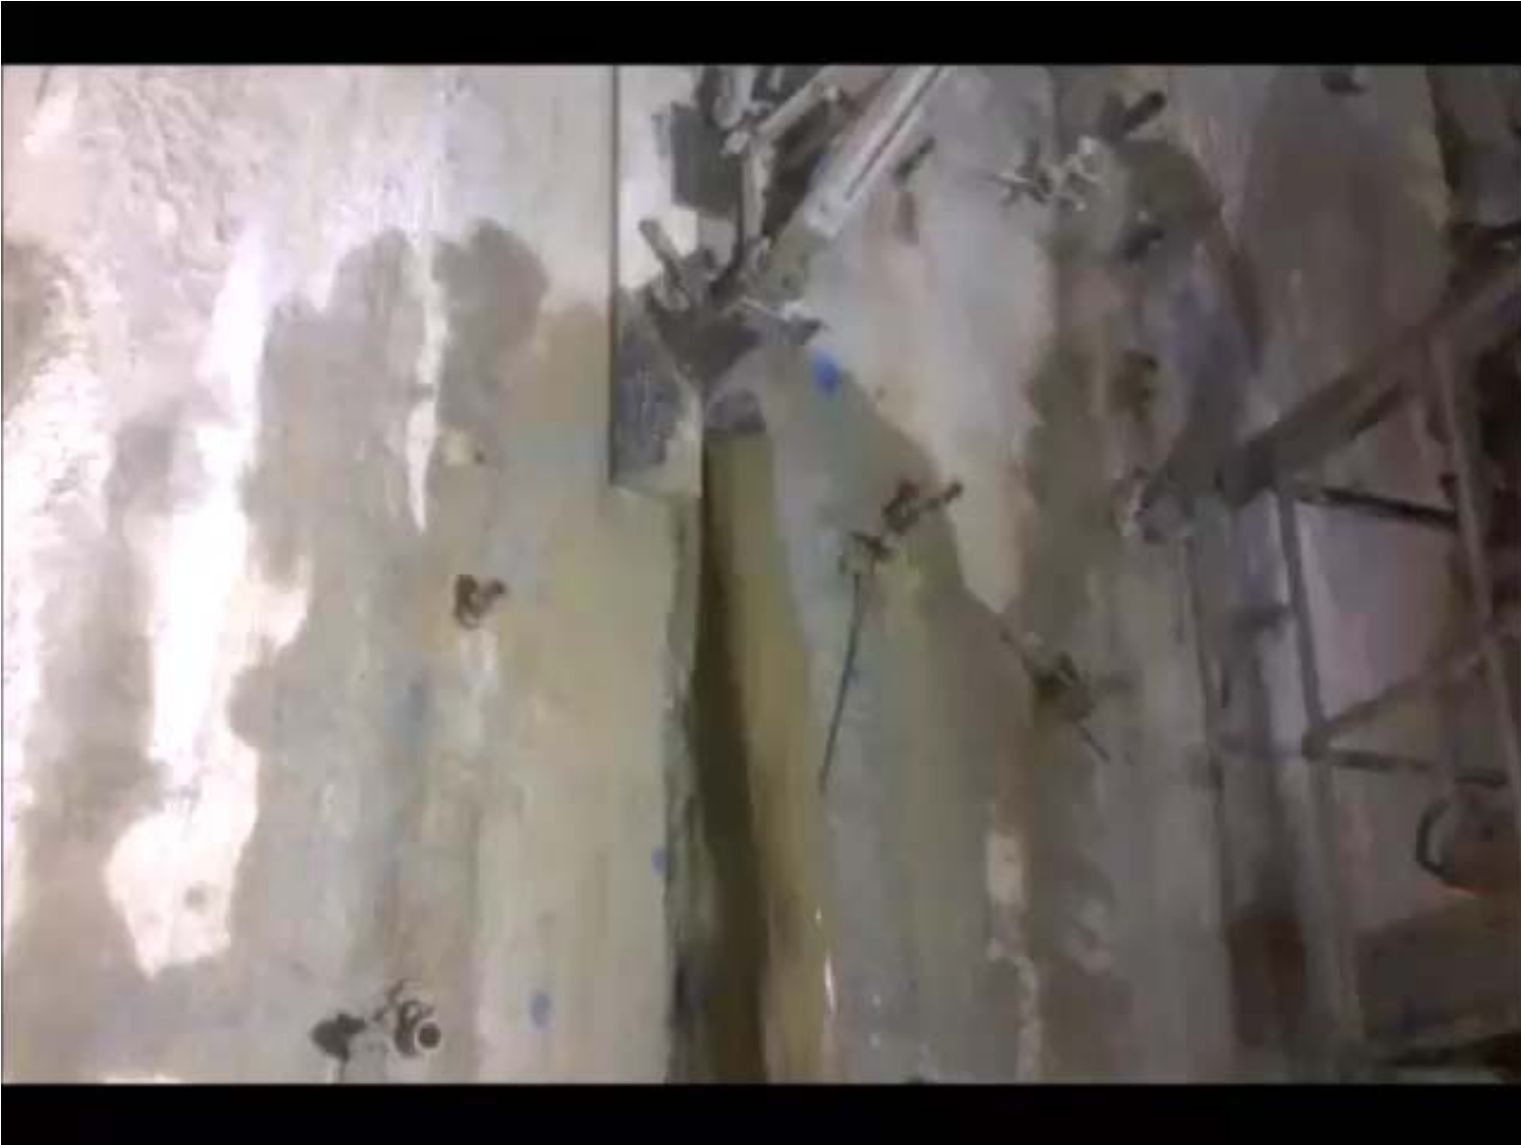
Ingress (this was a video)

- ▶ More contact grouting between the DWall and the ground
 - ▶ Complete phase 3 grouting
 - ▶ Drill & grout additional low level phase 3 TaMs within the Box
 - ▶ Re-inject some earlier TaMs with even finer and less viscous materials
-
- But this creates some heave in Electra House.
 - Grouting suspended whilst additional ceiling protection mitigation is installed
 - Then carry out further validation GI prior to decision to open up.

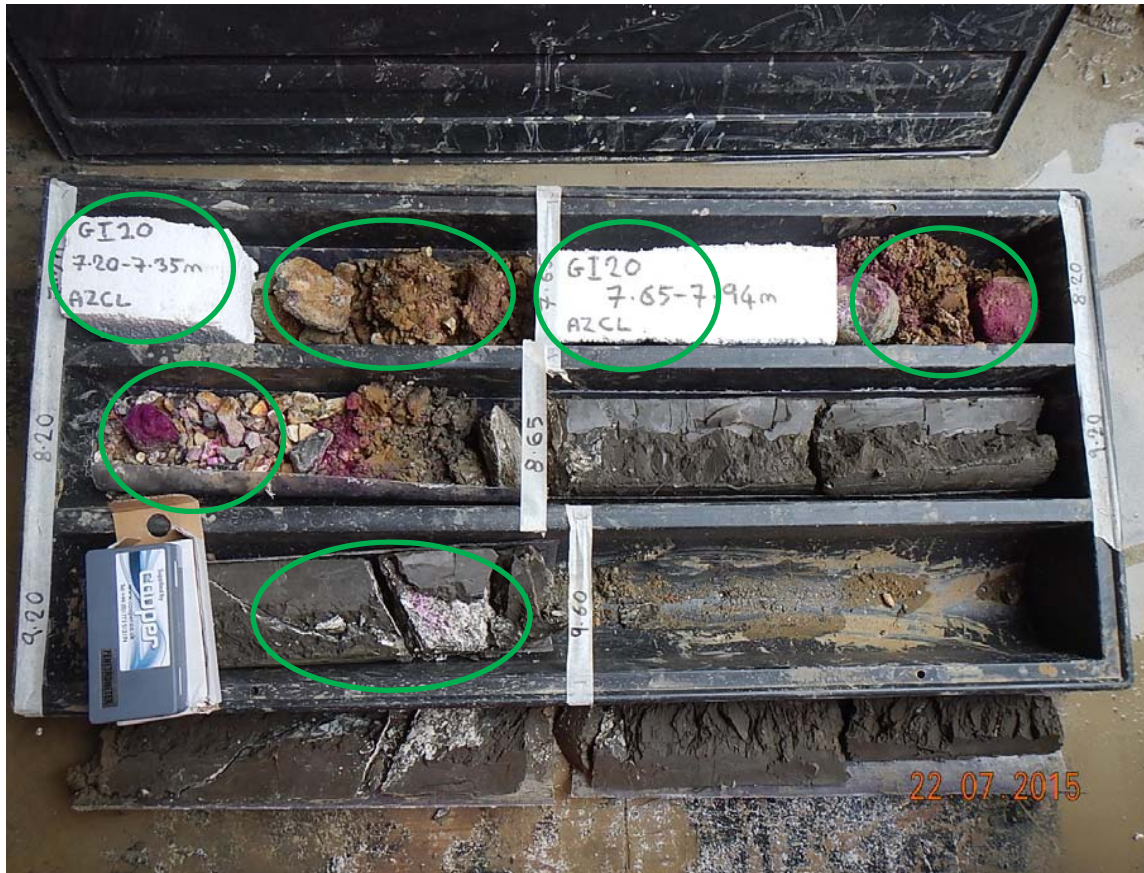
Moorgate GI

- ▶ Shallow inclined boreholes drilled out from Moorgate Box.
- ▶ These experience unexpected core loss & water ingress in places.
- ▶ Switched to sonic coring. This found complex layered and channelled clay/silt/sand just the above the LC / RTD interface.
- ▶ Grout unevenly distributed – even in groutable materials.
 - This flags up the risk of pathways within the treated area that link to permeable water bearing in untreated ground.
 - Encounters with flowing water and permeable ground are very difficult to manage safely in an SCL tunnel and risk significant surface settlement and face instability.
 - Breakout through the DWall prior to tunnelling becomes a high risk activity

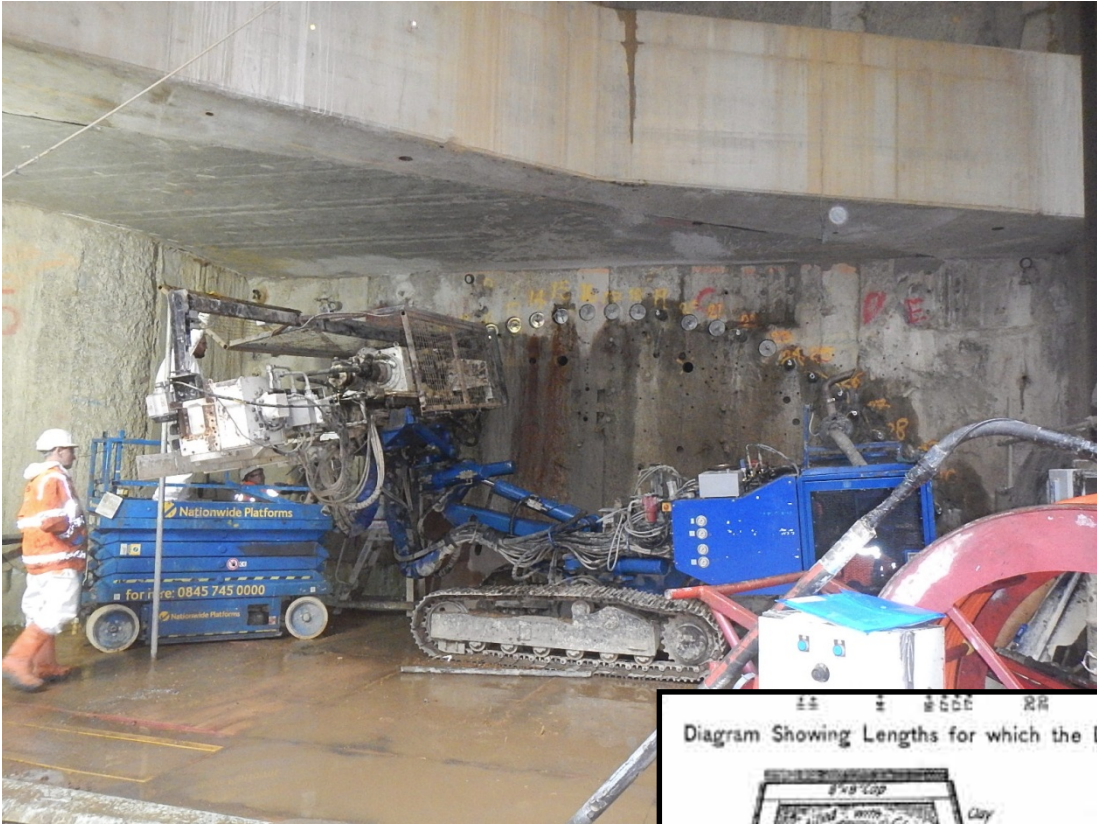
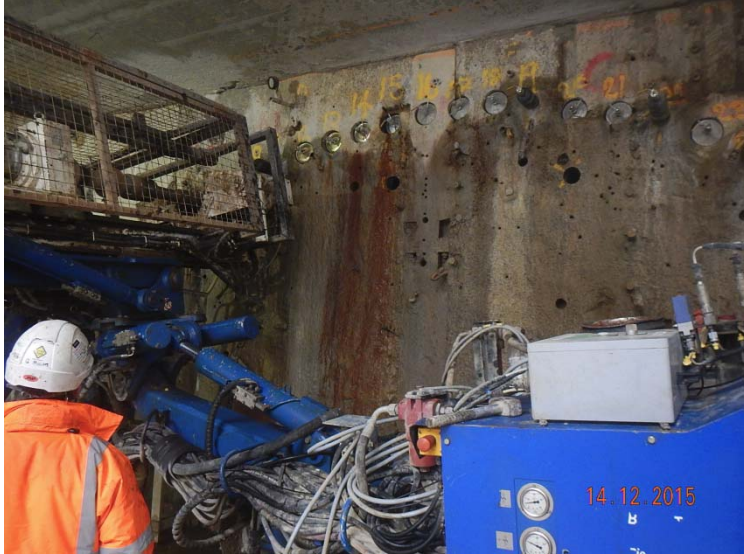
Pipe canopy installation

- ▶ The installation of the groutable canopy TaM pipes finds areas of untreated ground and some limited (clear) flowing water, particularly in the crown just below the sewer.
- ▶ Painted timber fragments were seen in some pipe drill returns below the Goswell Sewer.
- ▶ This timber raises possibility of unexpected Victorian Goswell Sewer temporary works and associated drains and/or dewatering sumps just above the AP9 crown. These could act as high permeability conduits across the top of AP9.
- ▶ Ground freezing was now seriously being considered – parallel design for this was begun.
- ▶ Additional infill pipes were added to the canopy scope above the opening.
