Engineering Geological Aspects of Embankment Dams on Mercia Mudstone

Tim Blower, CEng, MICE, CGeol, FGS

Lincoln WTW Project – Storage Reservoir

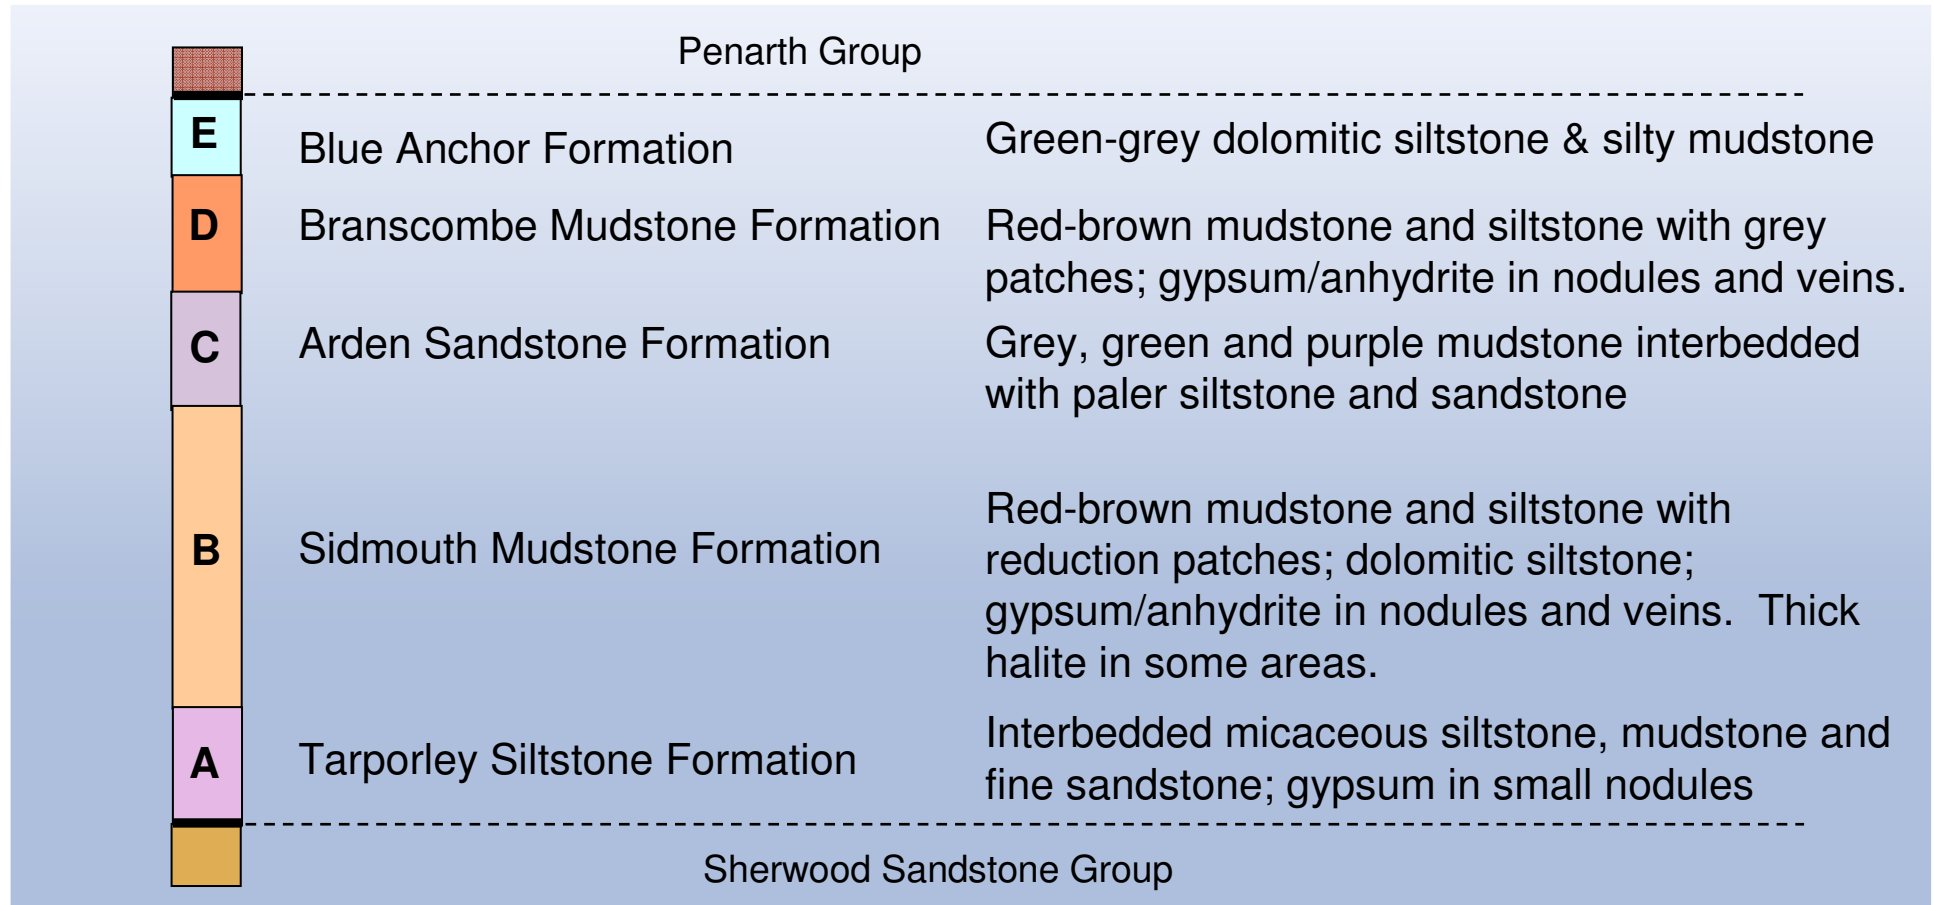
Stratigraphy

(after BGS Report RR/08/04, 2008)

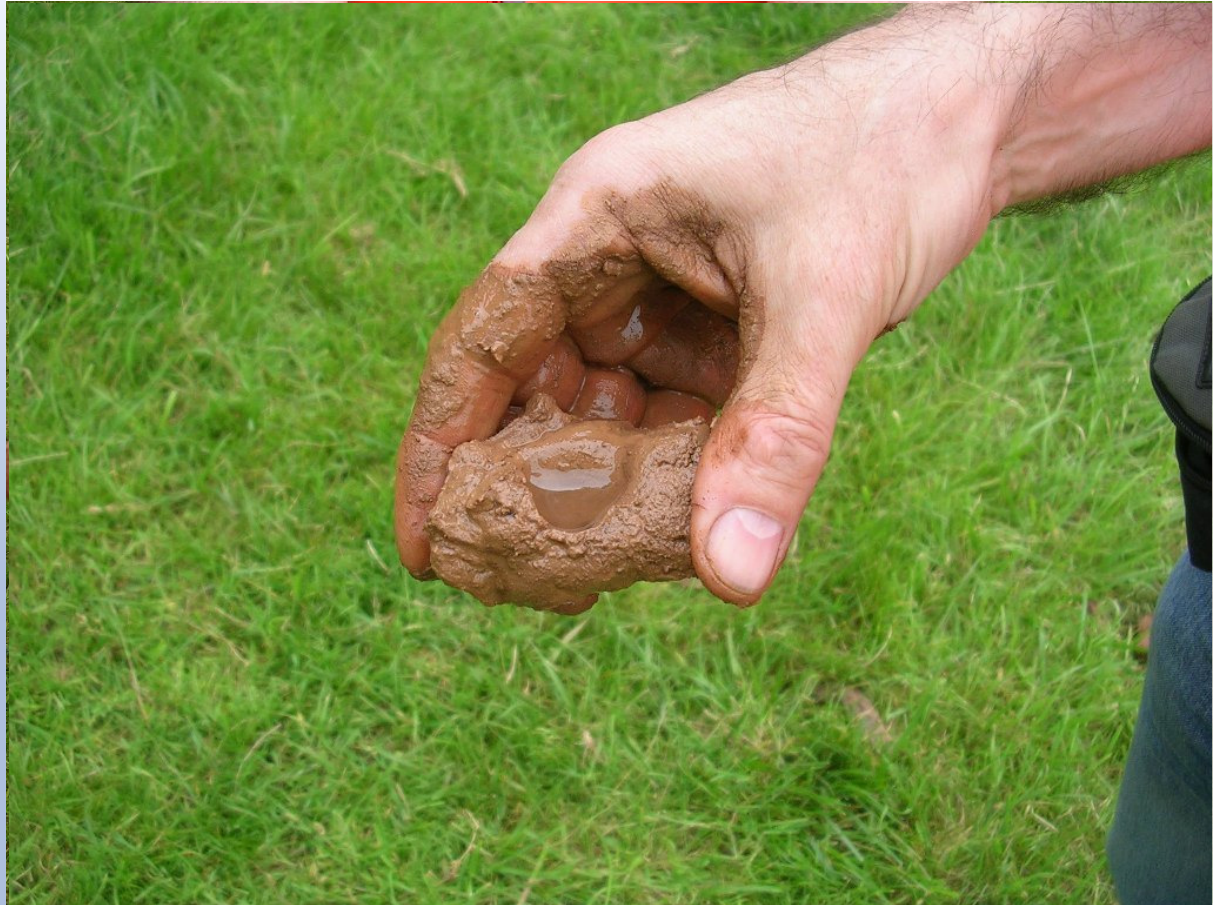
Field Observations on Permeability

- Trial pit spoil - crumbly, almost granular appearance
- When wetted & moulded, became very plastic – “gritty clay”
- Appears to be of low permeability

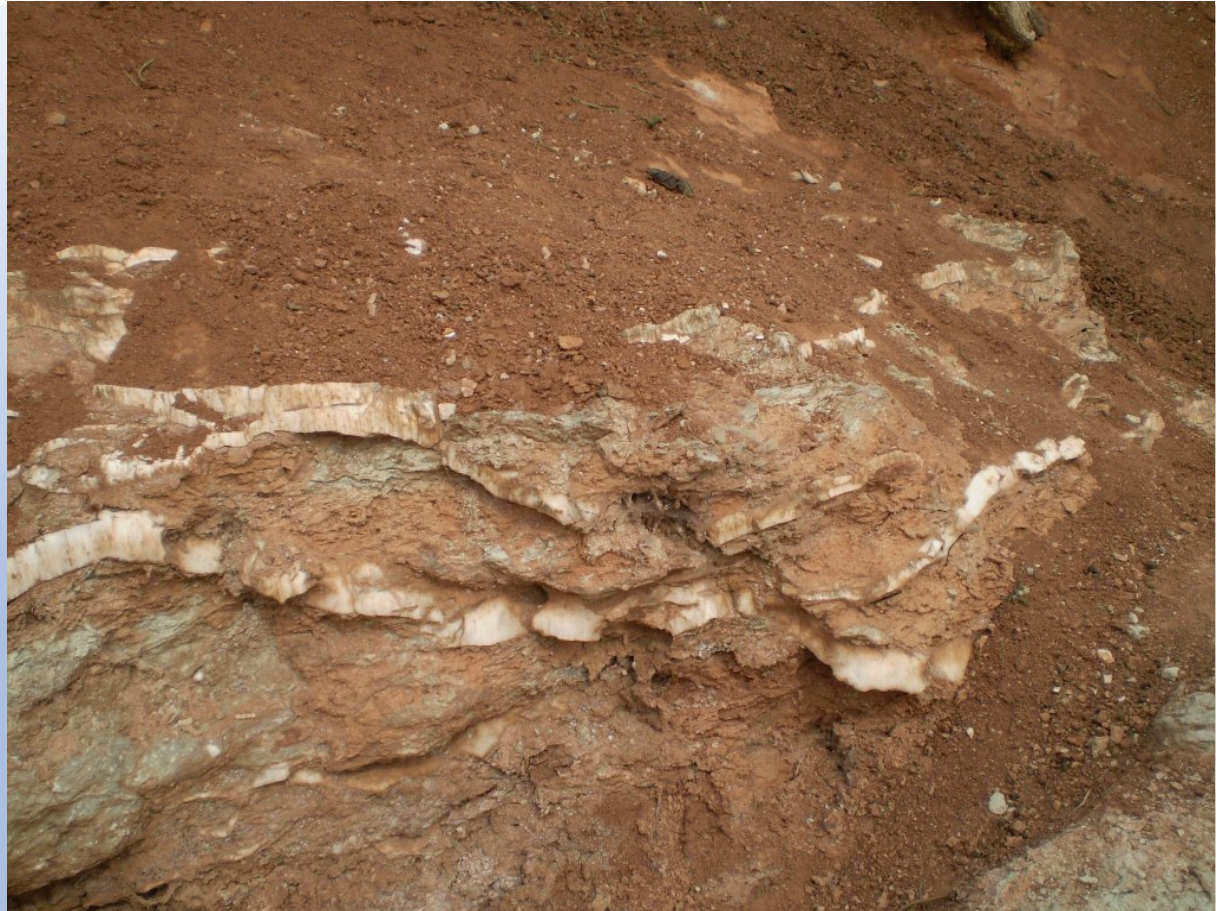
Field Observations on Strength

- At Newton Cliff – steep slopes
- Slope angle estimated
- Strong bands of mudstone, skerries, gypsum, etc.
- overall effect is soil or “rock” mass with significant c' component

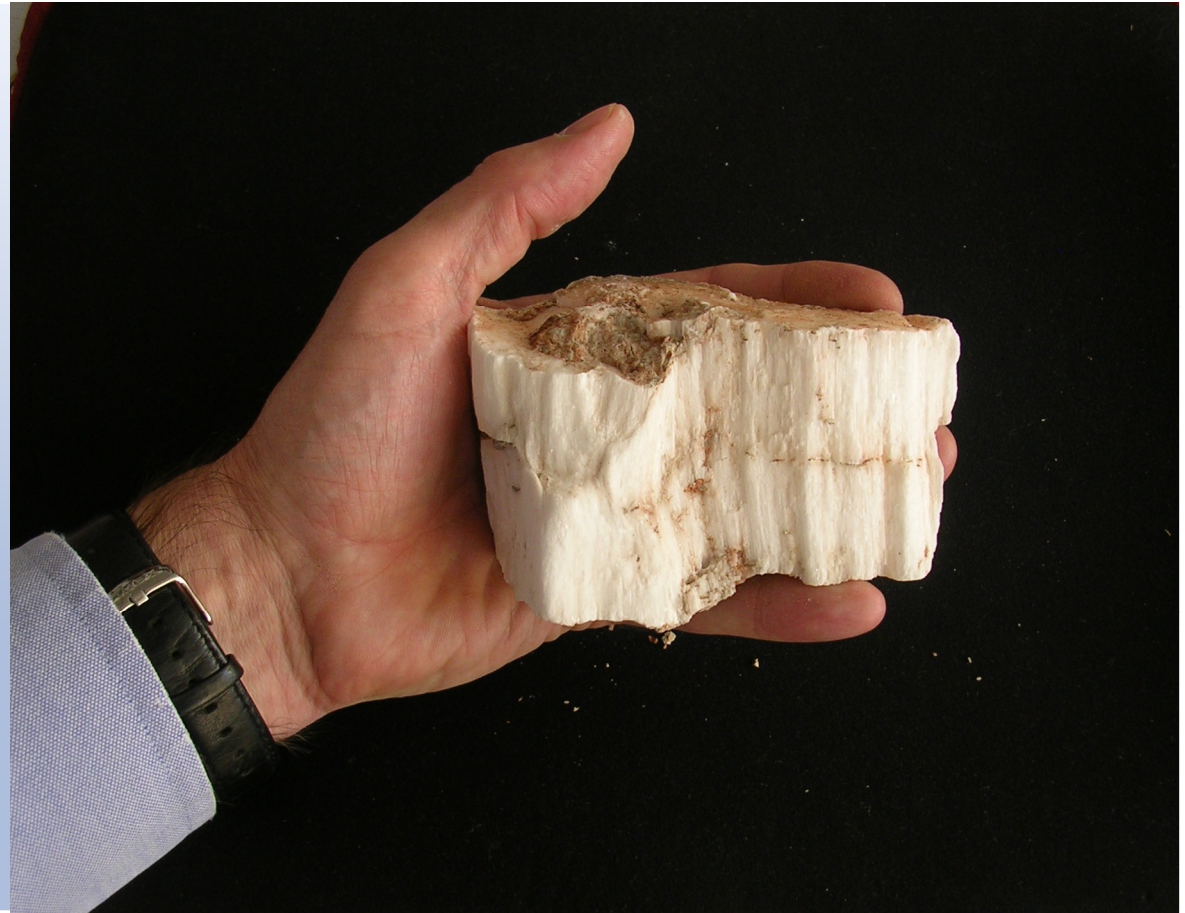
Gypsum veins common

High sulphates –

Equivalent to Class
DS3 in soils and DS4
in groundwater

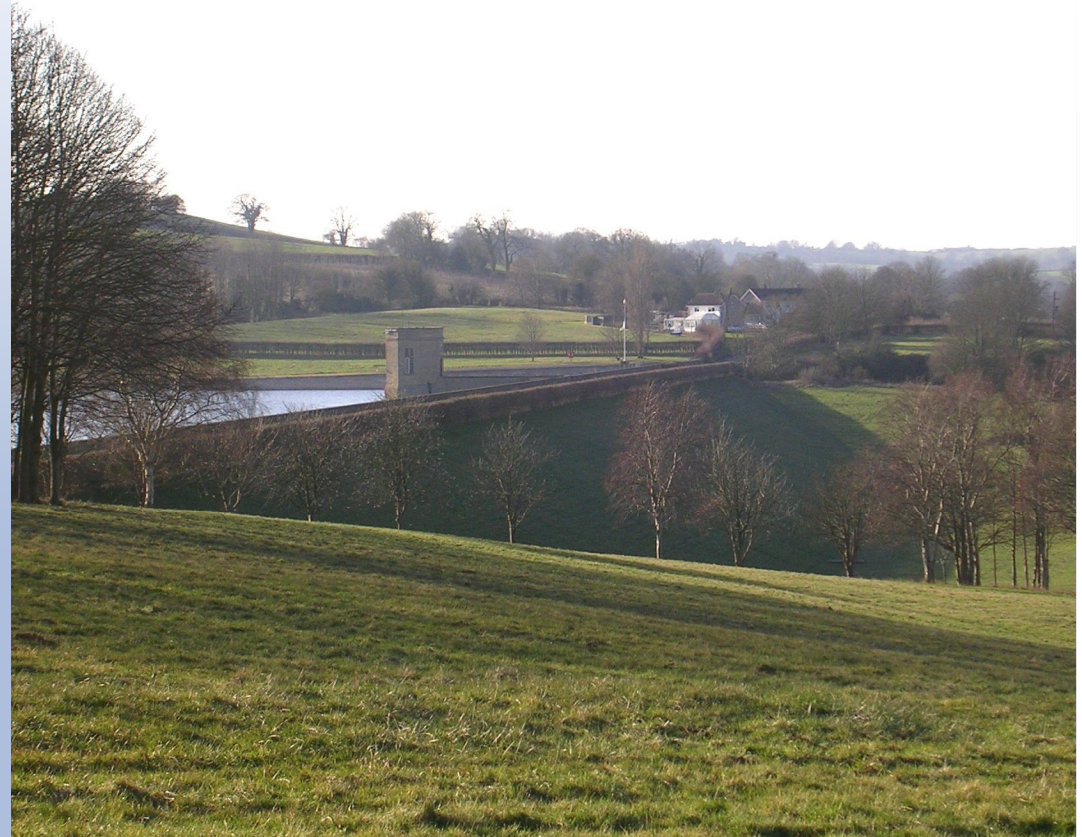
Chew Valley Dam, Bristol

- Bristol Water
- Constructed 1957
- Public Water Supply
- 12m high, 470m long
- Capacity 20,457,000 m³
- Clay core with concrete cut-off
- Minor leakages only

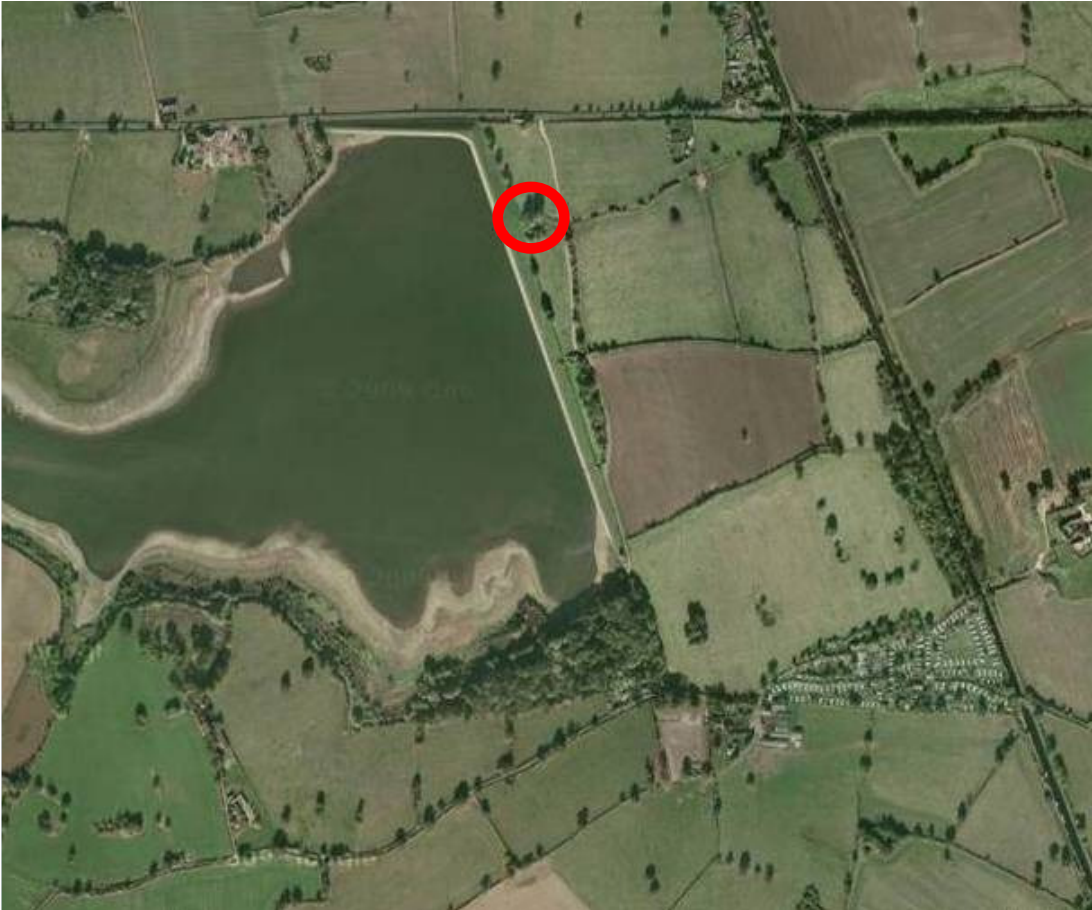
Belvide Dam, Shropshire

- British Waterways
- Constructed 1833
- Canal Feeder
- 14m high, 1,025m long
- Capacity 2,196,000 m³
- Clay core
- Foundation leakages around the “morass”
