Track Monitoring Data Systems for Evaluation of Earthworks Instability

*Ian Payne – Senior Asset Engineer (Geotechnics)
Jonathan Garelick – Asset Engineer (Geotechnics)
Jason Lund - On Track Machine Engineer*

26th October 2017

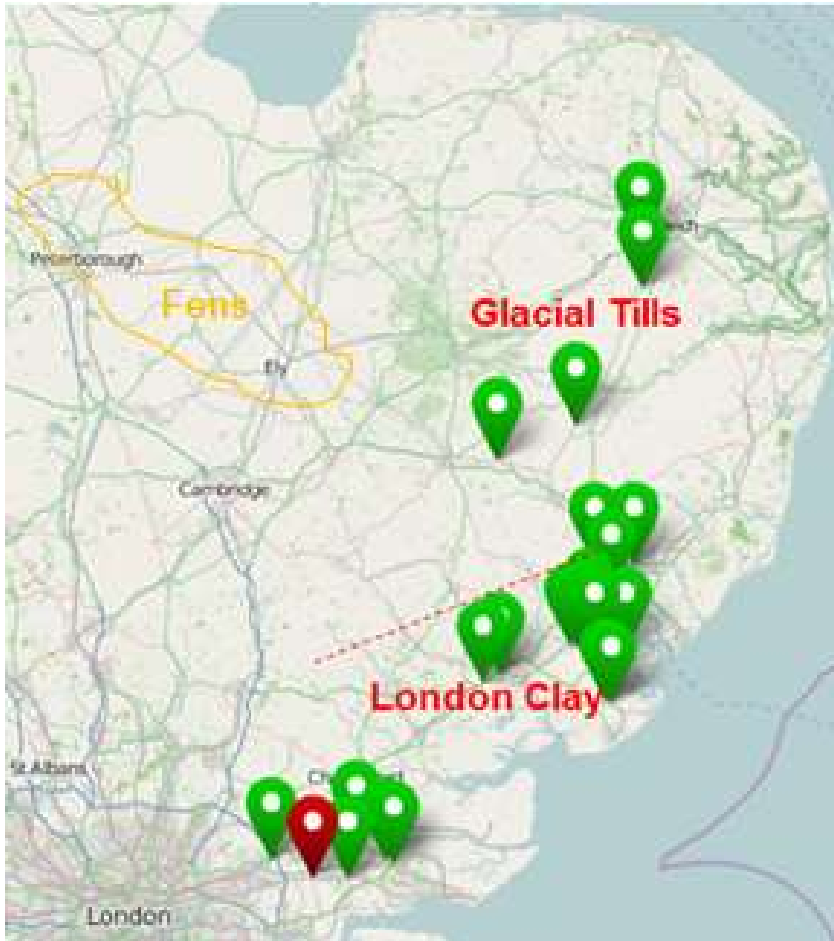
Large post construction collapse settlement following rainfall infiltration.
Readily available locomotive ash and track ballast reinstated embankments.

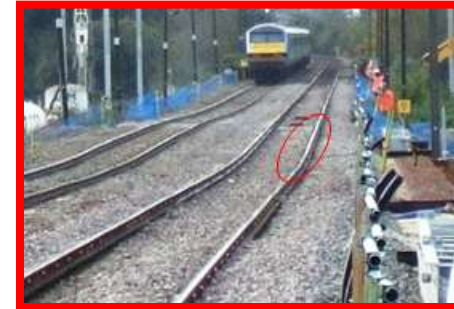
Peat Wastage /Subsidence
Thrandeston Bog 2008

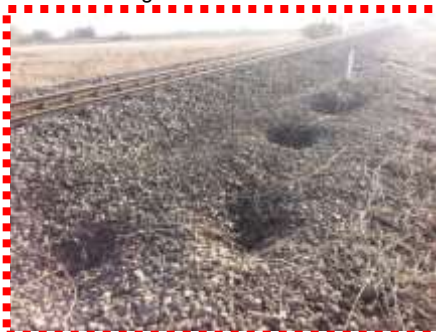
Badger burrowing subsidence
Fordham 2016

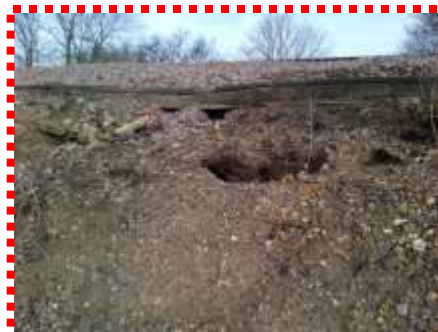
Rabbit burrowing subsidence
Pesthouse Lane 2015

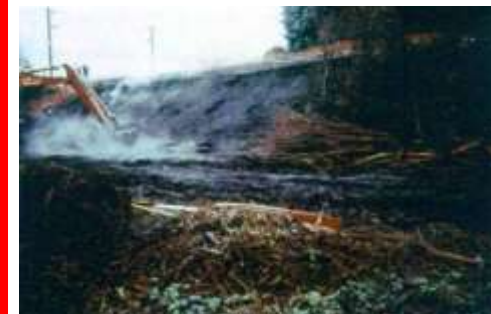
Ash Fires
Jacques Hall 1985

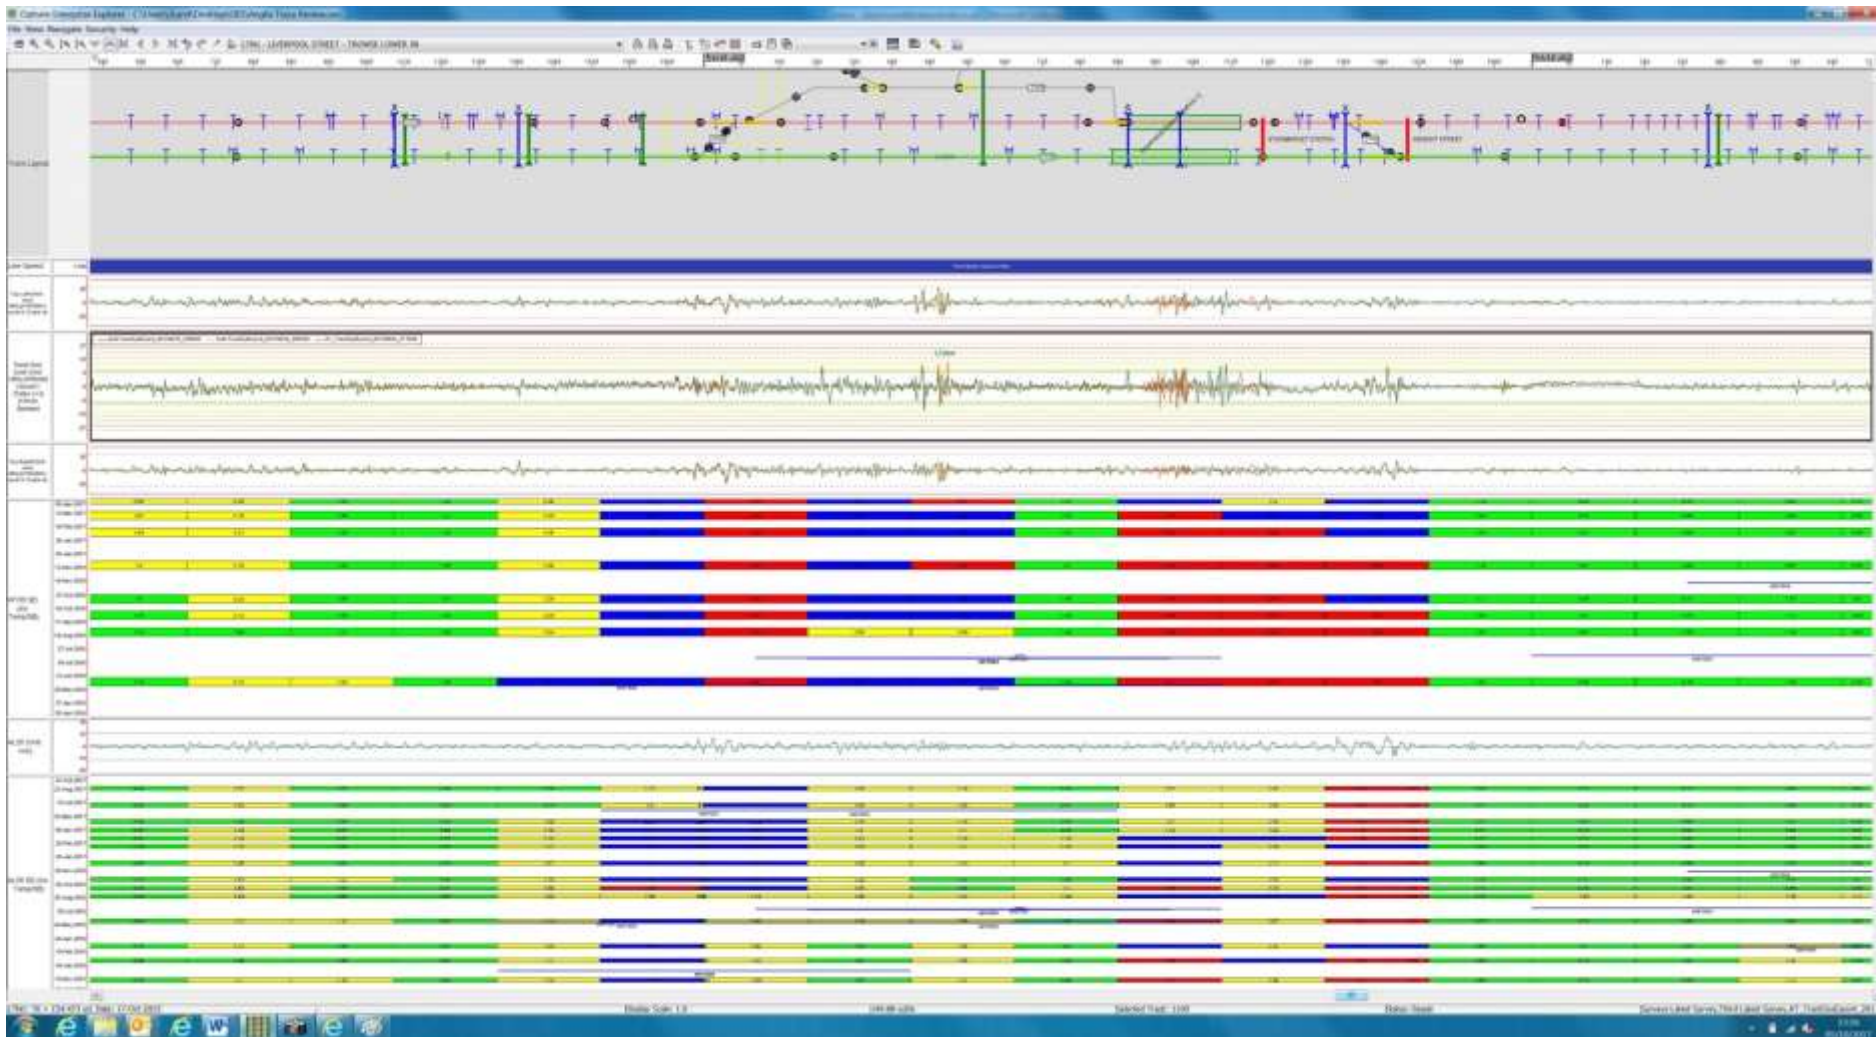
What Bad LADS Track Data Looks Like

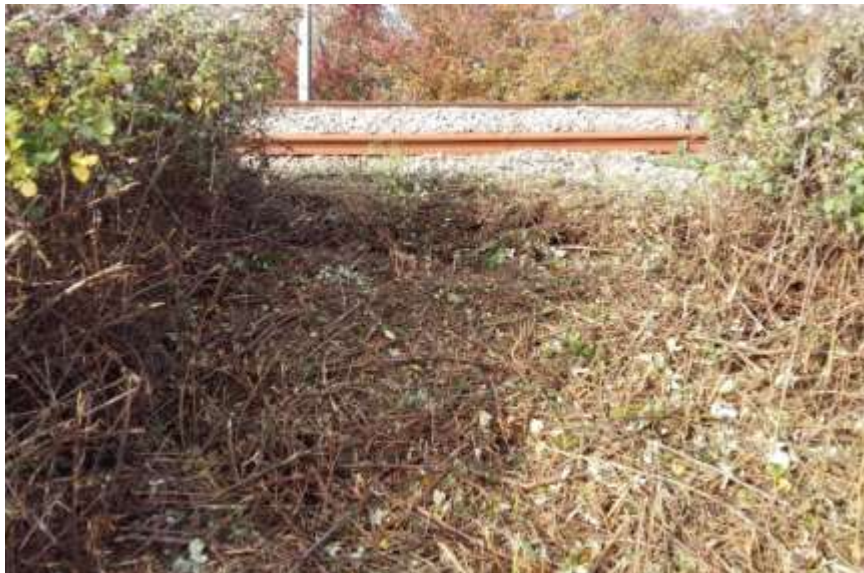
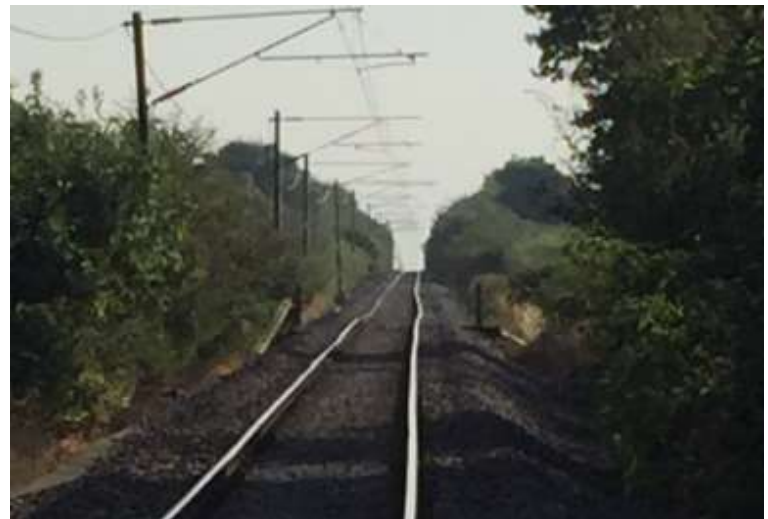
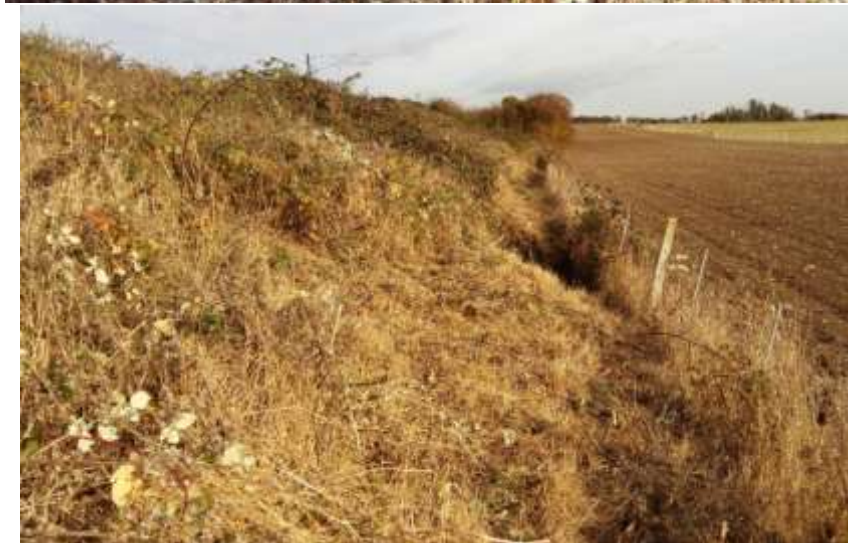
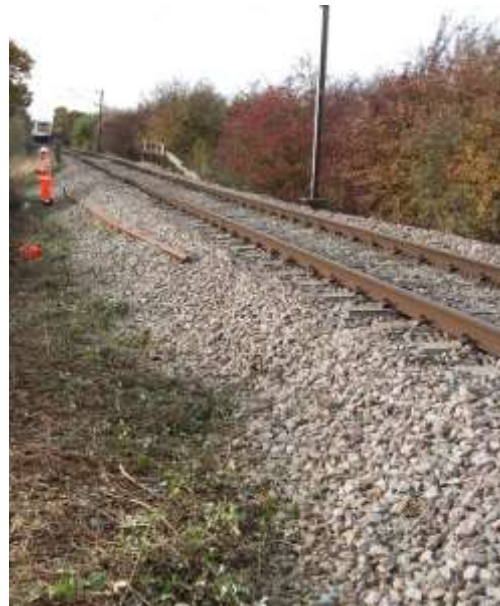
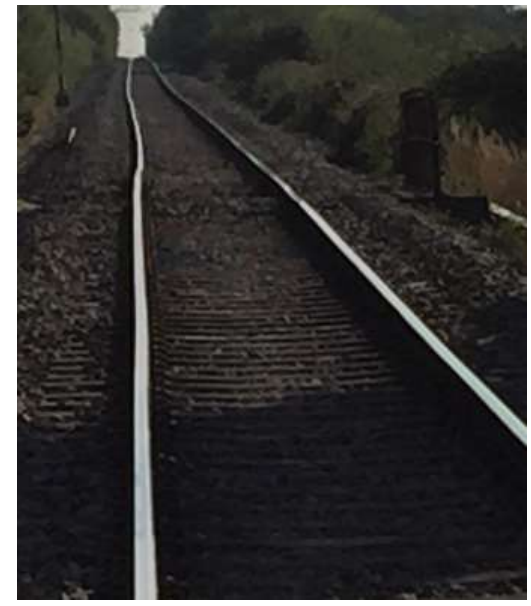
Ulemans Farm WIS 38 miles 1100yds - Embankment instability

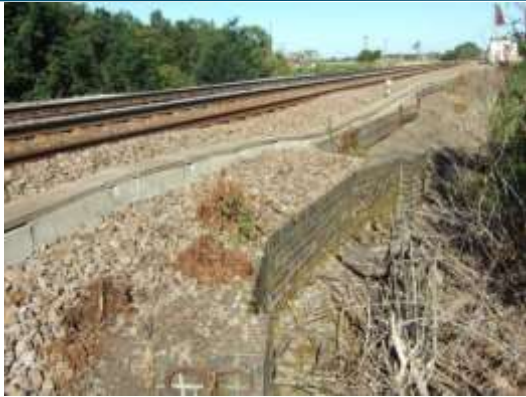
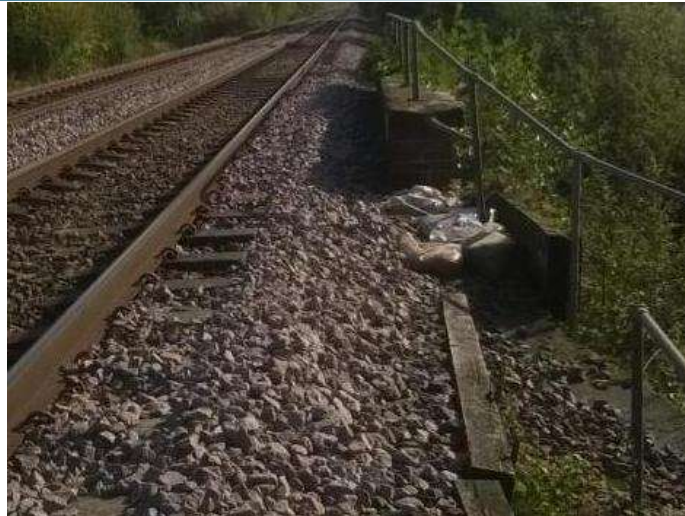
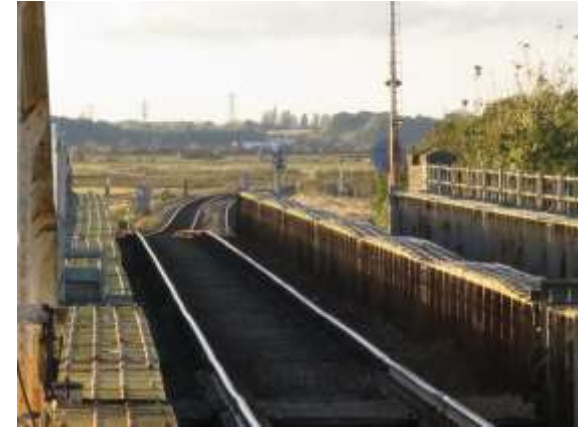
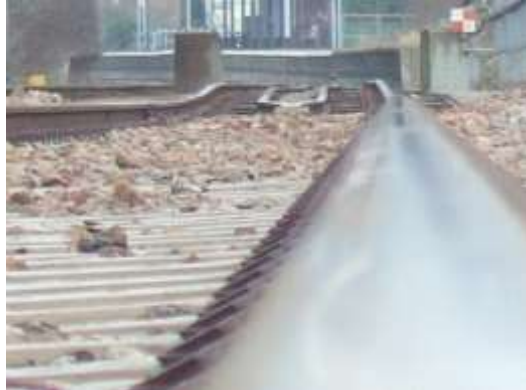
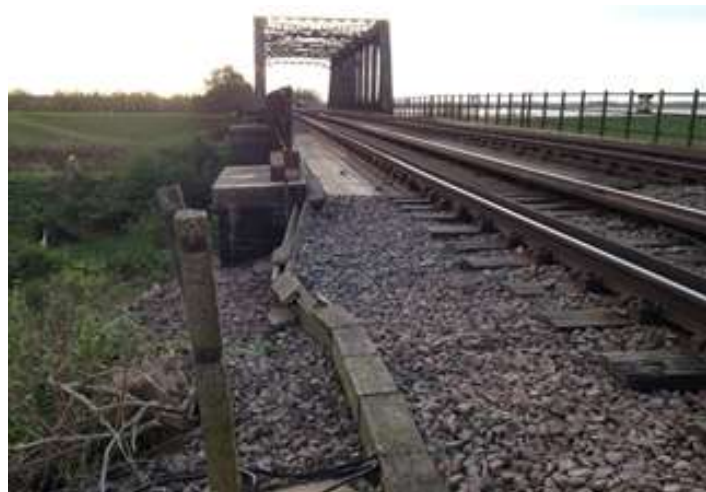
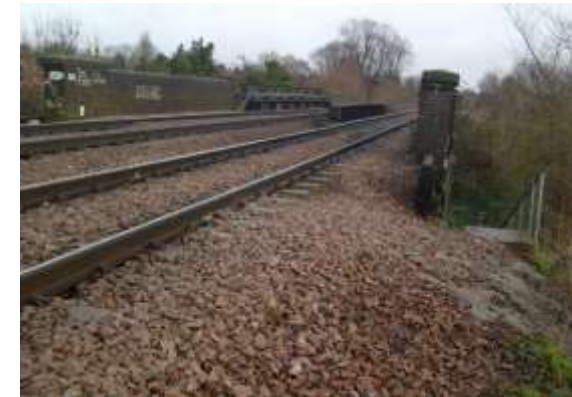
Typical Anglia Embankment/Structure Run-on/Run-off Differential Settlements

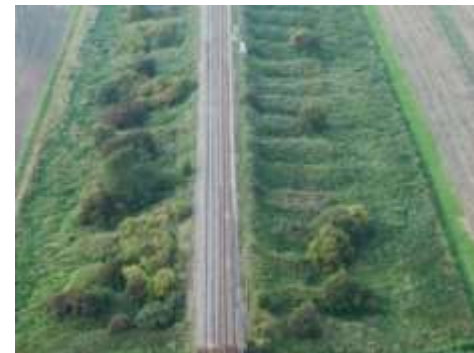
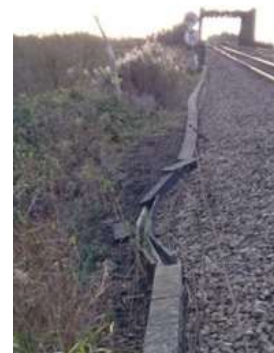
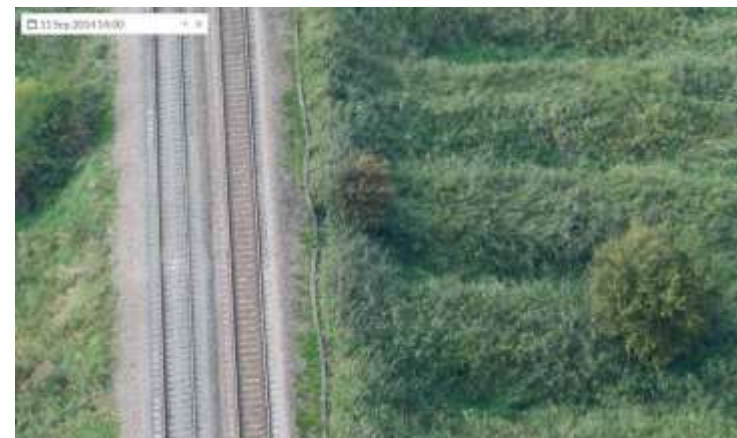
Manea Viaduct Approach Embankments EMP 78m (east) to 79m (west) - LADS Down

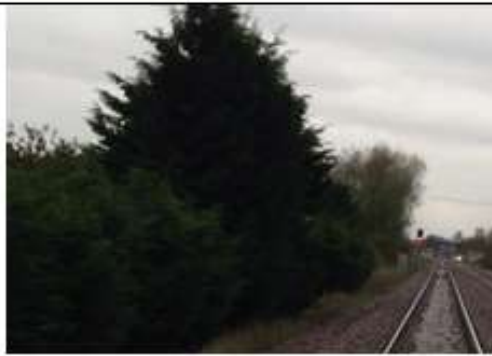
Plate-6a-72m-1020yds-Up-to-0940yds

Local Twist Faults on Peat Fens due to Trees
